FINAL 11-16-20

MAP 'AA' - AREAS WITHIN ASSOCIATION RESPONSIBILITY

RANCHO VISTOSO COMMUNITY ASSOCIATION - DRAINAGE FACILITIES INVENTORY MAP 'ES' - EAGLE SUMMIT

2020.03.xx
WLB No. 185050-V-A06

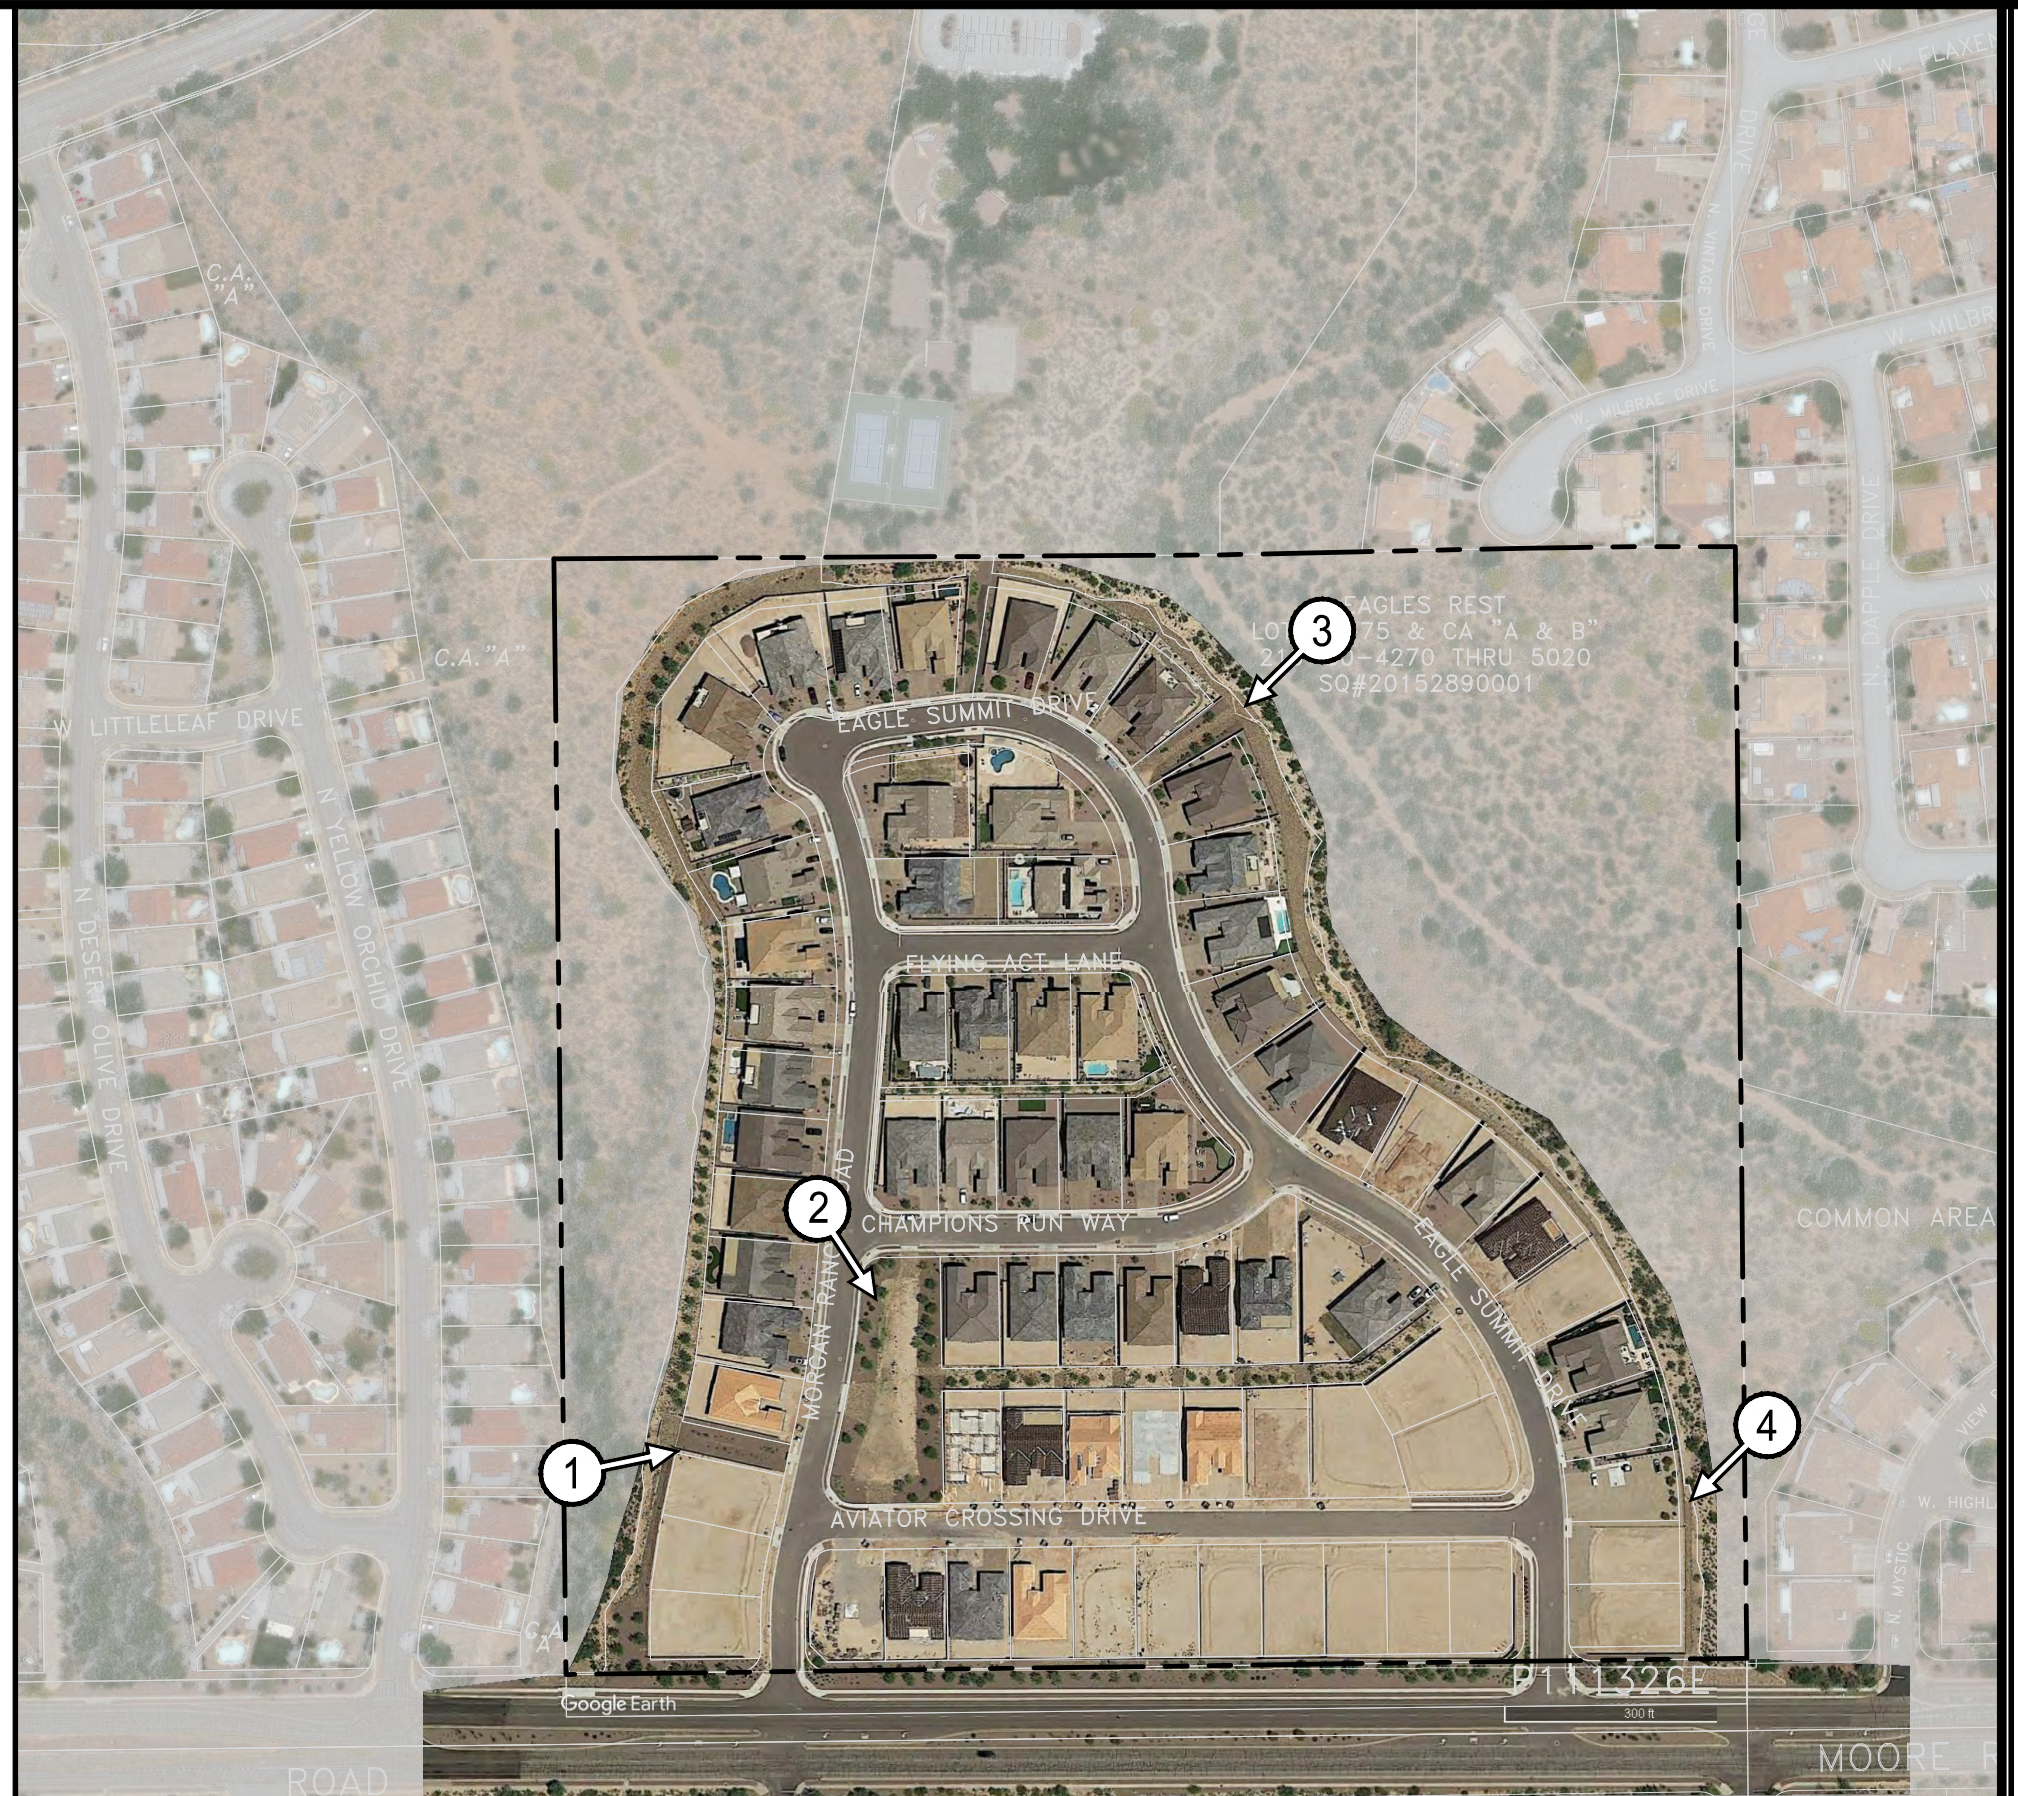
MAP 'ES' - EAGLE SUMMIT

RANCHO VISTOSO MASTER ASSOCIATION				
Subdivision/Facility ID	Date/Description	Field Observations	Priority	Recommendations
Eagle Summit (ES)	May 2020			PRIORITY: Red - Urgent, Blue - 0 to 6 months, Yellow - 6 to 12 months, Clear - Monitor
Site 1	Detention/Retention Basin and Channel outlet	Facilities in good condition ; the channel outlet has minor erosion and vegetative growth		Repair outlet and remove excess vegetation
Site 2	Detention/Retention Basin	Basin in good condition (includes outlet pipes, scuppers and slopes); Grass and vegetation present		
Site 3	Channel with Spillway	Channel in good condition ; some erosion at the outlet spillway (south side)		Repair erosion at outlet
Site 4	Rock rip rap Swale	Swale in good condition

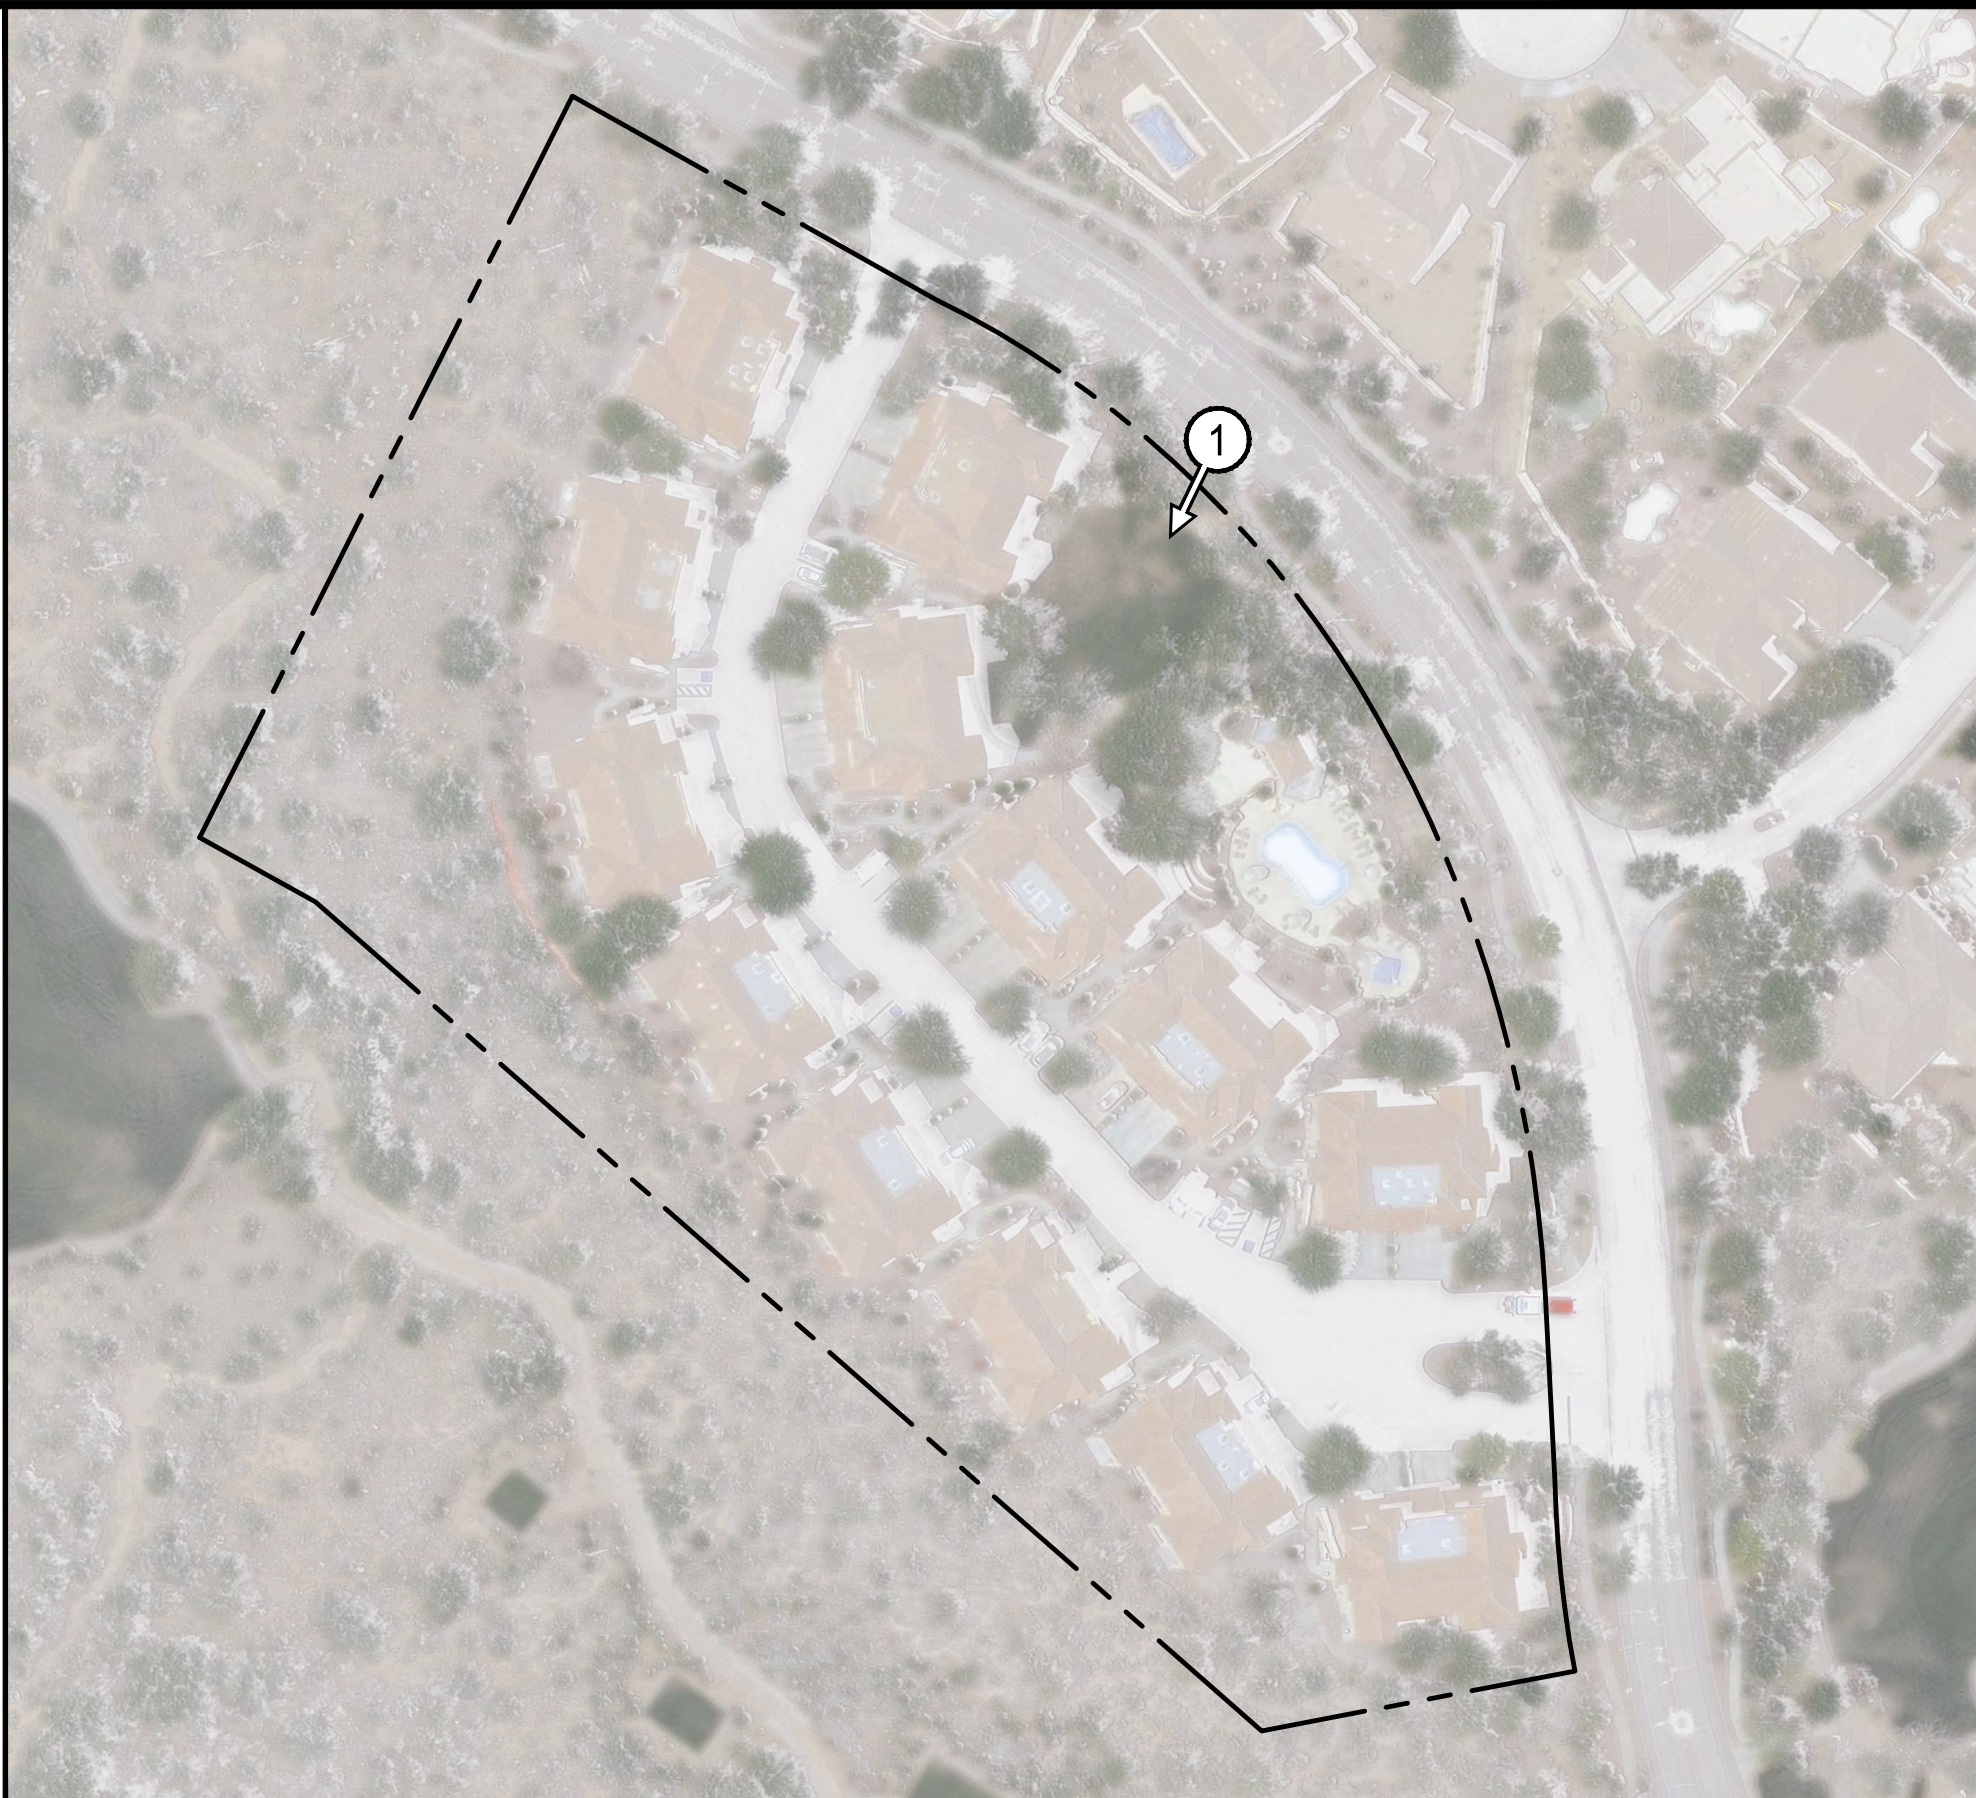
MAP G1' - VISTOSO GOLF CASITAS I

RANCHO VISTOSO MASTER ASSOCIATION				
Subdivision/Facility ID	Date/Description	Field Observations	Priority	Recommendations
Vistoso Golf Casitas I (G1)	March 2020			PRIORITY: Red - Urgent, Blue - 0 to 6 months, Yellow - 6 to 12 months, Clear - Monitor
Site 1	Splash pads into Detention/Retention Basin with Culvert outlet	Splash pads intact, culvert has minor sedimentation and debris

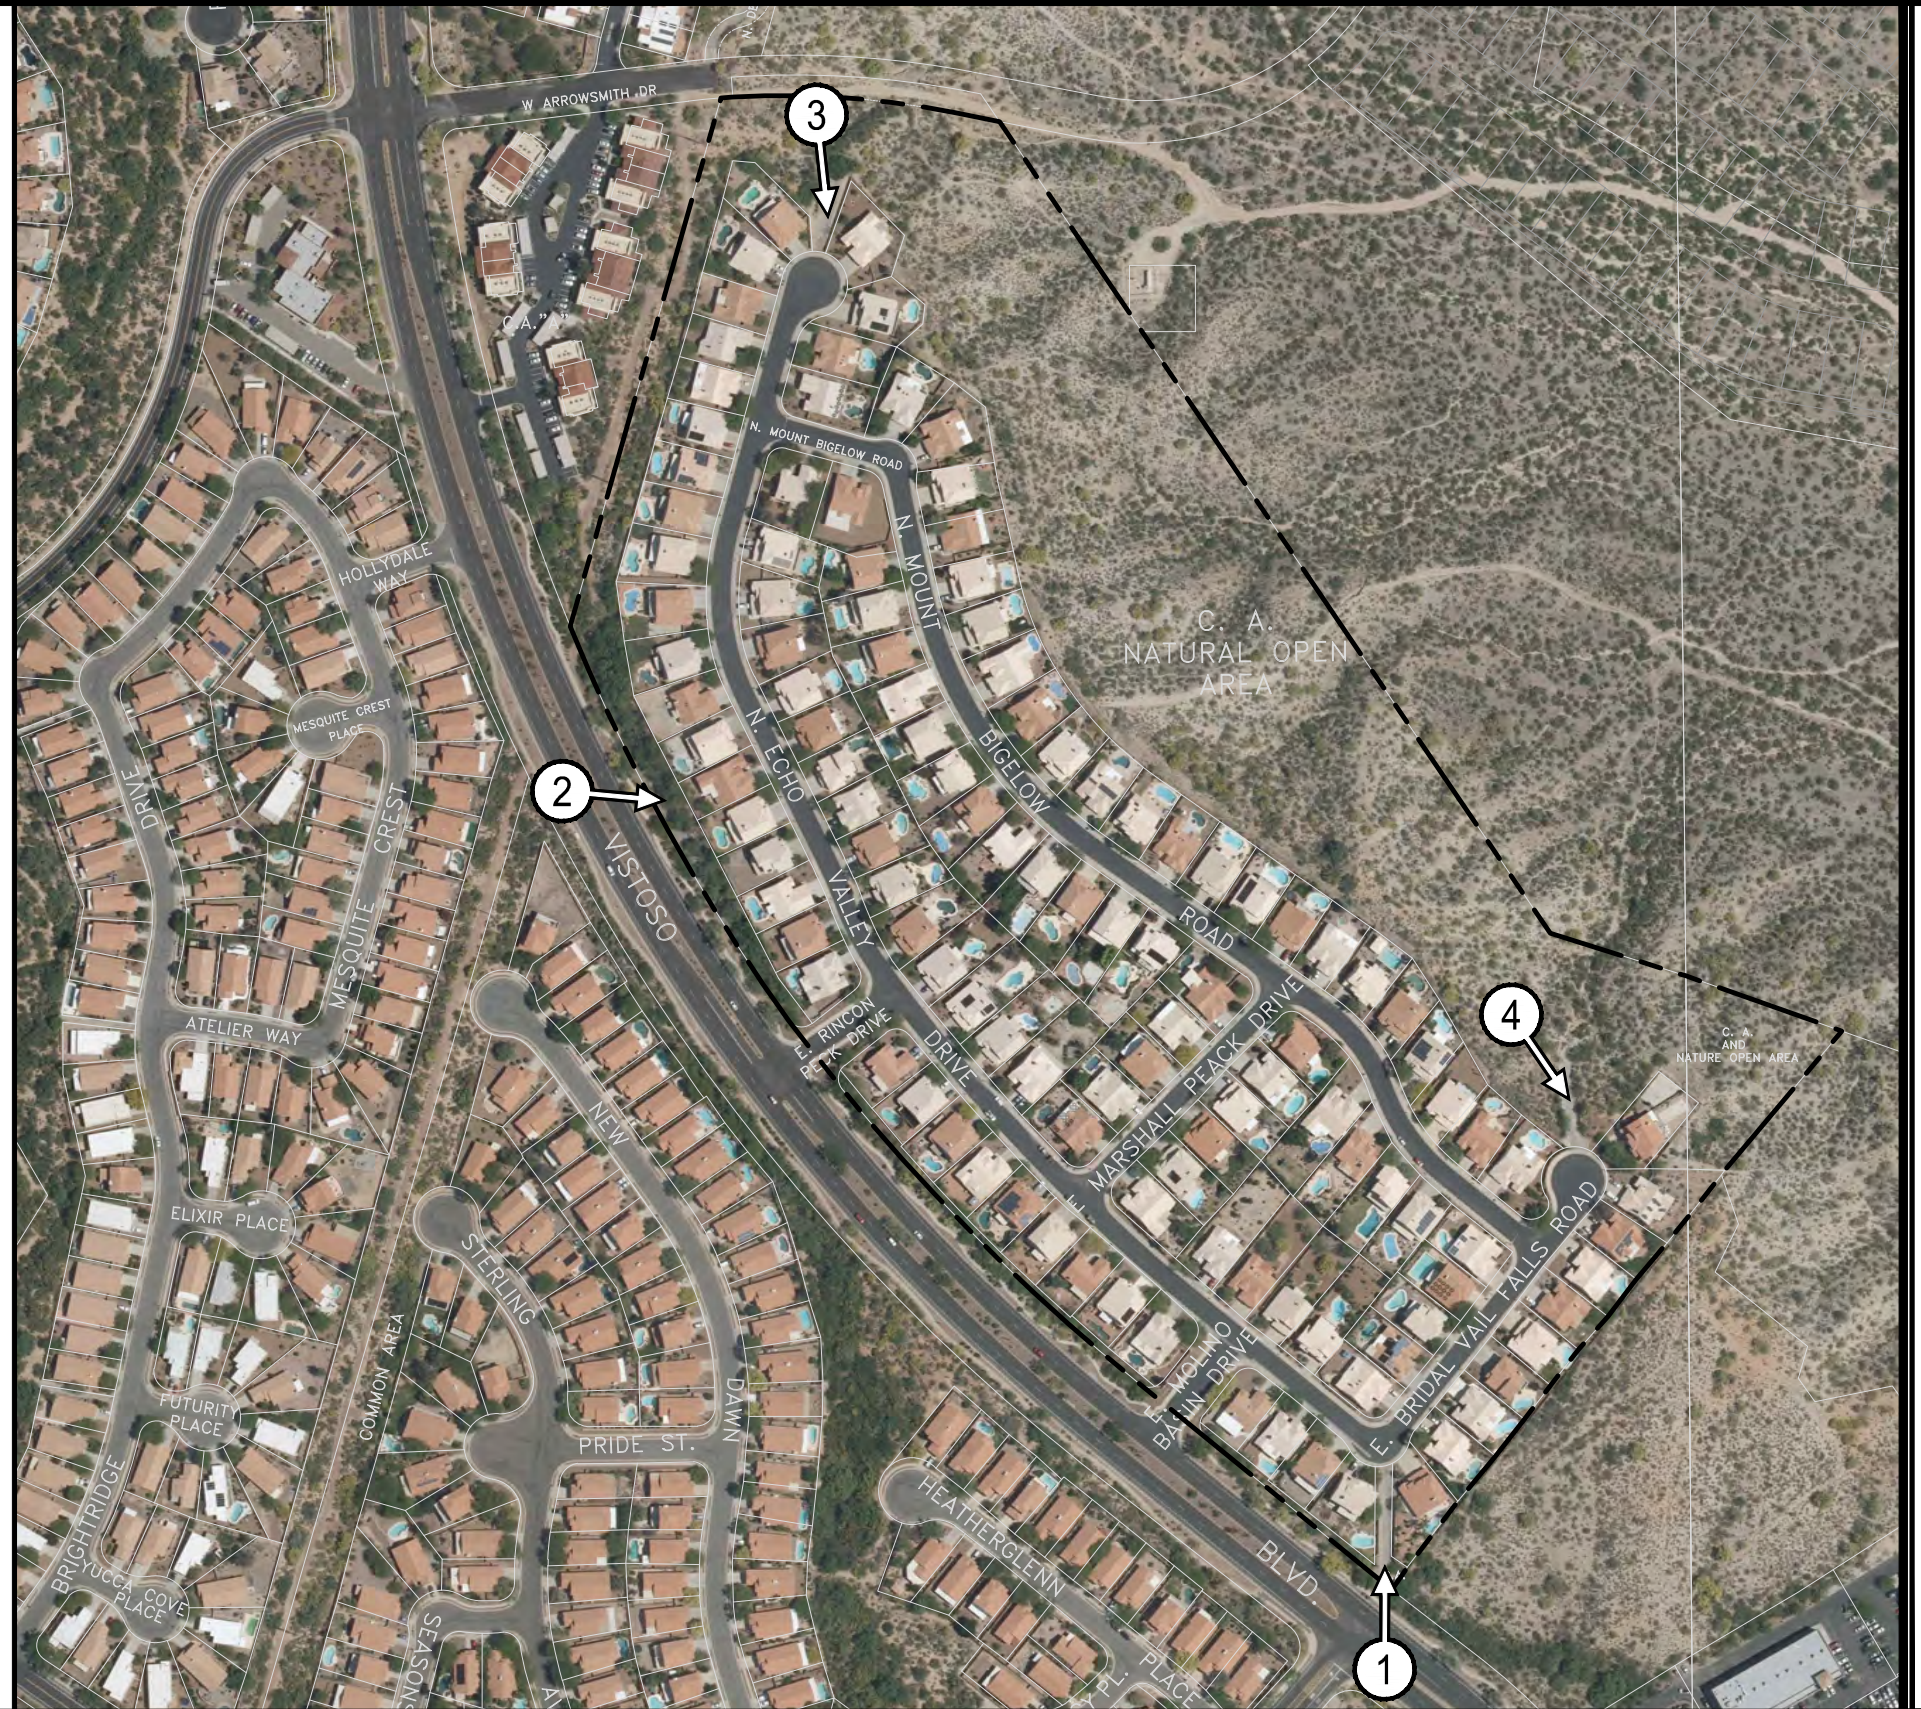
MAP 'HZ' - HORIZONS

RANCHO VISTOSO MASTER ASSOCIATION - DRAINAGE INVENTORY - NOVEMBER 2020				
Subdivision/Facility ID	Date/Description	Field Observations	Priority	Recommendations
Horizons (HZ)	May 2020			PRIORITY: Red - Urgent, Blue - 0 to 6 months, Yellow - 6 to 12 months, Clear - Monitor
Site 1	Channel	Channel in good condition		
Site 2	August 2020/Landscaped Slope	Well maintained - good condition		
Site 3	Channel/Spillway	Upstream reach in good condition, erosion occuring at downstream end of rip rap		Repair erosion
Site 4	Channel	Upstream in good condition; major erosion is occuring downstream		VCA Special Project (Design by WLB) - repair erosion and improve structure

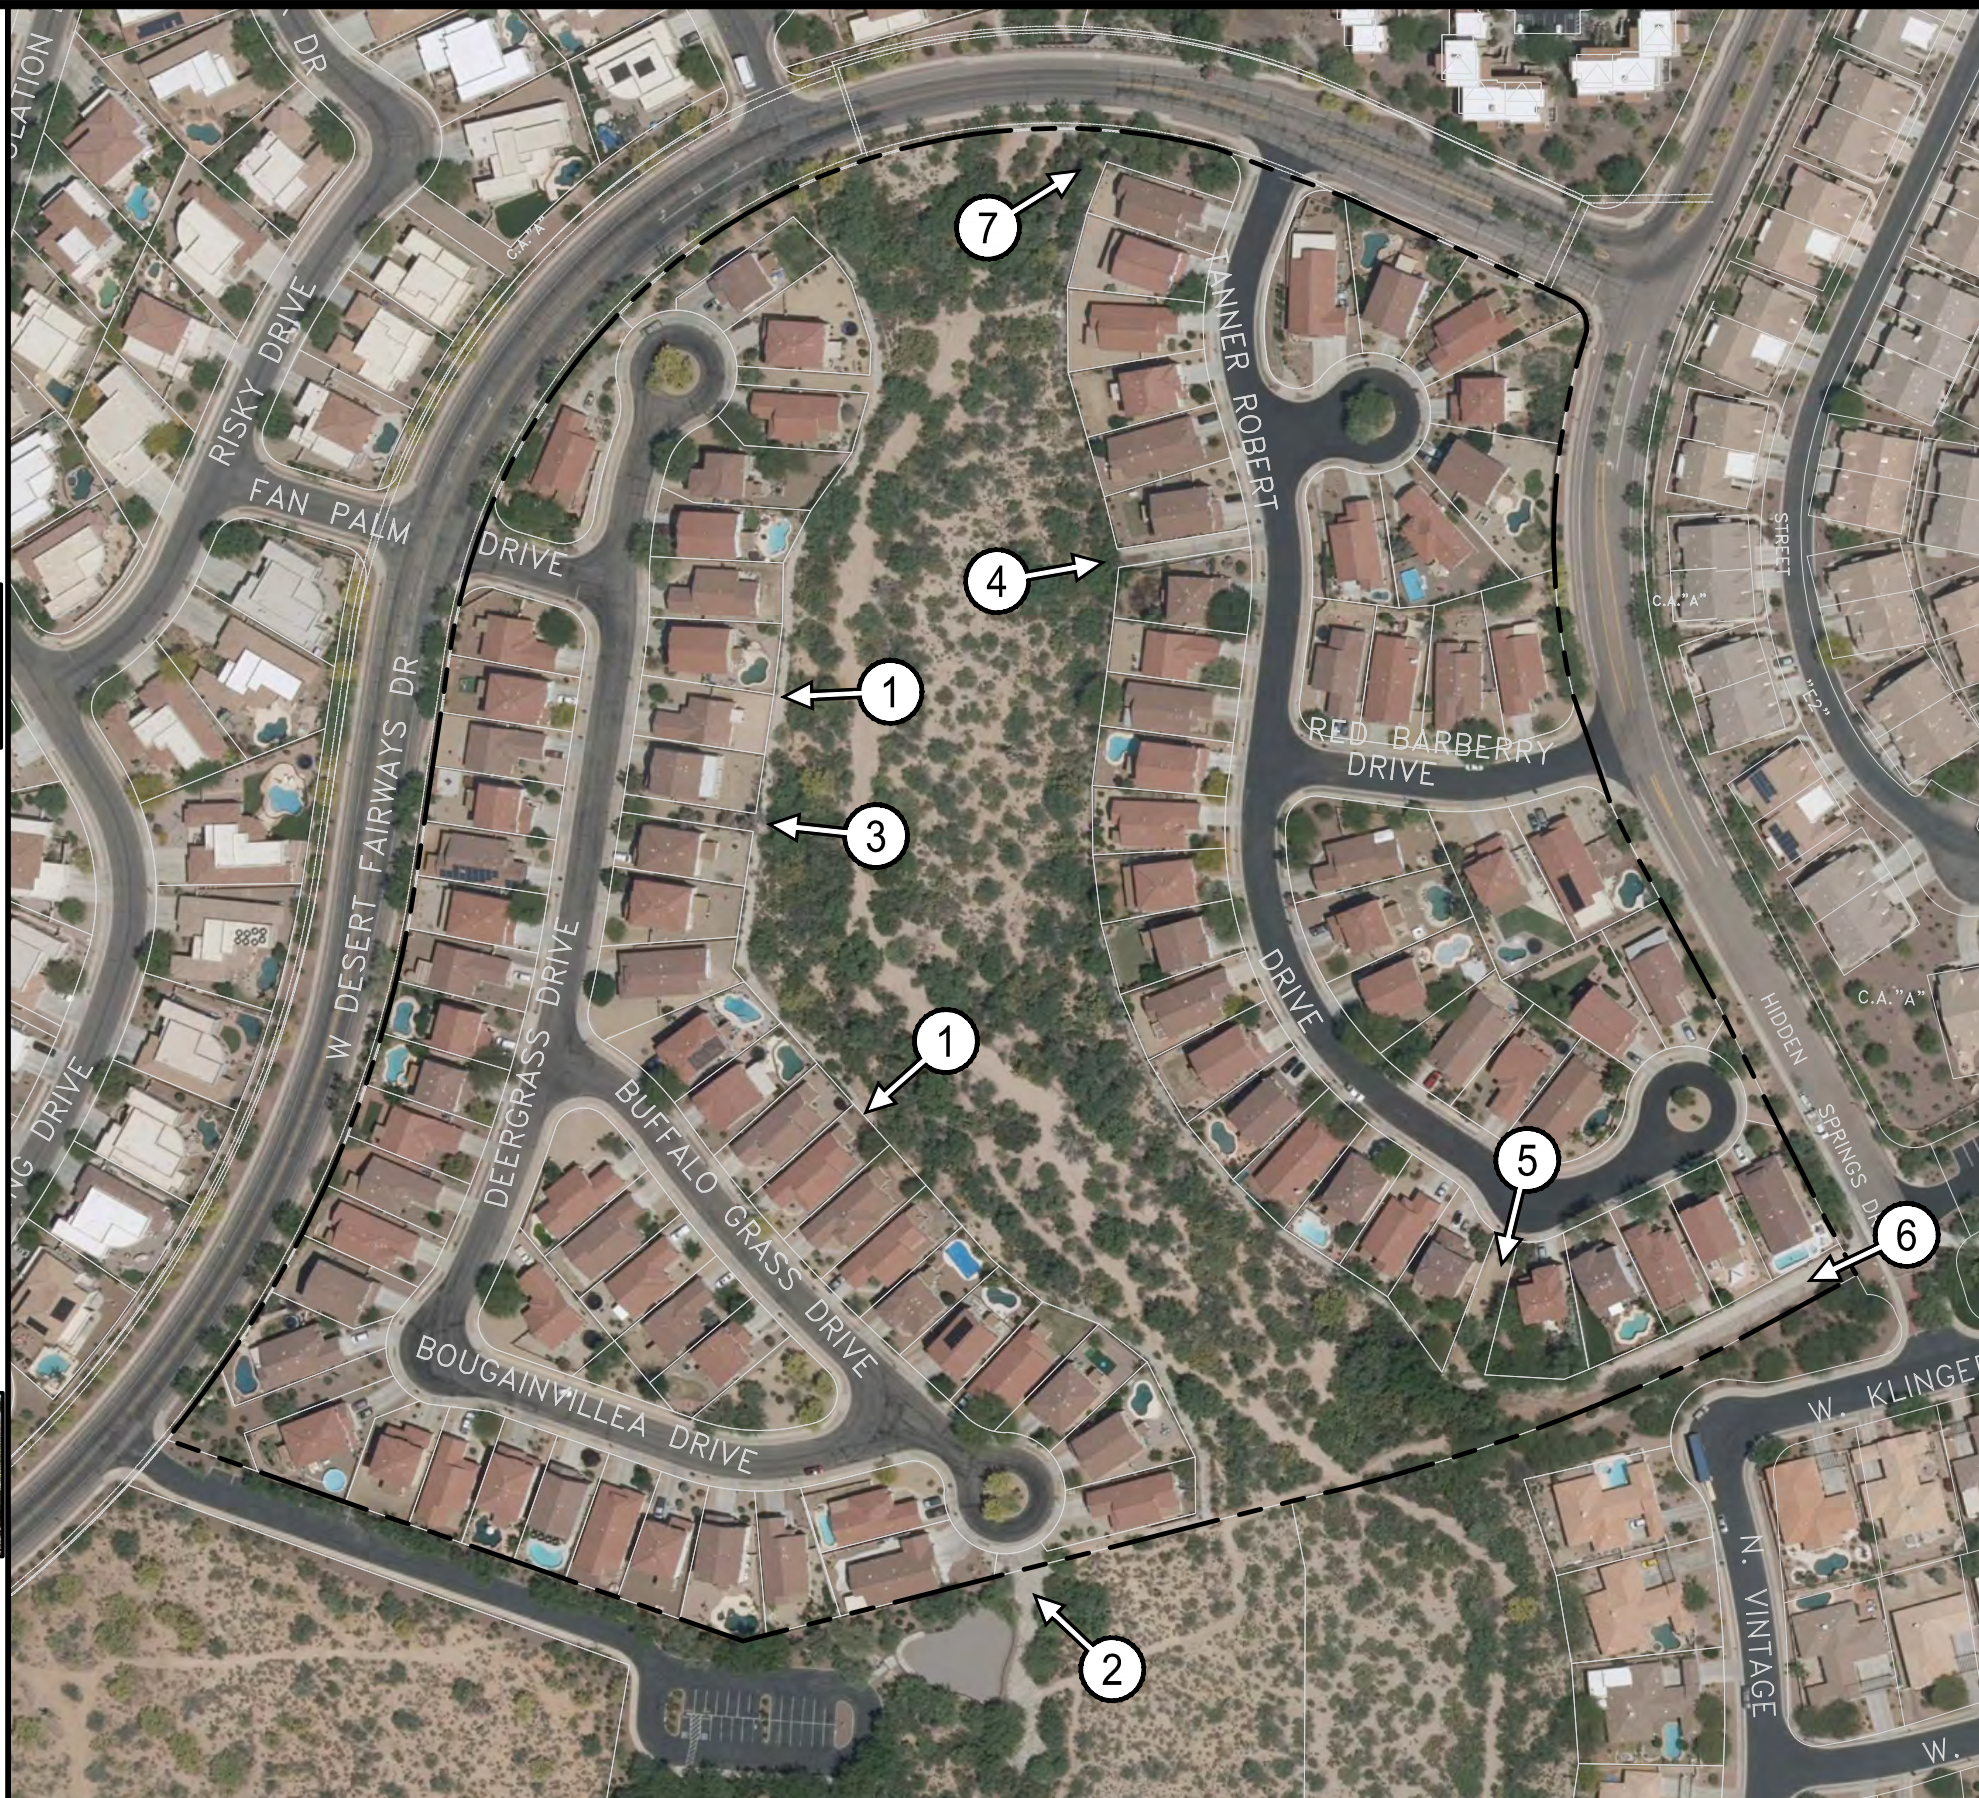
MAP 'S1' - ST. ANDREWS

RANCHO VISTOSO MASTER ASSOCIATION - DRAINAGE INVENTORY - NOVEMBER 2020				
Subdivision/Facility ID	Date/Description	Field Observations	Priority	Recommendations
St. Andrews (S1)	March 2020			PRIORITY: Red - Urgent, Blue - 0 to 6 months, Yellow - 6 to 12 months, Clear - Monitor
Site 1	Retaining Wall within Channel	Retaining wall intact, overgrowth within channel		Clear overgrowth in chsnnel
Site 2	Sidewalk Scupper to Channel	Sidewalk scupper clear of debris, channel intact (large rocks within)		
Site 3	August 2020/Grate Inlet, Pipe, Rip-Rap Wall	Grate Inlet and pipe clear of debris, rip-rap wall good condition, heavy vegetation present		Clear vegetation overgrowth at pipe outlet and along wall
Site 4	Grate Inlet to Channel	Grate Inlet clear of debris, minor sedimentation within channel bed		
Site 5	August 2020/Grate Inlet, Pipe, Rip-Rap Wall	Grate inlet clear of debris, pipe outlet and rip-rap wall covered with heavy vegetation overgrowth		Clear vegetation overgrowth at pipe outlet and along wall, inspect pipe for debris (remove if necessary), and inspect wall condition

Site 6	Channel	Channel in fair condition, minor sedimentation within channel bed		
Site 7	Wall and Channel side	Some noticeable leaning of lot wall, overgrowth within channel.		Recommend the wall be evaluated for repair

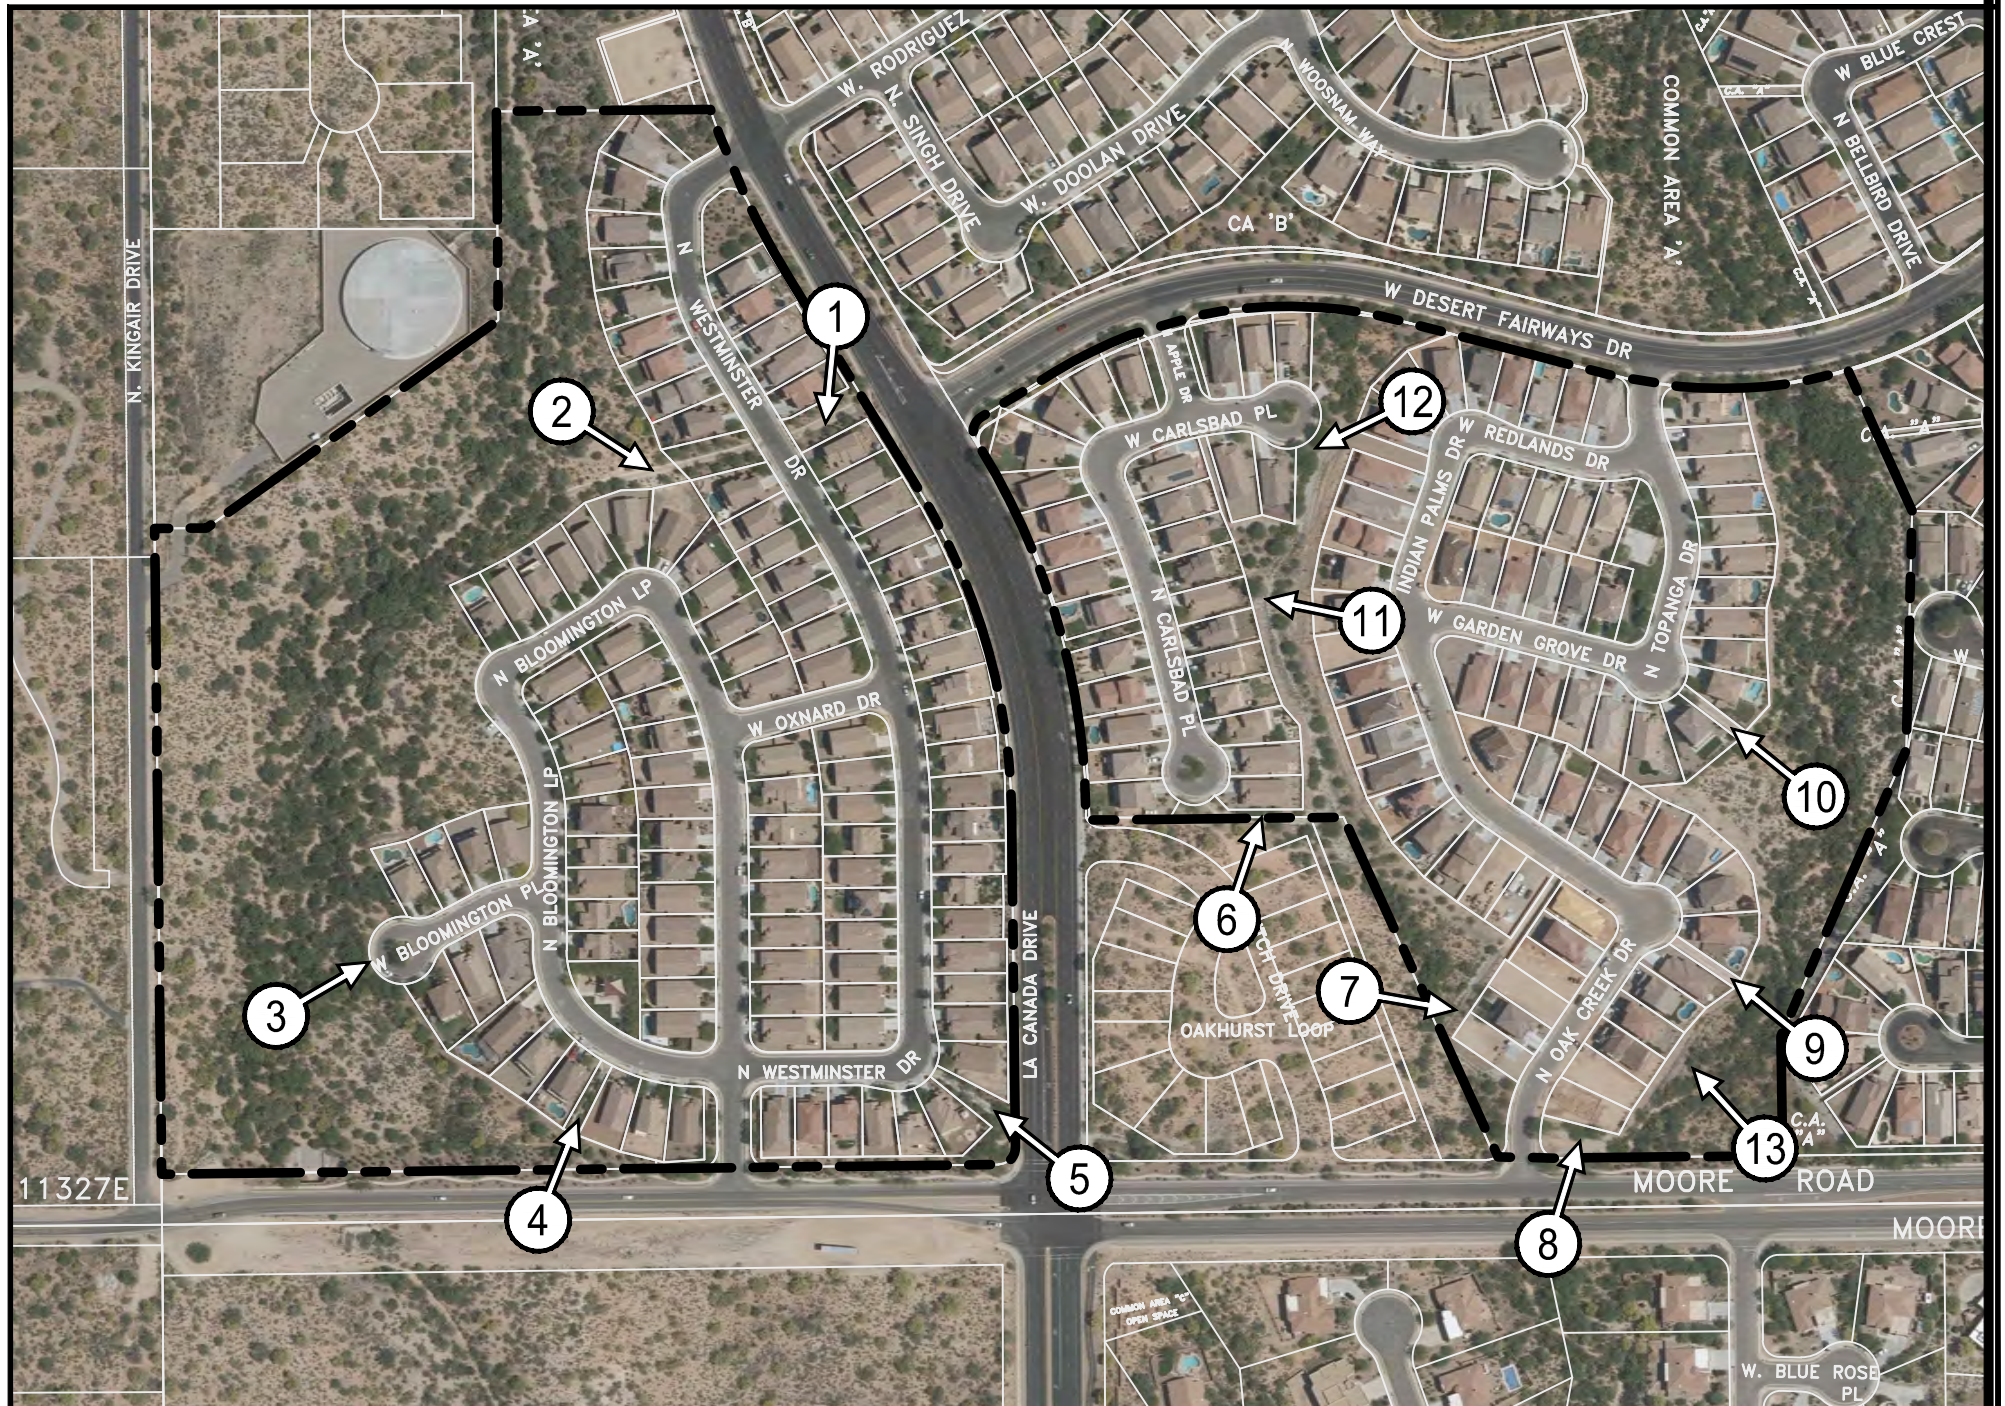
MAP 'TR' - TORRENO

RANCHO VISTOSO MASTER ASSOCIATION				
Subdivision/Facility ID	Date/Description	Field Observations	Priority	Recommendations
Torreno (TR)	May/June 2020			PRIORITY: Red - Urgent, Blue - 0 to 6 months, Yellow - 6 to 12 months, Clear - Monitor
Site 1	Channel	Channel in good condition		
Site 2	Channel	Channel in good condition; at the outlet to natural wash, heavy vegetation obstructing flow		Remove vegetation at channel outlet
Site 3	Scupper	Scupper and rip rap in good condition; excess vegetation at the natural wash		Remove excess vegetation
Site 4	Scupper/Channel	Scupper, channel and outlet in good conditon; some vegetative overgrowth into the natural wash		Remove excess vegetation
Site 5	Scupper/Channel	Scupper, channel and outlet in good conditon		
Site 6	Scupper/Channel	Scupper and channel in good condition; some vegetative overgrowth at the outlet		Remove excess vegetation
Site 7	Channel	Channel in good condition; vegetative overgrowth at the rip rap outlet		Remove excess vegetation

Site 8	Channel	Channel in good condition		
Site 9	Scupper/Channel	Scupper and channel in good condition; debris and vegetative overgrowth at outlet		Remove excess vegetation
Site 10	Scupper/Channel	Scupper and channel in good condition; debris and vegetative overgrowth at outlet		Remove excess vegetation
Site 11 & 12	Scupper/Channel	Scupper and basin look good; significant vegetation in the channel and vegetative overgrowth at downstream rip rap outlet		Remove excess vegetation
Site 13	Detention/Retention Basin	Excessive foliage in the basin		Thin out the vegetation/foliage/trees
