Update "With-Site-Visit" Reserve Study

Vistoso Community Master Association Oro Valley, AZ

Report #: 8973-8
For Period Beginning: January 1, 2021
Expires: December 31, 2021

Date Prepared: October 8, 2020

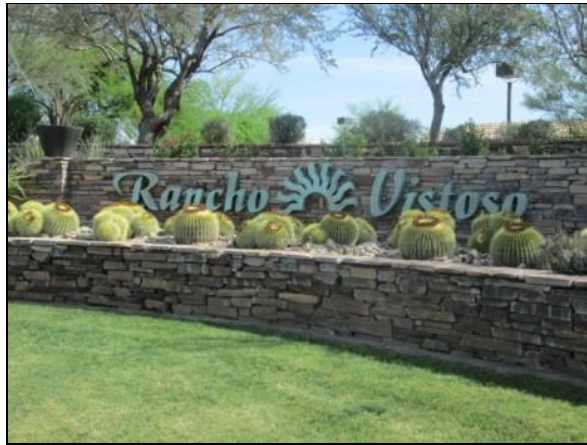
Comp #: 100 Monuments - Replace

Useful Life:
25 years

Remaining Life:
5 years

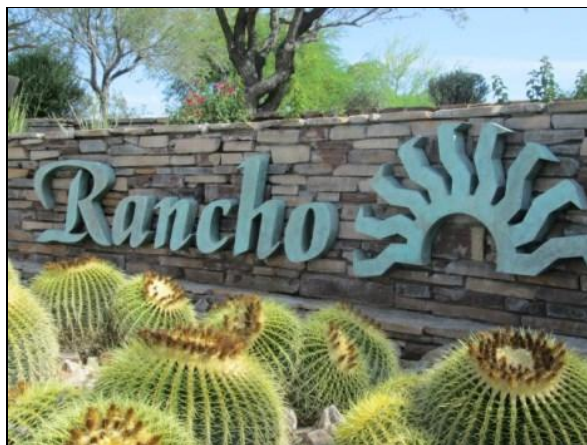
Useful Life:
5 years

Remaining Life:
0 years

Best Case: \$ 3,700

Worst Case: \$ 3,700

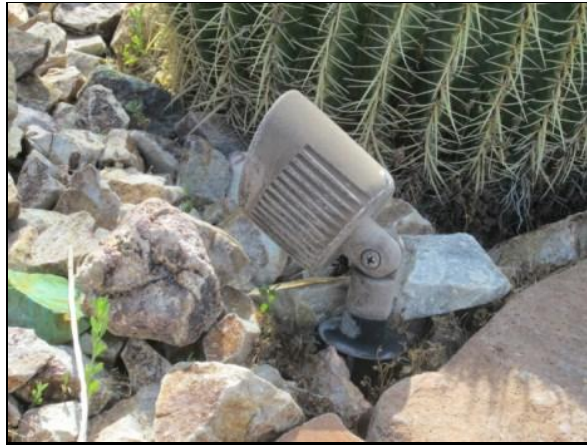
Useful Life:
15 years

Remaining Life:
4 years

Best Case: \$ 9,500

Worst Case: \$ 9,500

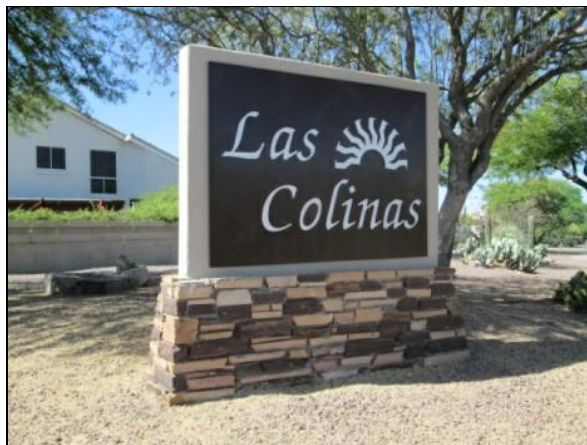
Useful Life:
20 years

Remaining Life:
14 years

Best Case: \$ 84,400

Worst Case: \$ 84,400

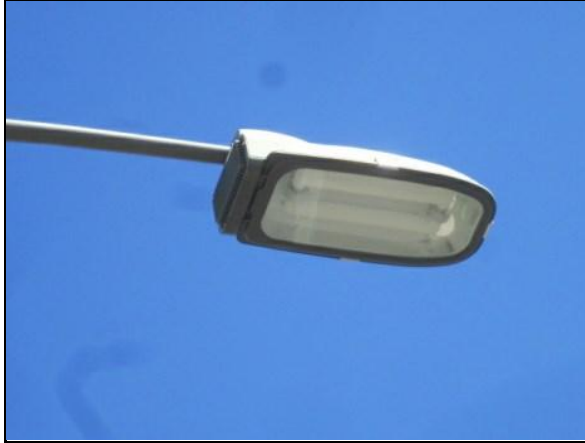
The age difference between these lights is minimal, so plan to replace all of them together in the future. Issues have been reported with parts already obsolete, so that could result in replacing prematurely. Remaining life has been accelerated somewhat in light of this problem. Repair or replace individually as an Operating expense if needed. There is no expectancy for widespread replacement of the light poles under normal circumstances, so this component only funds replacement of the fixture heads.

Useful Life:
25 yearsRemaining Life:
10 years

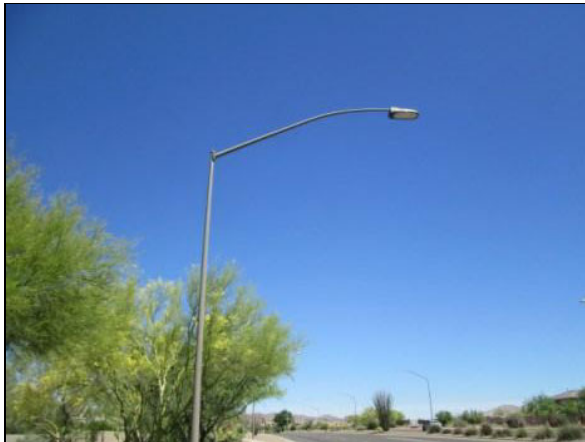
Comments: Surfaces vary in condition. Some still look fine, but others are faded with oxidized paint. Repainting should be planned in the near future.

Useful Life:
8 yearsRemaining Life:
0 years

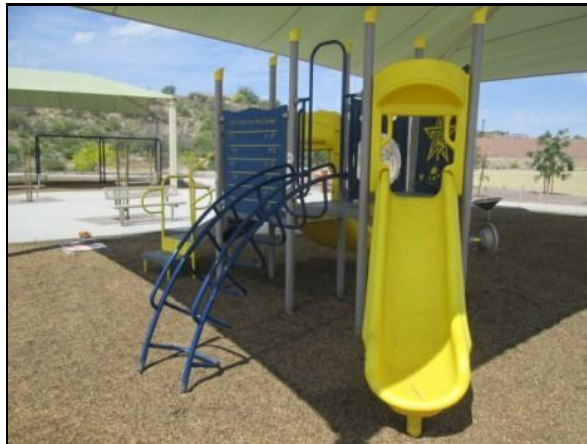
Useful Life:
3 years

Remaining Life:
0 years

Best Case: \$ 5,400

Worst Case: \$ 5,400

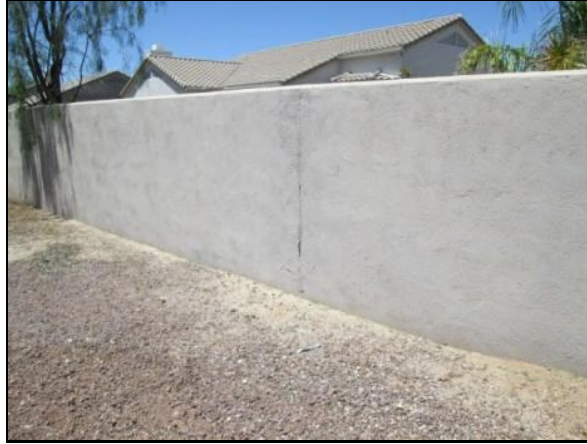
Useful Life:
5 years

Remaining Life:
0 years

Best Case: \$ 15,200

Worst Case: \$ 15,200

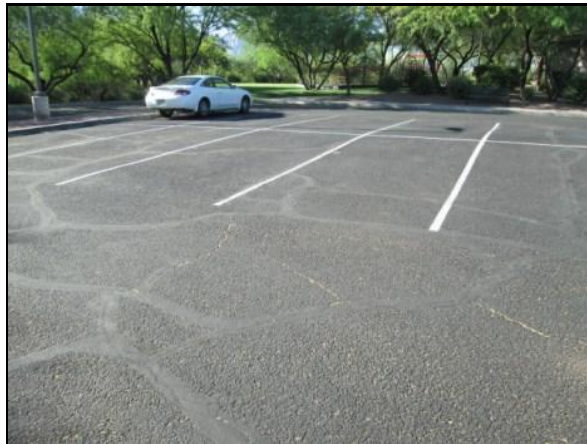
Remaining Life:

1 years

Best Case: \$ 8,000

Worst Case: \$ 8,000

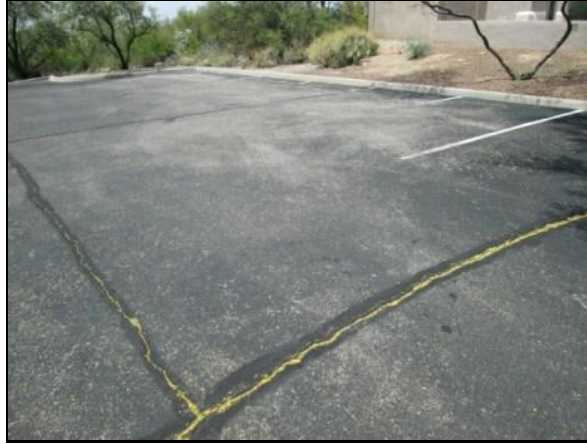
Useful Life:
4 years

Remaining Life:
0 years

Best Case: \$ 6,000

Worst Case: \$ 6,000

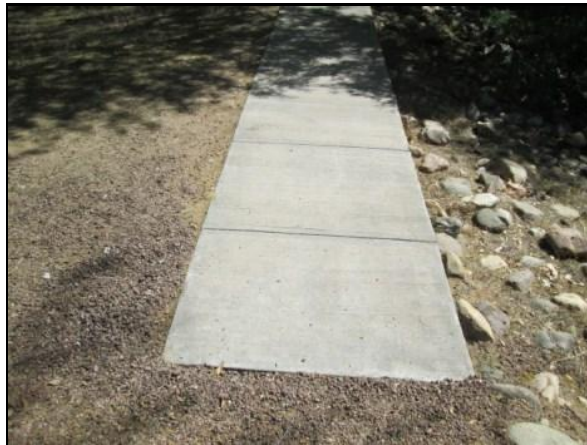
Useful Life:
3 years

Remaining Life:
0 years

Best Case: \$ 4,500

Worst Case: \$ 4,500

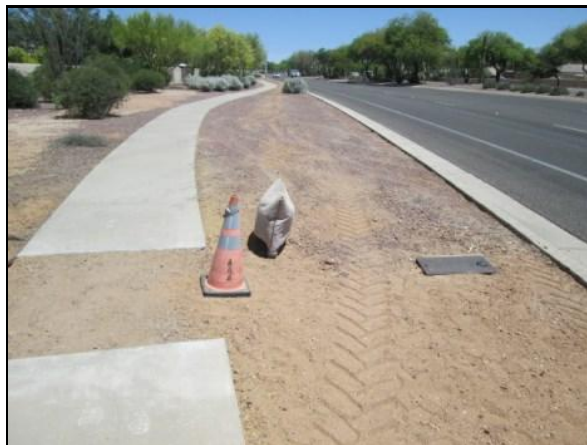
Useful Life:
20 years

Remaining Life:
19 years

Best Case: \$ 142,000

Worst Case: \$ 142,000

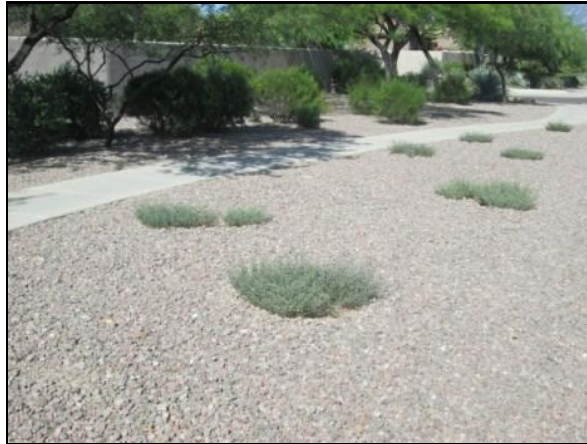
Useful Life:
20 years

Remaining Life:
4 years

Best Case: \$ 110,000

Worst Case: \$ 110,000

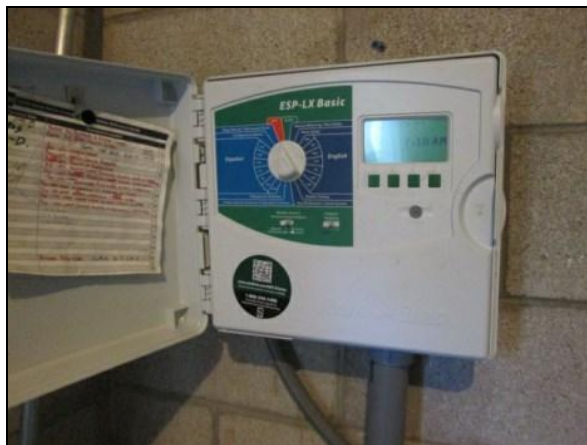
Useful Life:
5 years

Remaining Life:
0 years

Best Case: \$ 13,000

Worst Case: \$ 13,000

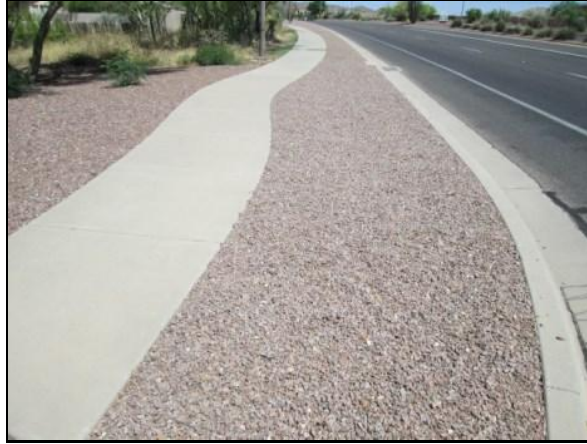
Useful Life:
10 years

Remaining Life:
6 years

Best Case: \$ 113,000

Worst Case: \$ 113,000

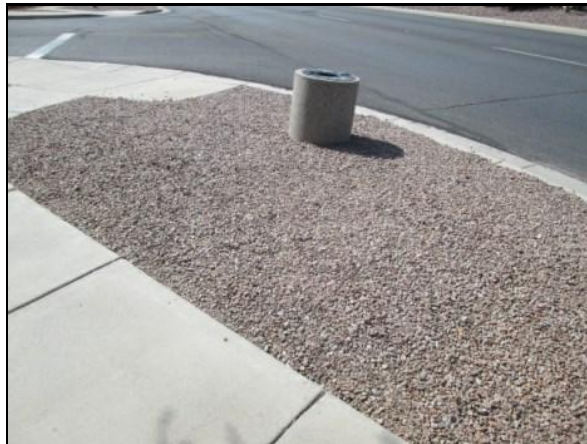
Useful Life:
10 years

Remaining Life:
7 years

Best Case: \$ 66,400

Worst Case: \$ 66,400

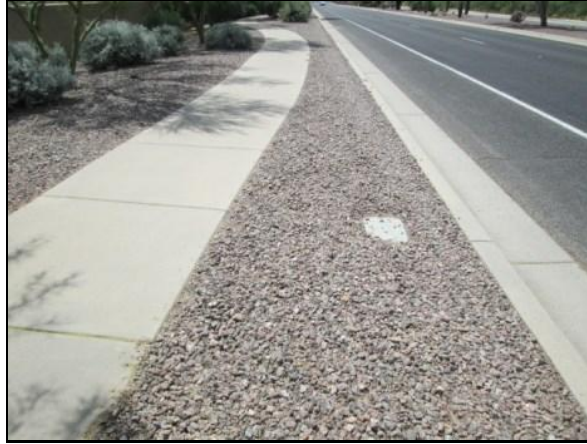
Useful Life:
10 years

Remaining Life:
9 years

Best Case: \$ 50,500

Worst Case: \$ 50,500

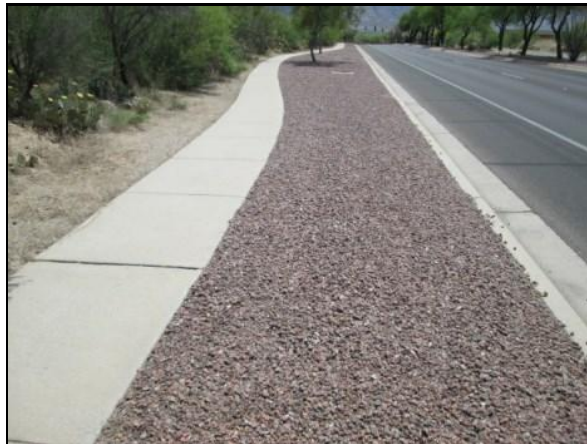
Useful Life:
10 years

Remaining Life:
9 years

Best Case: \$ 44,000

Worst Case: \$ 44,000

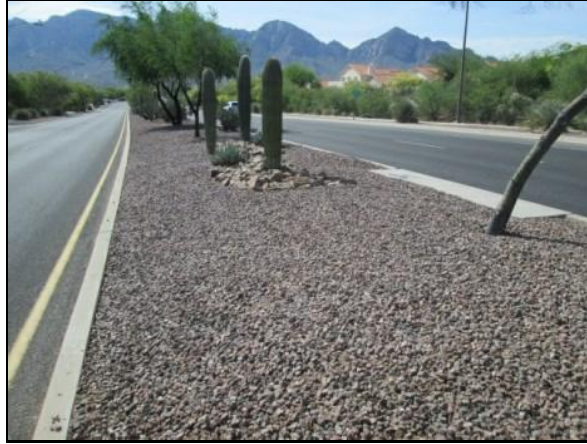
Useful Life:
20 years

Remaining Life:
14 years

Best Case: \$ 725,000

Worst Case: \$ 725,000

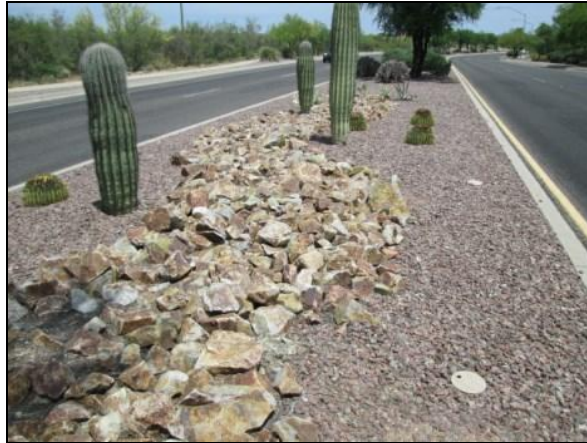
Useful Life:
20 years

Remaining Life:
4 years

Best Case: \$ 102,700

Worst Case: \$ 102,700

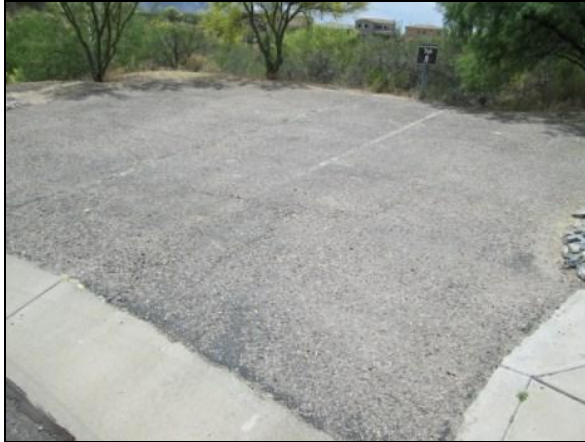
Comments: This is just a small parking pad that does not appear to receive much use. HOA is reportedly responsible to maintain it. Surface has not been maintained. It is rough and eroded. Long term replacement/repaving should be anticipated.

Useful Life:
24 yearsRemaining Life:
1 years

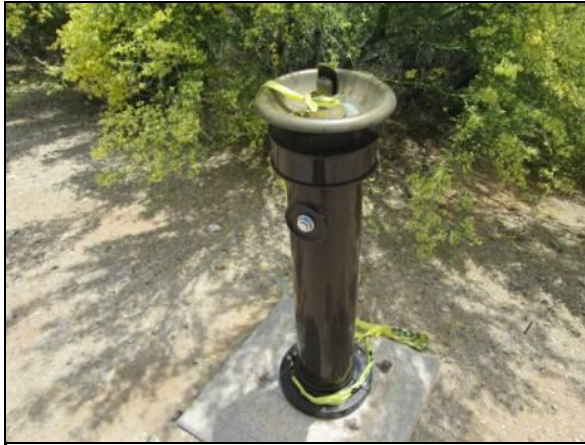
Useful Life:
15 years

Remaining Life:
11 years

Best Case: \$ 5,600

Worst Case: \$ 5,600

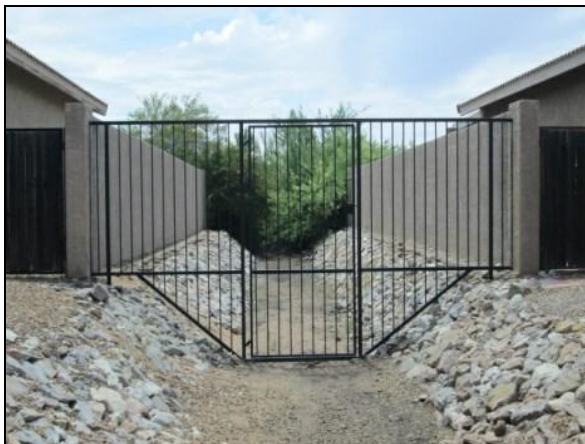
Useful Life:
30 years

Remaining Life:
7 years

Best Case: \$ 4,300

Worst Case: \$ 4,300

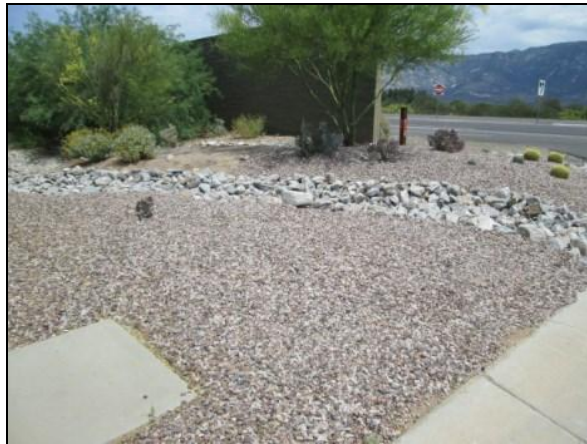
Useful Life:
10 years

Remaining Life:
6 years

Best Case: \$ 10,400

Worst Case: \$ 10,400

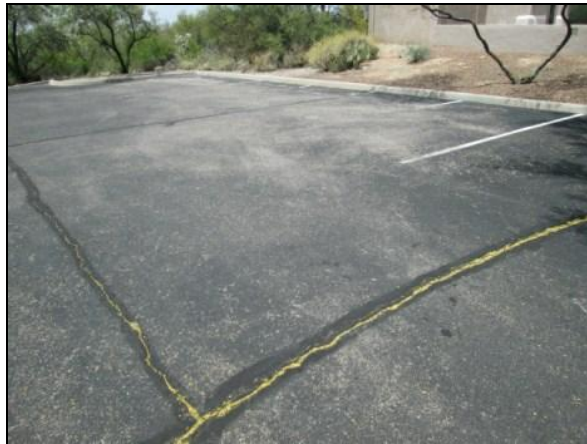
Comp #: 261 Asphalt - Seal/Repair**Quantity: Approx 4,860 Sq Ft**

Comments: Seal is worn off and in poor condition.

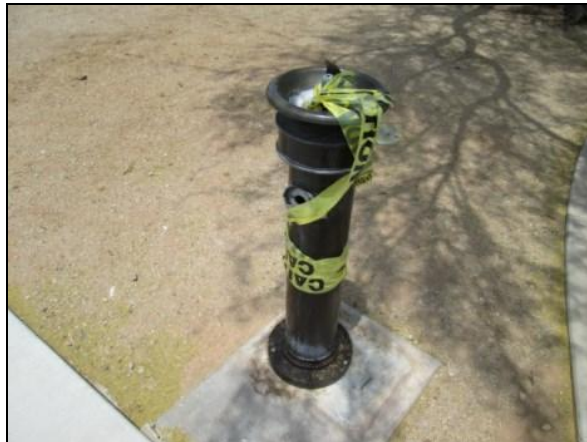
Comp #: 274 Drinking Fountain - Replace**Quantity: (1) Fountain**

Comments: This is a decorative metal drinking fountain. Attractive and appears to be in good working condition.

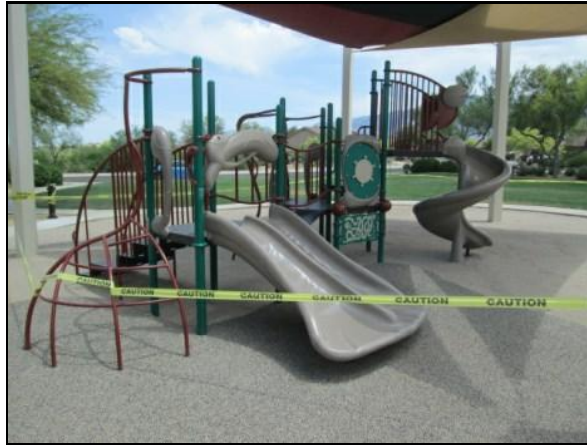
Comp #: 280 Play Equipment - Replace**Quantity: (1) Play Structure**

Comments: Cost of the 2015 replacement included demo of the old structure, installation of a Playworld Challengers #350-1401 structure, and 42 tons of new sand. Still in good condition. No signs of damage or vandalism.

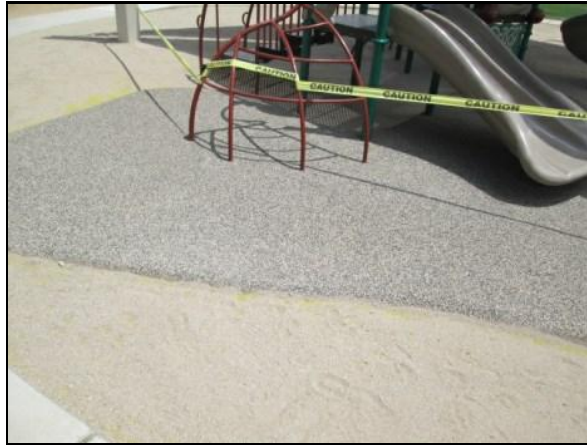
Comp #: 284 Playground Turf - Replace**Quantity: Approx 250 Sq Ft**

Comments: Rubberized turf was installed as part of the play structure replacement project. Surface is still in good condition. It feels soft, and there are no holes. A couple of surface cracks were noted though.

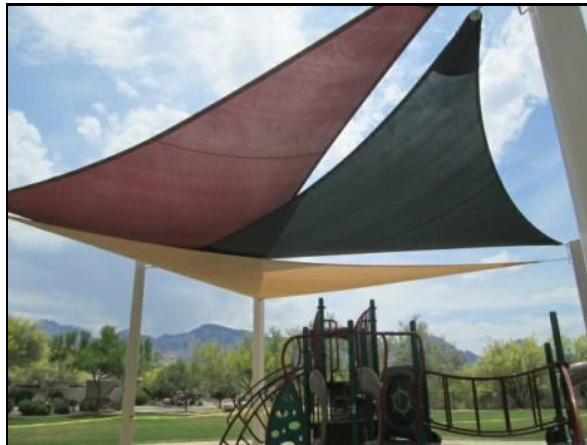
Comp #: 286 Shade Sails - Replace**Quantity: (3) Sails: 1,070 Sq Ft**

Comments: Shade structure was added over the tot lot in 2010. It was described as a 30'x30'x12' structure. Fabric is still in good condition. No signs of holes or tears. There is no expectancy to completely replace the structure. This component funds to periodically replace the shade sails. Painting the structure posts is included with the walls & fences under the Neighborhood 2 section of this report.

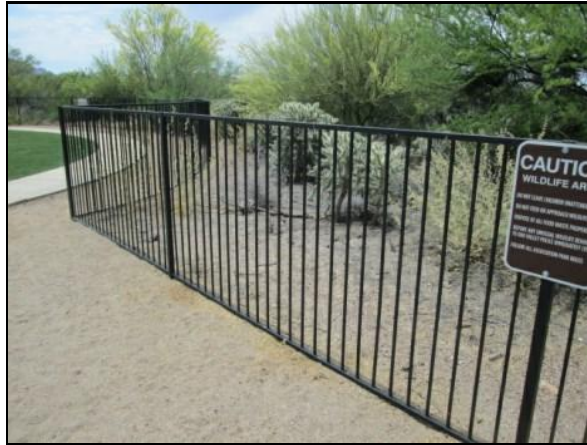
Comp #: 290 Metal Fence - Replace**Quantity: Approx 280 LF**

Comments: Fence is still holding up fine and looks good overall. Support posts feel secure and solid. Periodic painting is included with the walls & fences under the Neighborhood 2 section of this report.

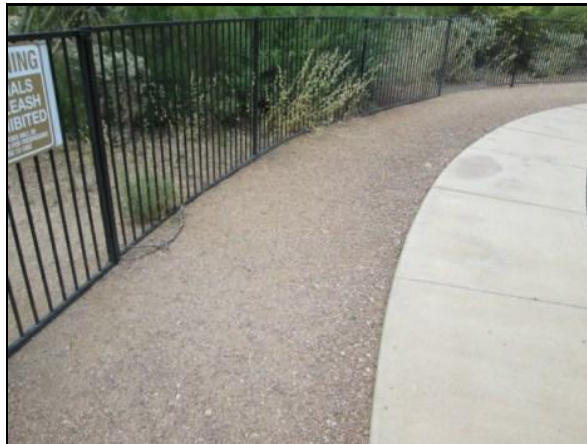
Comments: Granite coverage is low and looks generally depleted. It was going to be replenished in 2017, but that project did not happen. Periodic replenishing should be planned to restore the appearance.

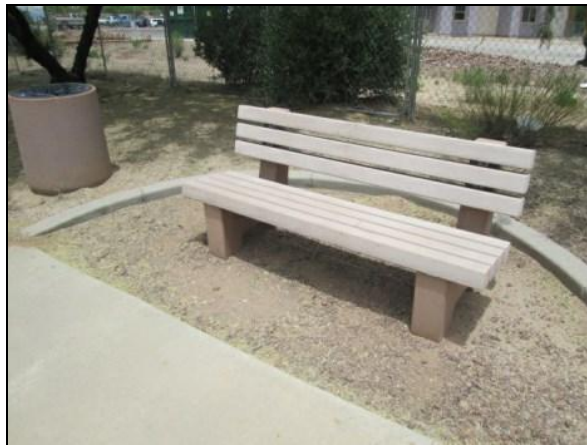
Comp #: 310 Park Furniture - Replace

Comments: Furniture is manufactured by Wassau Tile. Benches have concrete frames with recycled plastic seats and backs. Trash cans are concrete with flat, metal tops. Bench slats look weathered but intact. Overall fair condition, but getting old.

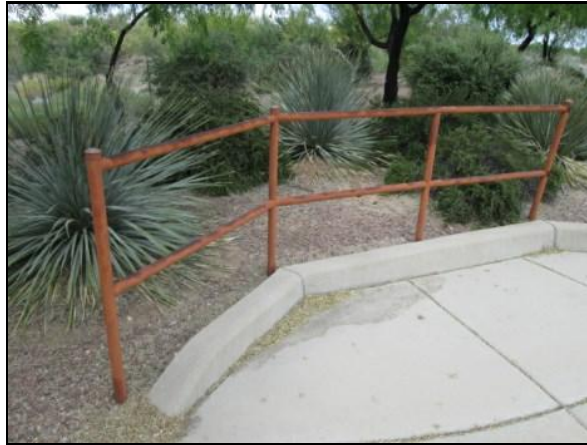
Comments: Paint surfaces are old, rusty, and generally in poor condition.

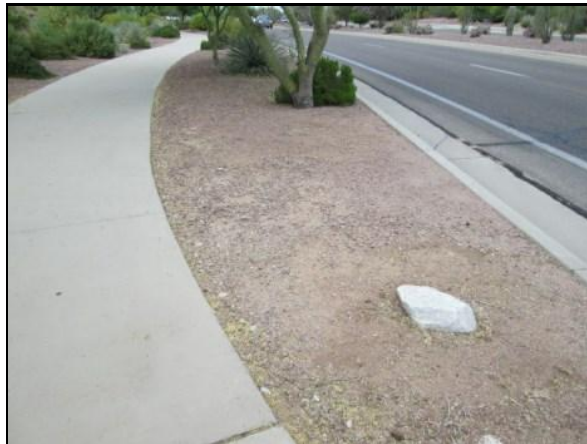
Comp #: 320 Irrigation System - Replace

Comments: It is beyond the scope of this Reserve Study to quantify and assess conditions of the irrigation system. System is reportedly in disrepair and needs replacing. AAA Landscape provided an estimate to replace the irrigation along both sides of Innovation Park Drive for ~\$194,000. This project is anticipated in the near future.

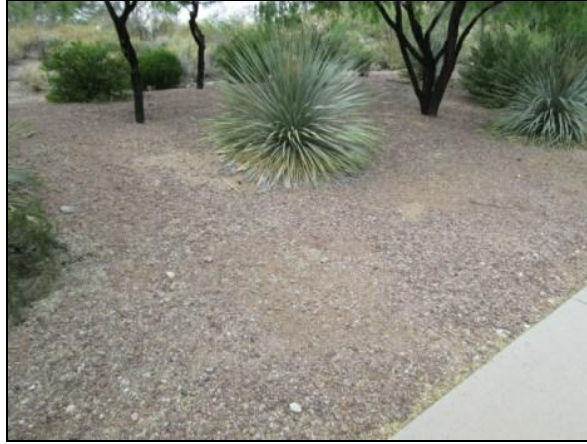
Comments: Granite coverage in planter areas along the sides of the road is aged and depleted. AAA Landscape provide a quote to replace this granite in conjunction with irrigation replacement for ~\$207,000. This cost is much higher than expected for just a top dress. Due to the depleted nature of this granite coverage, more rock is needed to restore the 2" layer than needed for the typical 1" top dress. This component is scheduled as a one-time expense.

Useful Life:
10 yearsRemaining Life:
0 years

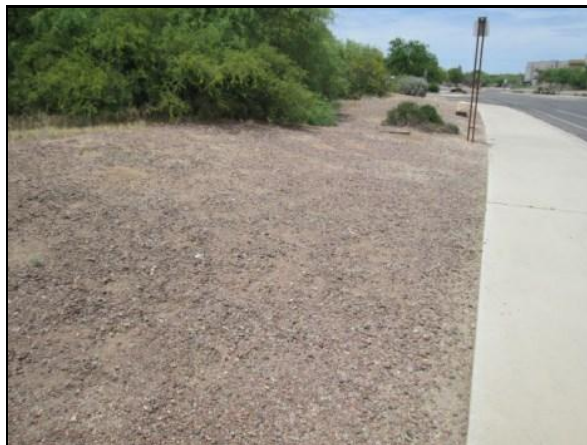
Comments: This component funds to periodically top dress with a new 1" layer of rock. We calculate ~1,100 tons is needed to accomplish the top dress. This is the component that will fund future replenishing work after the 2021 project.

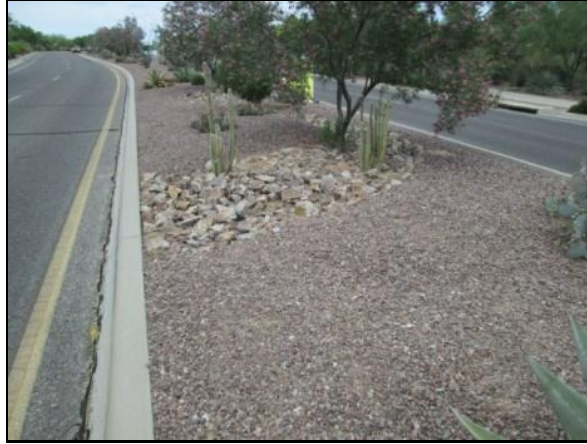
Comments: Medians were completely renovated with new plants, 364 tons of granite, 330 tons of rip rap, (10) 2-station irrigation controllers, and new irrigation lines. Landscaping still looks newer and clean. Overall attractive and in good condition. This component funds for similar renovations in the future.

Useful Life:
20 yearsRemaining Life:
14 years

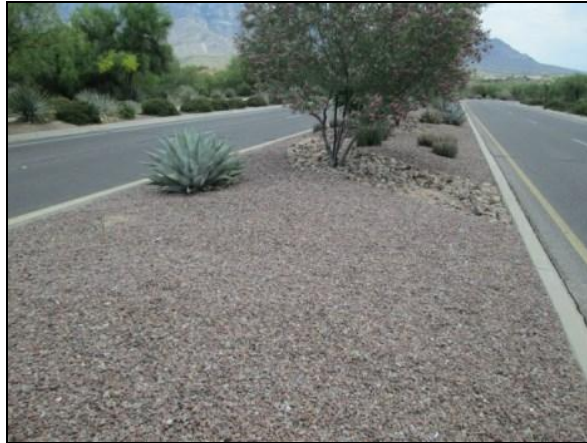
Comments: Median granite will need replenishing sooner than scheduled under the renovation project. This component funds to top dress or replenish the granite once between renovation projects.

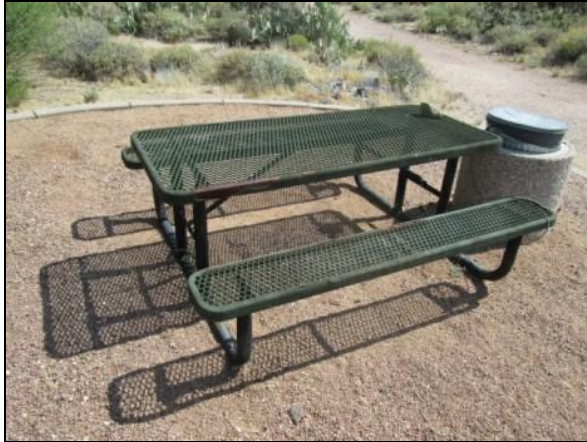
Comp #: 500 Park Furniture - Replace**Quantity: (12) Pieces**

Comments: Furniture includes (4) concrete benches, (4) concrete trash cans, (3) concrete picnic tables, and (1) metal picnic table. Still intact and functional but looks old. Metal table looks pretty worn and beat up. decent shape overall. The metal picnic table looks aged and weathered, but it is still functional. These are long life pieces under normal circumstances.

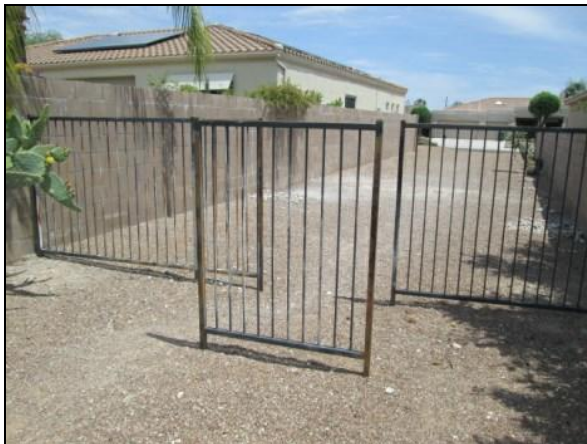
Comp #: 510 Metal Fence - Replace**Quantity: Approx 33 LF**

Comments: Metal fences are still securely mounted. They look very old and rusty. Still in fair condition. Long life expectancy under normal circumstances, but future replacement should be anticipated. These fences do not appear to serve a purpose, so HOA should consider removing them rather than funding replacement.

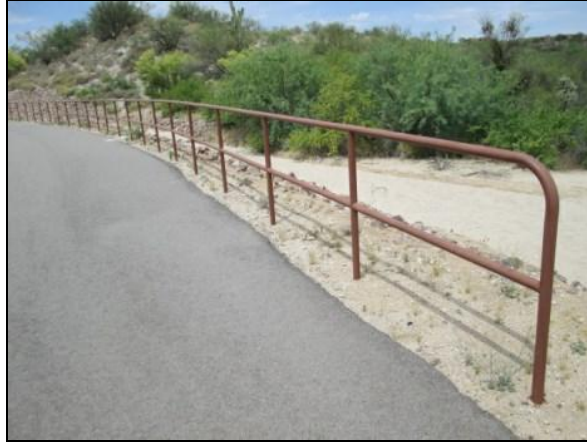
Comments: This component accounts for culvert rails along Moore Rd (east of RVB) outside of any parcels. It also includes rails at the park; those rails were not completely installed and will have to be measured again after the park is finished. There is no expectancy to replace these rails, but periodic painting to maintain the appearance and inhibit rusting should be planned. Although not too old, surfaces already look faded.

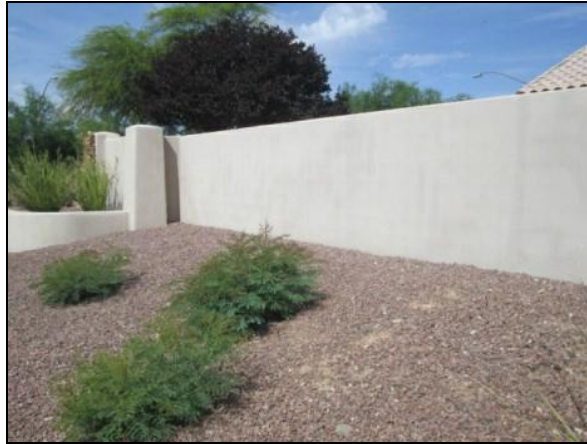
Comments: This component funds to paint ~21,800 sq ft of common stucco walls, 33 LF of metal fence in the Vistoso Heights parcel, and 217 LF of culvert rails. A lot of the stucco surfaces are covered by trees. Exposed wall sections look faded and aged. Some peeling was noted. Metal surfaces look old and are in poor shape. They were not painted with the wall project in 2014. Fences in Vistoso Heights look like they have never been painted. Touch-up paint as a maintenance expense as needed.

Useful Life:
6 yearsRemaining Life:
0 years

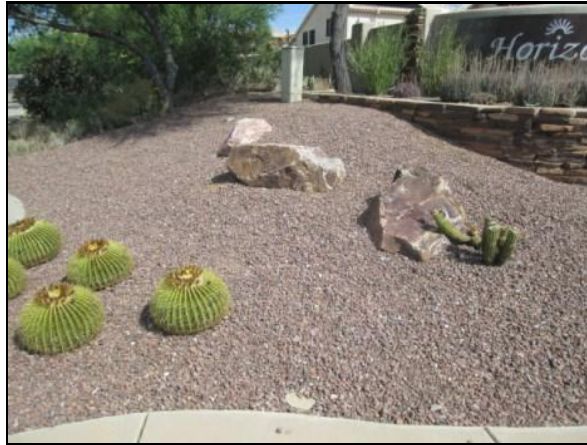
Comments: Common tracts at the Horizons and Vistoso Heights parcels appear to have a thick layer of granite. Coverage is still in good condition. This component funds to periodically top dress with a new 1" layer of rock.

Useful Life:
10 yearsRemaining Life:
2 years

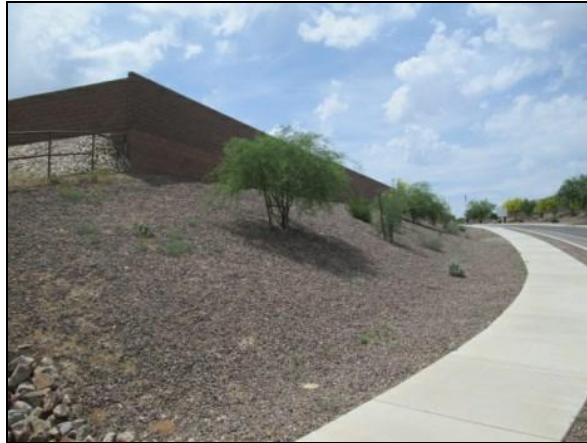
Comments: This section of the community is newer. Granite coverage is in good condition where installed. Satellite imaging for this section of the community is limited at this point, so quantities will have to be re-estimated in the future when more data can be compiled. This component funds to periodically top dress with a new 1" layer of rock.

Useful Life:
10 yearsRemaining Life:
9 years

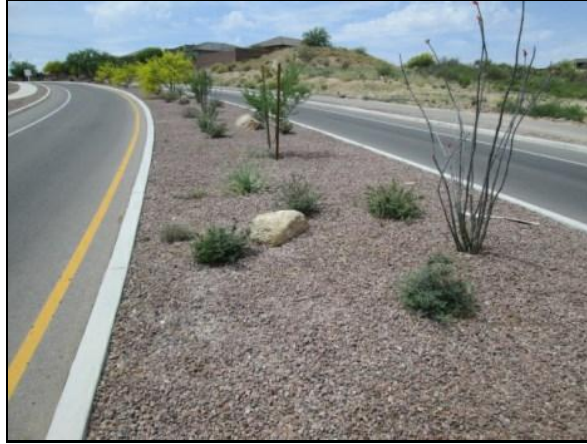
Comments: Medians are near new with granite, rip rap, irrigation, and plants. Attractive and in good condition. This component funds to renovate medians in the future as has been done at other areas of the community. Surface area is estimated at 21,300 sq ft.

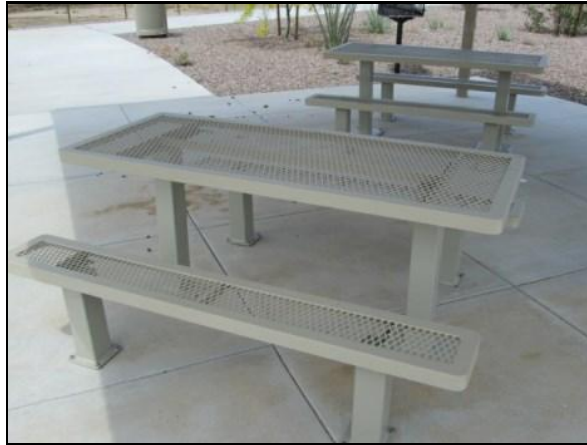
Comments: Quantity includes (6) 6' benches, (2) picnic tables, (1) trash can and (1) BBQ grill. Count will likely increase as the park is built out, so quantity will be adjusted in a future update to this report. This furniture is new and in good condition.

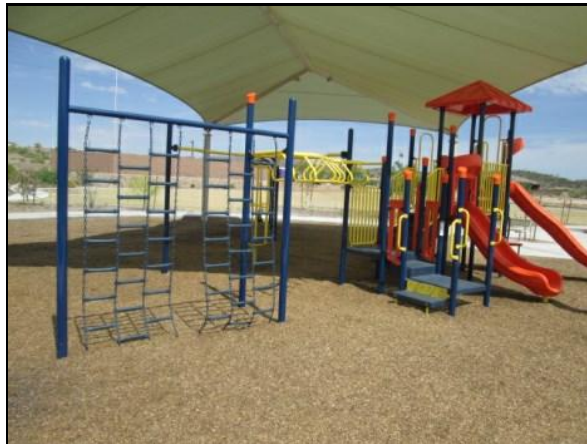
Comments: Equipment includes (2) play structures, (1) single bay, arched swing set, (1) double bay arched swing set, (1) spin cup, and (1) climbing boulder. Still near new and in good condition.

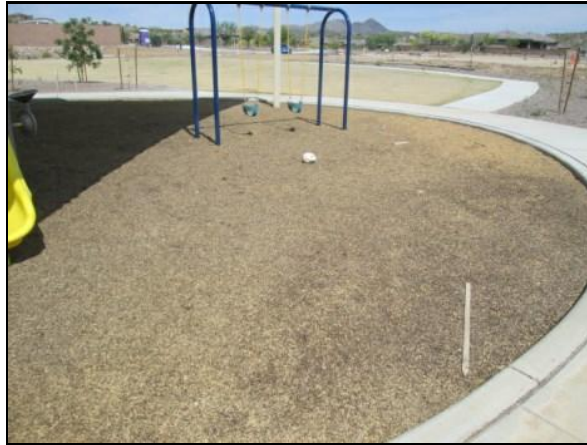
Comments: Both playground sections at this park have wood chip surfacing. There is no expectancy to completely replace the wood surfacing, but periodic replenishing will be needed to maintain proper depths.

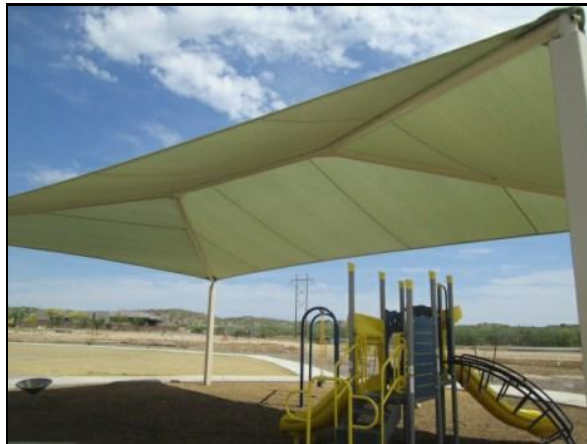
Comments: Shade screens are new and in good condition. There is no expectancy to completely replace the structures. This component funds to periodically replace the shade screens only.

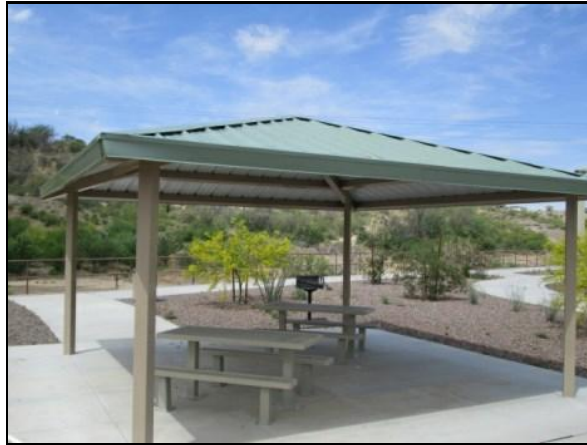
Comments: Ramada has a prefabricated metal roof. Long life expectancy under normal circumstances. Replacement should be planned eventually due to either vandalism or to update the appearance.

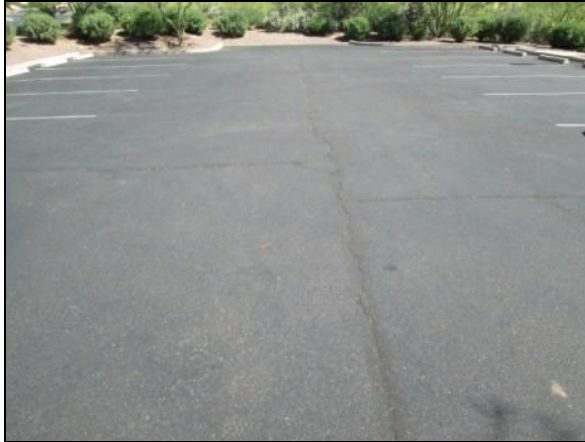
Comments: Parking lot asphalt is in fair condition. Some larger cracks visible. Most of the surface is still relatively smooth and not eroded. Life span is based on periodically seal coating and maintaining the surface.

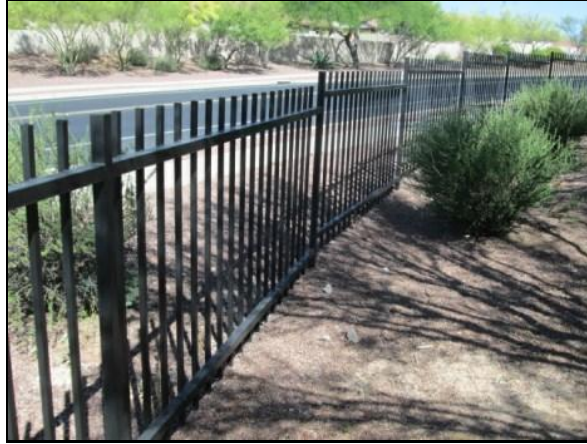
Comments: This component accounts for painting 290 LF of metal fence, (8) light poles, bollards, (2) basketball posts, (2) volleyball posts, (1) bike rack, and (6) metal posts for the shade sails. Fence surfaces still look fine, but the other surfaces do not look like they have been painted since 2015. Repaint periodically to maintain the appearance and prevent rusting.

Useful Life:
6 years

Remaining Life:
0 years

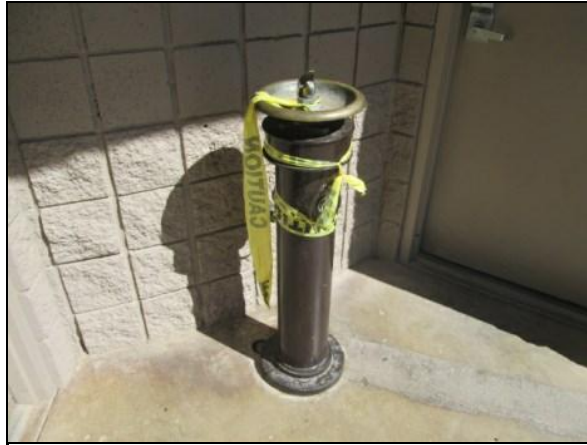
Comp #: 758 Drinking Fountain - Replace

Comments: This is a decorative metal drinking fountain. Attractive and appears to be in good working condition.

Useful Life:
15 years

Remaining Life:
11 years

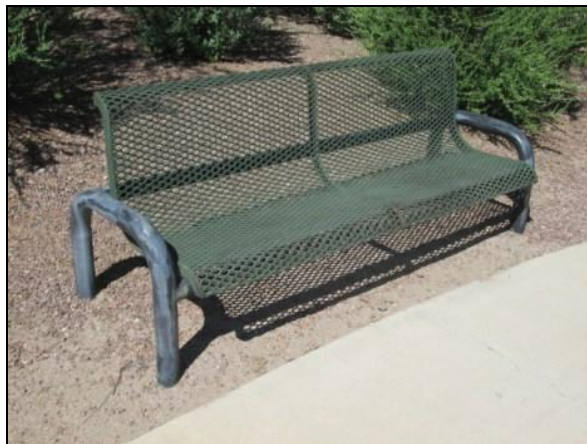
Comp #: 760 Park Furniture - Replace (A)

Comments: Quantity includes (7) benches, (11) picnic tables, (3) trash cans, and (5) BBQ grills. Furniture is still original. Benches, tables, and other items look old and weathered. Recommend planning to replace in the near future.

Useful Life:
20 years

Remaining Life:
0 years

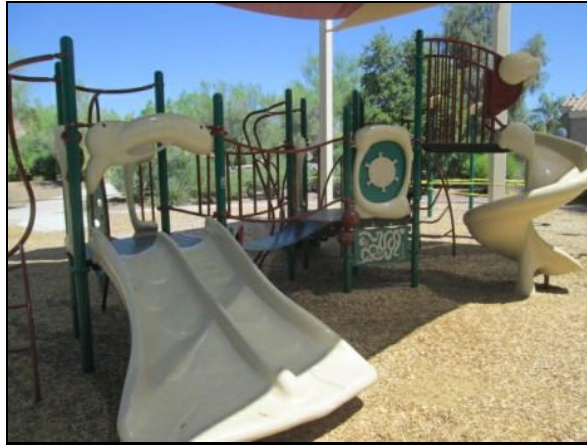
Comp #: 770 Play Equipment - Replace**Quantity: (2) Pieces**

Comments: Equipment is manufactured by Playworld and includes (1) play structure and (1) double bay swing set. Play structure is fairly large with 4-slides plus multiple climbers and attachments. Still in good condition. No signs of damage or vandalism observed.

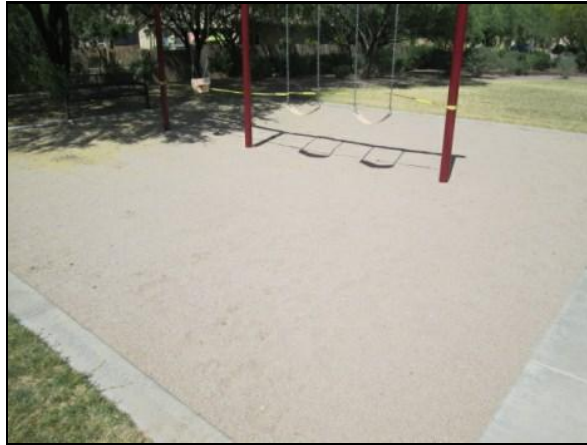
Comments: Sand looks full and is in good condition.

Funded?: No. There is no expectancy to completely replace the sand separate from the play equipment. Cost to replenish is below the Reserve expense threshold. Recommend replenishing as needed with Operating funds.

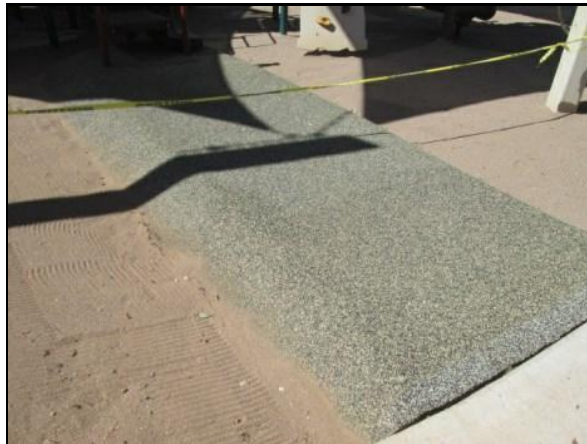
Comp #: 774 Playground Turf - Replace

Comments: The original turf was removed and replaced with a smaller quantity as part of the 2010 play structure replacement project. There is a patched spot next to the sidewalk, plus a gap has developed along the sidewalk. Otherwise, turf still appears to be in fair condition but getting older.

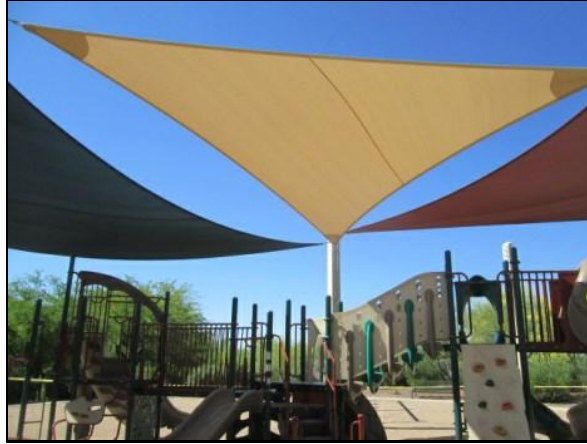
Comp #: 776 Shade Sails - Replace**Quantity: (3) Sails: 800 Sq Ft**

Comments: Shade structure was added over the tot lot in 2010. It is described as a 26'x30'x12' structure. It has (3) sails mounted to (6) metal posts. Fabric still looks fine. No signs of holes or tears. There is no expectancy to completely replace the structure. This component funds to periodically replace the shade sails. Painting the structure posts is included with the other park assets.

Useful Life:
12 years

Remaining Life:
1 years

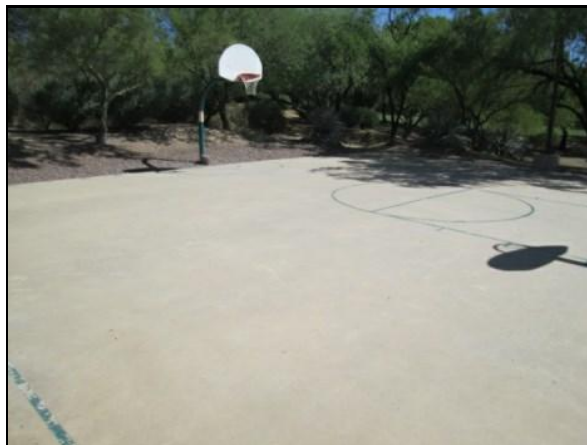
Comp #: 779 Basketball Court - Replace**Quantity: (1) Half Court**

Comments: This is a concrete based court with no coating. This type of court is normally expected to last the life of the community. However, concrete surface has cracks and pitting. It is still fine for now, but it will likely continue to deteriorate, so replacement should be expected at some point.

Useful Life:
30 years

Remaining Life:
10 years

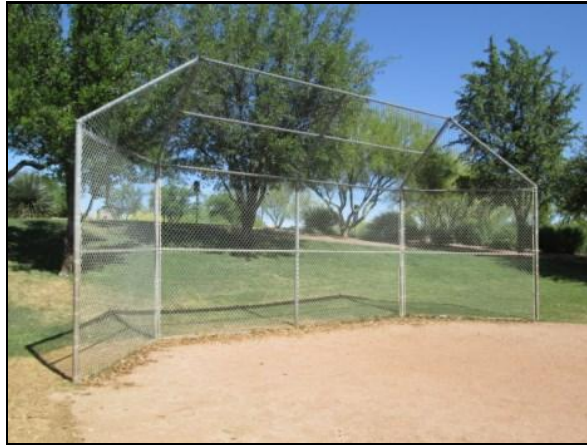
Comp #: 784 Baseball Backstop - Replace

Comments: Backstop looks intact and in good shape overall. Fence is bent along the bottom. Treat repairs as a maintenance issue when needed.

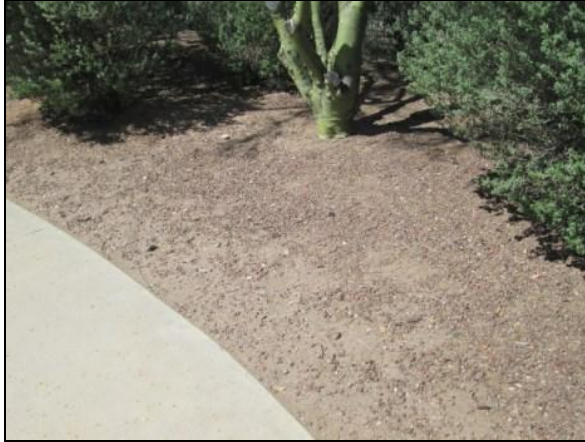
Comments: Conditions vary. Some spots have good, full coverage while other spots look bare/low. There is no expectancy to completely replace the granite, but periodic replenishing should be planned to restore the appearance. Per the previous Reserve Study, the 2013 replenish project included:

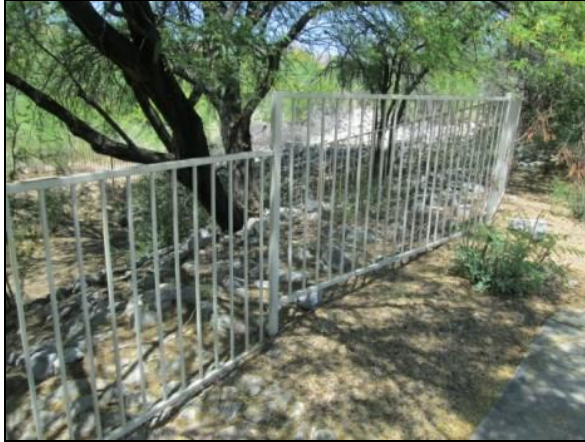
Comp #: 1000 Metal Fence - Replace

Comments: Fences vary between 2' metal mounted on top of a block wall base and 6' direct burial fence. They do not appear to have sprinkler exposure. Still in good to fair condition.

Useful Life:
25 years

Remaining Life:
8 years

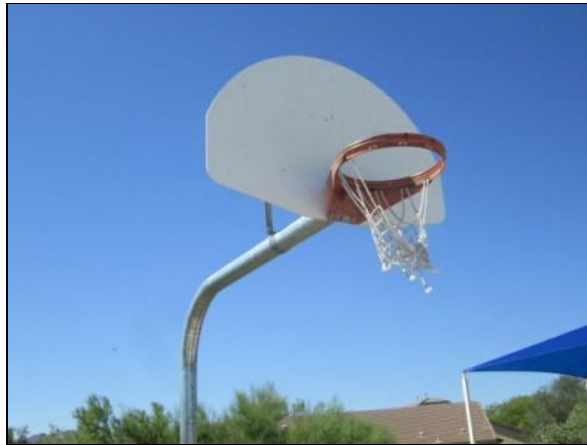
Comp #: 1060 Basketball Backboards - Replace**Quantity: (4) Metal Backboards**

Comments: They are good quality, metal backboards and rims. Manufactured by PW Athletics. No signs of damage or abuse. Still appear to be in good shape.

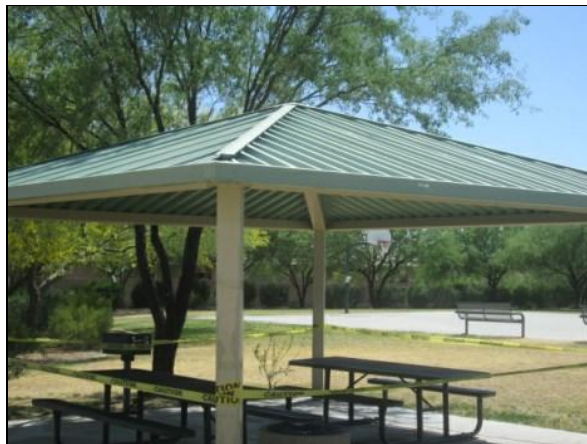
Comp #: 1062 Ramada Roofs - Replace**Quantity: (3) Ramadas: 1,050 Sq Ft**

Comments: Ramadas have prefabricated metal roofs. Long life expectancy under normal circumstances. Replacement should be planned eventually due to either vandalism or to update the appearance. There are some visible dents and cracks.

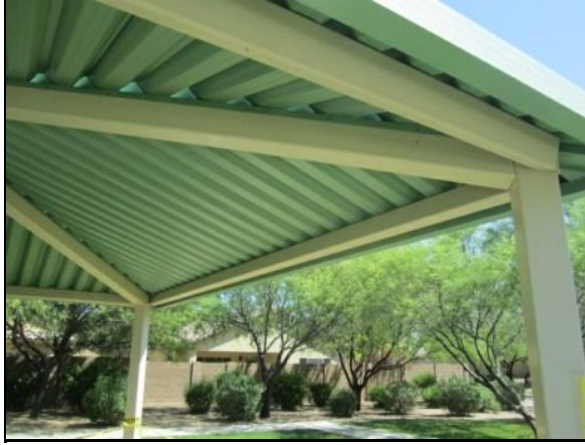
Comments: This component budgets to repaint metal posts and beams on the ramadas. Paint is old and peeling.

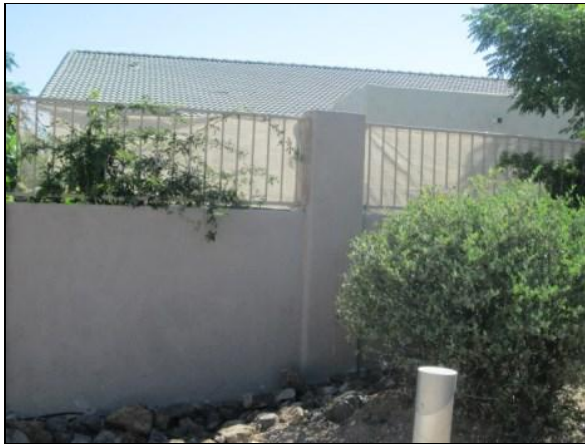
Comp #: 1070 Metal Fence - Replace (Somerset)**Quantity: Approx 147 LF**

Comments: These sections of view fence borders visible common areas, so we believe VCA is responsible for them. Fences are mounted high off the ground and not exposed to sprinklers, so a long life span is anticipated.

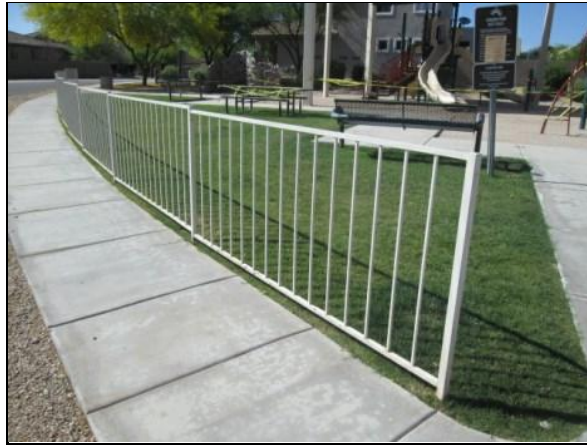
Comp #: 1072 Metal Fence - Replace (Torreno)**Quantity: Approx 74 LF**

Comments: This is a 3.5' high section of metal fence mounted between the park and the street. It is mounted in the grass and exposed to sprinklers regularly. Still securely mounted, but there is rusting, especially along the bottom rail. Periodic painting is included with the walls & fences component but likely needs painting more frequently due to the sprinkler exposure.

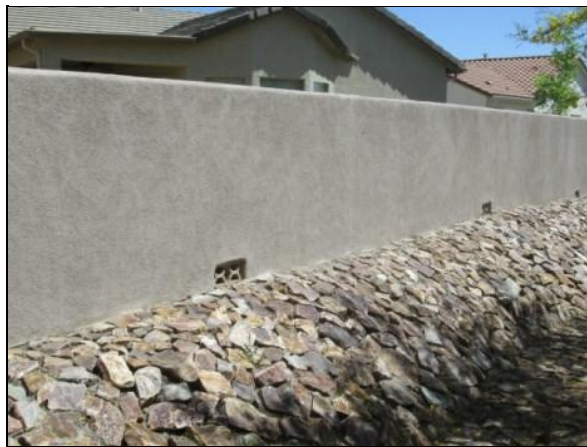
Comments: This component funds to paint ~51,800 sq ft of common stucco walls, 147 LF of metal fence, 575 LF of culvert rails, and 224 sq ft of metal shade structure posts at the parks. Surfaces vary in condition but are generally still in fair shape. West facing walls exhibit more fading. Some of the rails were not painted with the others and look older. Painting is planned again before the end of 2020. Recommend painting all common walls and fences together.

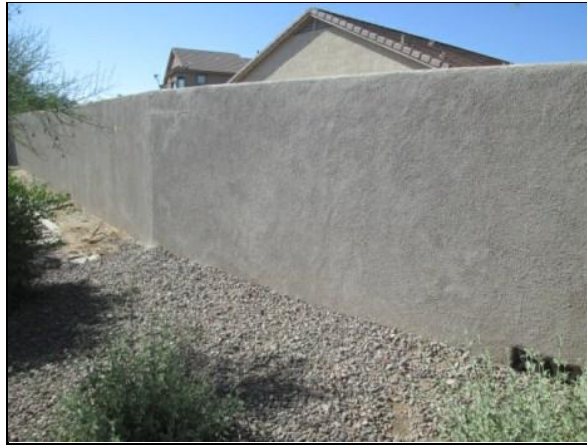
Comments: This component funds to paint ~35,800 sq ft of common stucco walls, 74 LF of metal fence, 424 LF of culvert rails, and 300 sq ft of metal shade structure posts at the park. Surfaces still appear to be uniform and in fair condition overall. West facing walls at the east parcel look more faded and discolored. Recommend painting all common walls and fences together.
