Update "With-Site-Visit" Reserve Study

Vistoso Community Master Association Oro Valley, AZ

Report #: 8973-8
For Period Beginning: January 1, 2021
Expires: December 31, 2021

Date Prepared: October 8, 2020

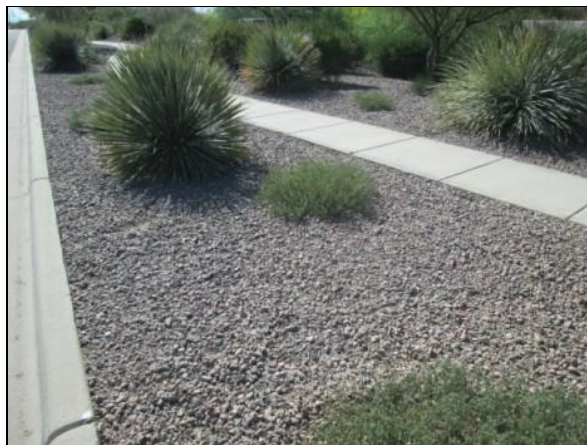
Comments: Most of this work was completed in 2020, but the section on Moore Rd was completed in 2019. Quantity is based on proposals from AAA Landscape, and project involved spreading 1,266 tons of rock. Coverage looks full and is in good condition. There is no expectancy to completely replace the granite, but periodic replenishing should be planned to restore the appearance.

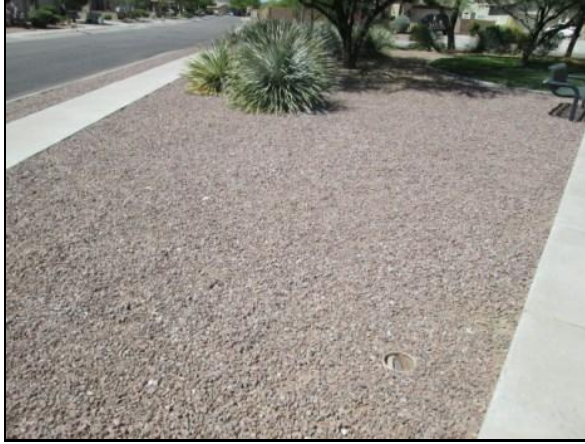
Comments: Common tracts within parcels (excluding La Canada & Moore Rd) are in good shape. They have been replenished, but timing and cost are unknown. There is no expectancy to completely replace the granite, but periodic replenishing should be planned to restore the appearance.

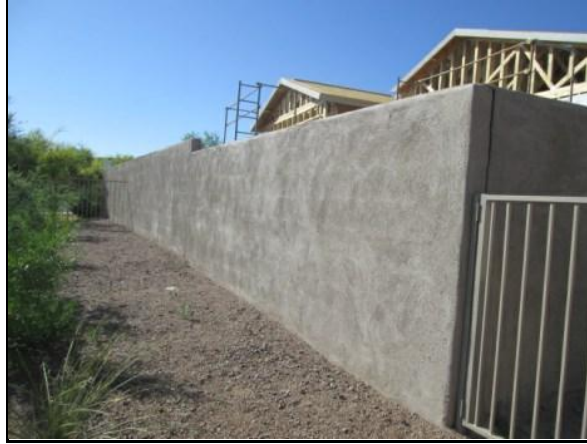
Comments: This component funds to paint ~7,030 sq ft of stucco walls, 150 LF of metal fence, 450 LF of view fence, and 120 LF of culvert rails. Paint surfaces are new and in good condition. Recommend painting all common walls and metal surfaces together in the future.

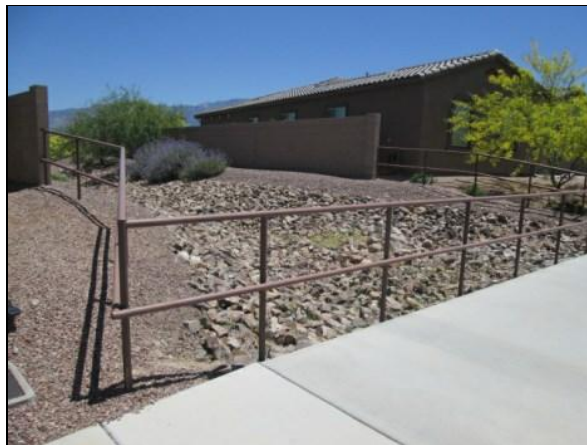
Comments: This component funds to paint 271 LF of metal fence, 174 LF of culvert rails, and ~250 sq ft of stucco walls (only located at monuments for Eagles Summit). Paint surfaces look older. Fence needs painting soon. Rails exhibit some fading but are not a priority to repaint yet. Recommend painting all common surfaces together in the future.

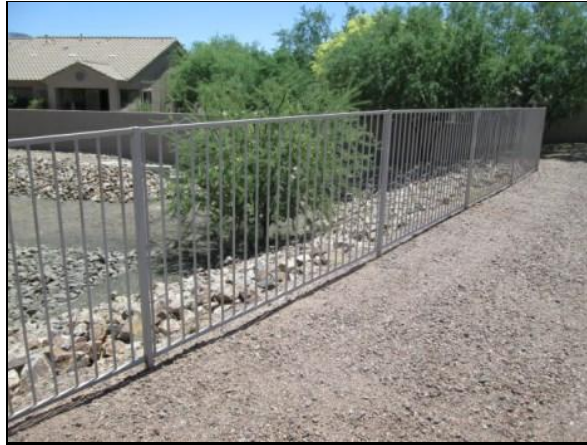
Comp #: 1084 Metal Fence - Replace (A)**Quantity: Approx 270 LF**

Comments: This is 4' high metal fence mounted around the retention basin. Fence still looks good, although some rust is developing.

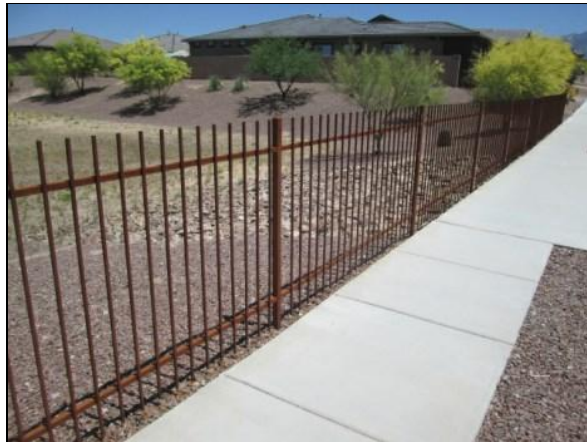
Comp #: 1084 Metal Fence - Replace (B)**Quantity: Approx 528 LF**

Comments: This is 4' high metal fence mounted around the retention basin. It has a rust finish and will not need to be painted.

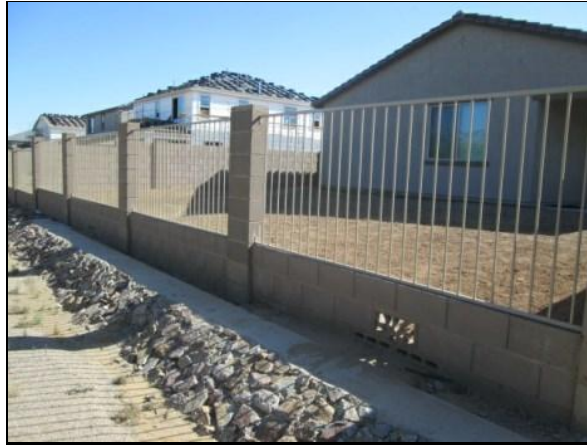
Comp #: 1084 Metal Fence - Replace (C)**Quantity: Approx 600 LF**

Comments: There is 150 LF of 4' high metal fence mounted around the retention basin at the corner of Moore Rd and La Canada. There is another 450 LF of 4' view fence behind the east perimeter homes. Fence is newer and in good condition.

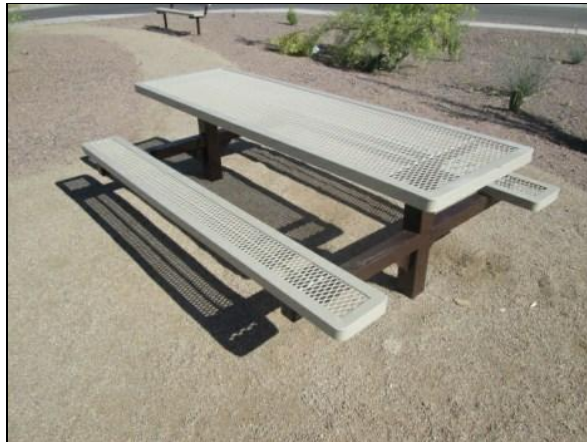
Comp #: 1086 Park Furniture - Replace**Quantity: (4) Pieces**

Comments: Pieces include (2) benches, (1) picnic table, and (1) BBQ grill. Furniture is new and in good condition.

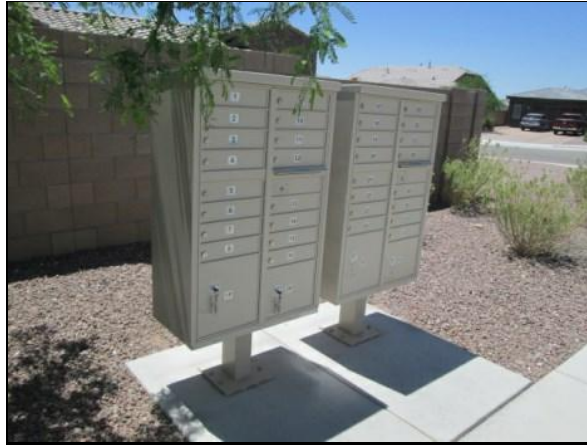
Comp #: 1088 Mailboxes - Replace (A)**Quantity: (7) Clusters**

Comments: Clusters include (5) 16-box and (2) 12-box. Due to the recent installation timing, these mailboxes are expected to be VCA's responsibility. They are still in good condition. Replacement should be anticipated eventually.

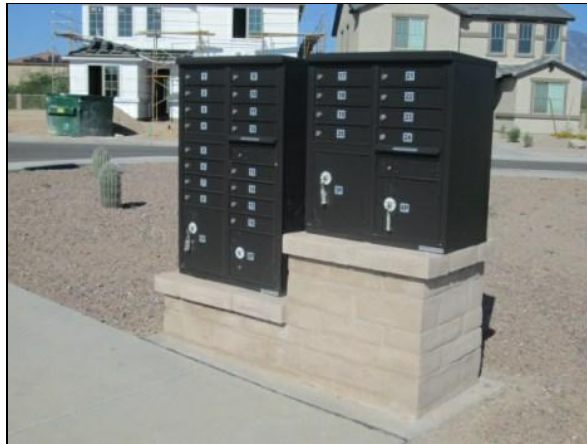
Comp #: 1088 Mailboxes - Replace (B)**Quantity: (2) Clusters**

Comments: Clusters include (1) 16-box and (1) 8-box. They look new and are in good condition. Replacement should be anticipated eventually.

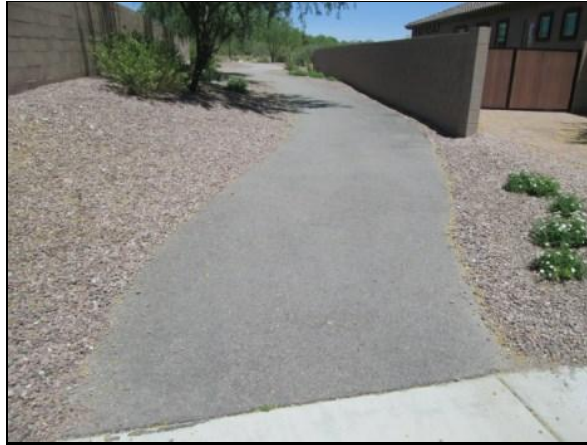
Comments: This asphalt path is still smooth and in good condition. No cracks yet. It still has not been sealed though. VCA is reportedly responsible to maintain this path. Long term replacement/repaving should be anticipated.

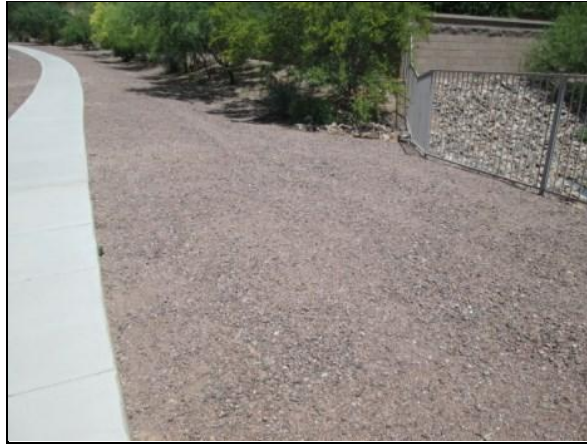
Comments: Rough estimate of granite coverage is 164,400 sq ft. This includes the space between curb and sidewalk in the Center Pointe section of the community (VCA is not responsible for landscaping beyond the sidewalk). Granite coverage is still in good shape. There is no expectancy to completely replace the granite, but periodic replenishing should be planned to restore the appearance.

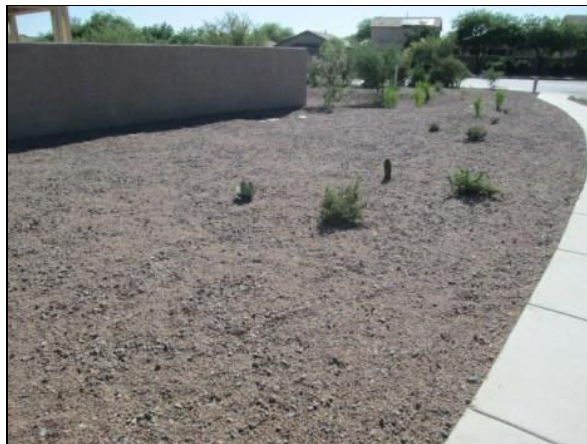
Comments: Surface area accounts for common tracts and around perimeter areas of this parcel. Coverage is full, but it has a high percentage of small rock content, so it will not last as long as other areas of the community. Remaining life has been decreased to reflect this condition. There is no expectancy to completely replace the granite, but periodic replenishing should be planned to restore the appearance.

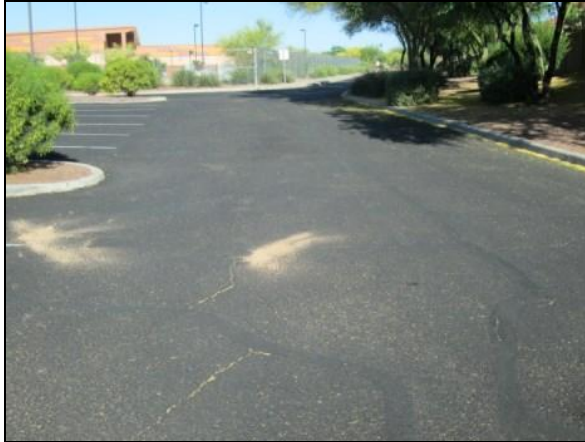
Comments: Surface is rough with a lot of exposed aggregate. There is moderate surface cracking too. Life span is based on periodically seal coating and maintaining the surface.

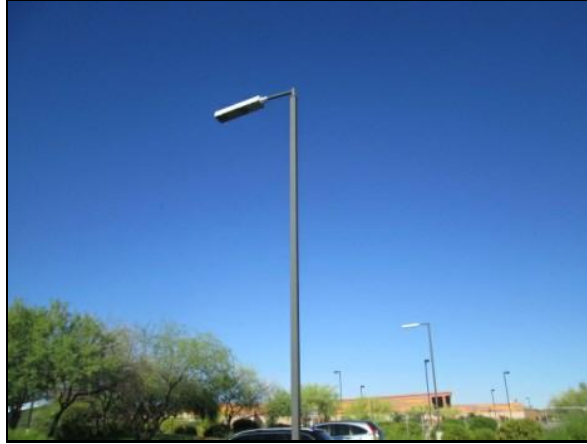
Comp #: 1106 Pole Lights - Replace**Quantity: (19) Lights, (17) Poles**

Comments: These pole lights are mounted on top of elevated concrete pads. They are not directly exposed to irrigation. Anticipate future replacement or renovation of the lights and poles.

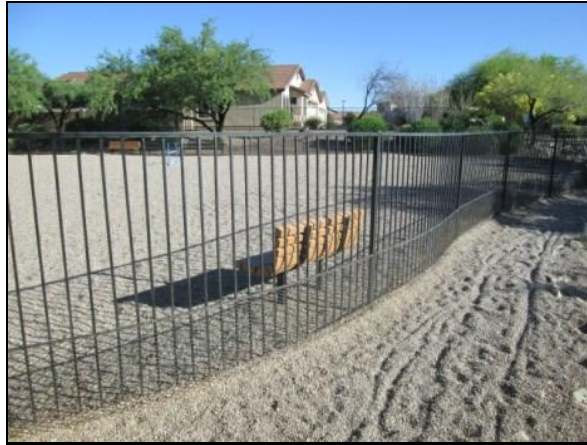
Comp #: 1108 Dog Park Fence - Replace**Quantity: Approx 310 LF**

Comments: Fence still appears to be in fair condition. Turf surfacing inside the dog park was removed, so fence is no longer hit by sprinklers. Fence securely mounted, and there is no severe rusting.

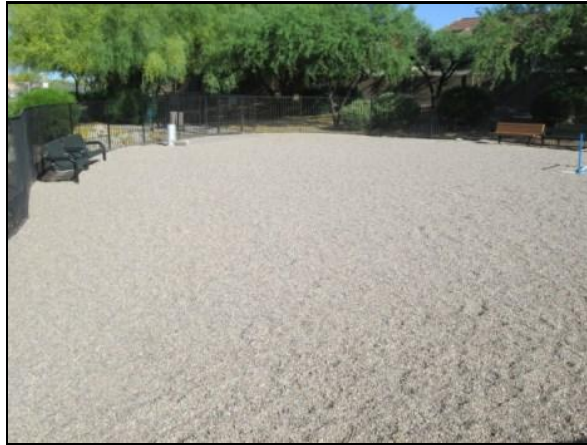
Comments: Dog park originally had grass surfacing. The 2015 project involved removing the grass and installing pea gravel in its place. There is no expectancy to completely replace the gravel, but replenishing it should be anticipated eventually.

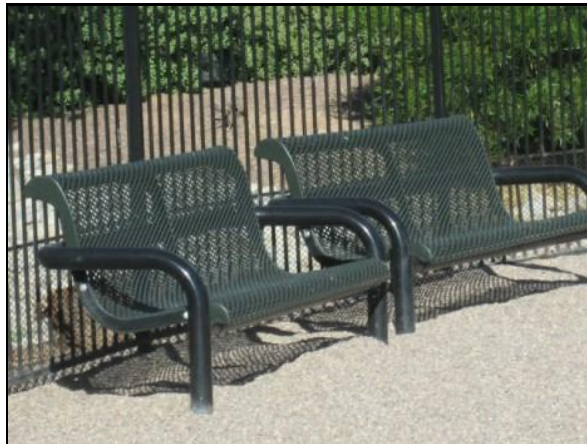
Comp #: 1110 Dog Park Benches - Replace**Quantity: (4) 6' Benches**

Comments: Dog park has (6) benches total. The (4) metal benches are funded under this component. The (2) newer benches with recycled plastic slats are funded with other benches at Hohokam Park.

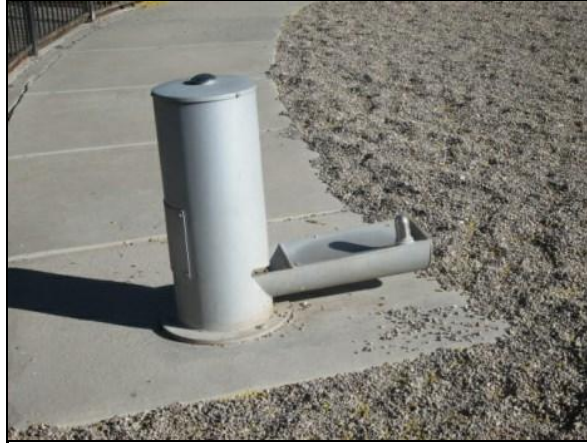
Comp #: 1112 Dog Park Fountain - Replace**Quantity: (1) MDF Fountain**

Comments: This MDF pet fountain was a new addition in 2014. Still appears to be in good condition.

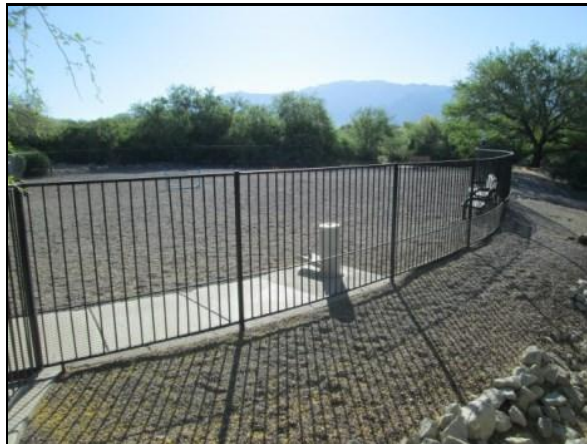
Comments: This component accounts for painting 310 LF of metal fence, (17) light poles, (2) basketball posts, and (10) metal posts for the shade sails. Fence surfaces look older and faded, but not bad. Pole lights are still in fair condition. Shade poles look good. Repaint periodically to maintain the appearance and prevent rusting.

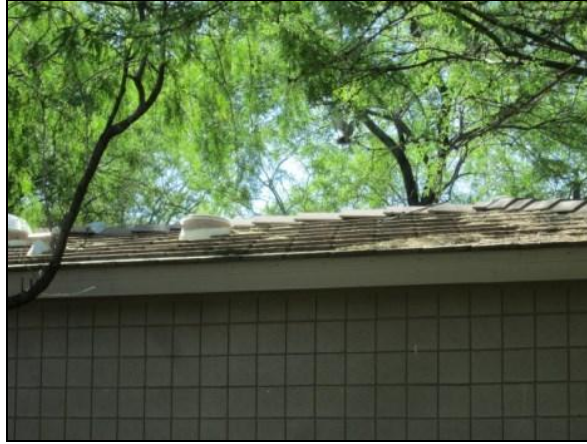
Comments: Tile roofs on the restroom building and ramadas were refurbished with new underlayment. Project occurred much sooner than normally anticipated. Roofs are expected to be in good condition. This component funds for replacement of the underlayment again in the future.

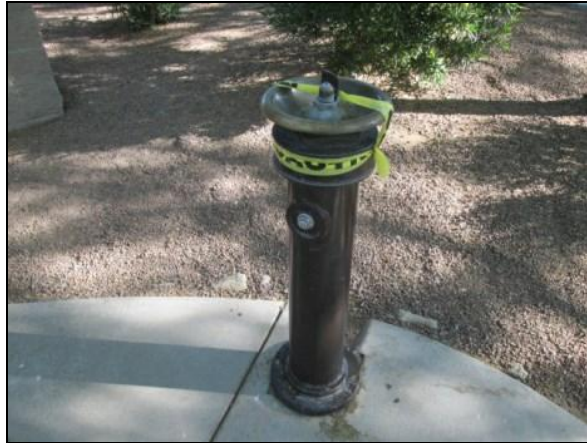
Comp #: 1119 Drinking Fountain - Replace**Quantity: (1) Fountain**

Comments: Surface is faded and looks old. It is still functional though. Expected to be nearing time for replacement.

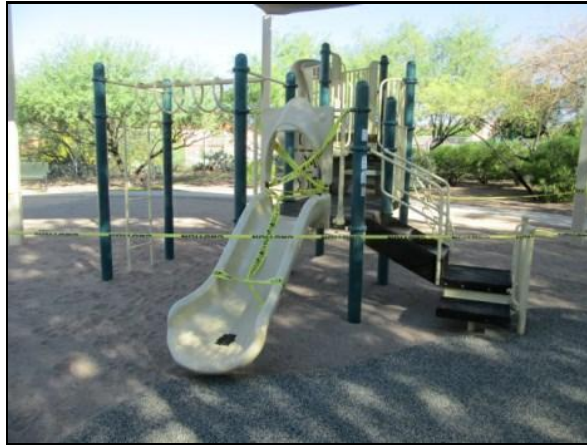
Comments: Equipment includes (2) play structures, (1) glide slide, (1) Ground Zero U-Bounce, (1) extreme climber, (1) balance beam, and (1) bench with rotating seats. Still functional but looking aged and weathered. Visible wear and tear too.

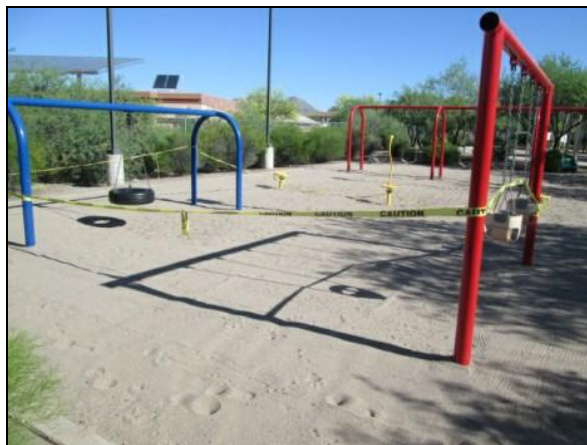
Comp #: 1130 Play Equipment - Replace (B)**Quantity: (13) Pieces**

Comments: Equipment includes (1) horizontal ladder, (1) 1/2 circle arched climber, (1) large spinner, (3) in-ground spinners, (2) spring riders, (1) triple bay arched swing-set (4-swings + Jenn Swing), (1) swing-set (2-posts, 2-swings), (1) arched tire swing, extreme climber, and (2) fitness stations with signs. There is also 624 LF of plastic playground border. This equipment still looks newer and is in good condition.

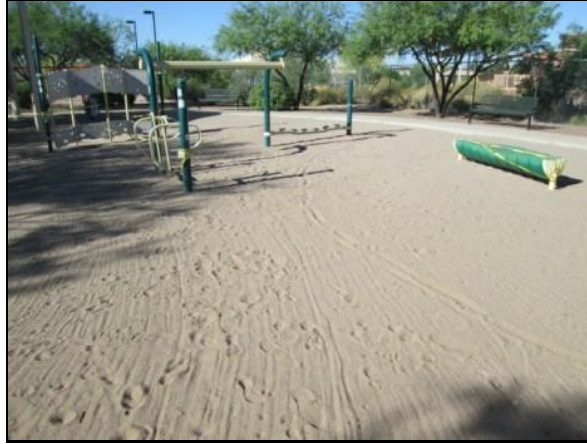
Funded?: No. There is no expectancy to completely replace the sand separate from the play equipment. Cost to replenish is below the Reserve expense threshold. Recommend replenishing as needed with Operating funds.

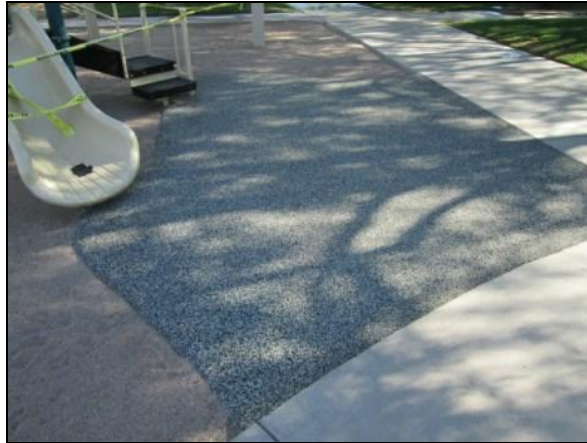
Comp #: 1134 Playground Turf - Replace**Quantity: Approx 350 Sq Ft**

Comments: This surface is used to help absorb the impact of a child's fall. It also provides handicap children with access to the play structures. Repairs were made along the turf edges. Some surface raveling but no cracks or holes. It has held up well and lasting longer than anticipated. At this point, we recommend delaying replacement until the play equipment is replaced.

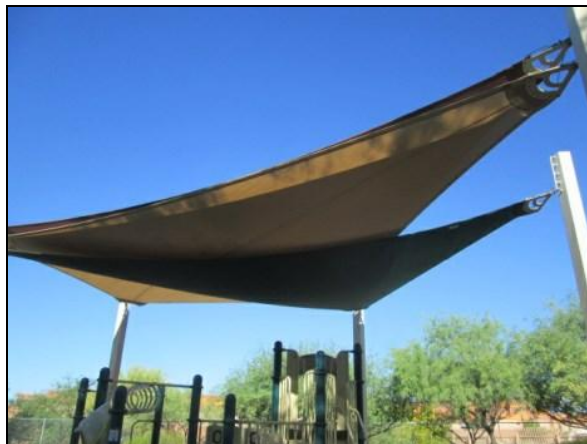
Comp #: 1138 Shade Sails - Replace**Quantity: (6) Sails: 1,880 Sq Ft**

Comments: Shade structures were added over the tot lots in 2010. They are described as a 25'x25'x12' structures. Each one has (3) sails mounted to (5) metal posts. Fabrics still look fine. There is no expectancy to completely replace the structures. This component funds to periodically replace the shade sails. Painting the structure posts is included with the other park assets.

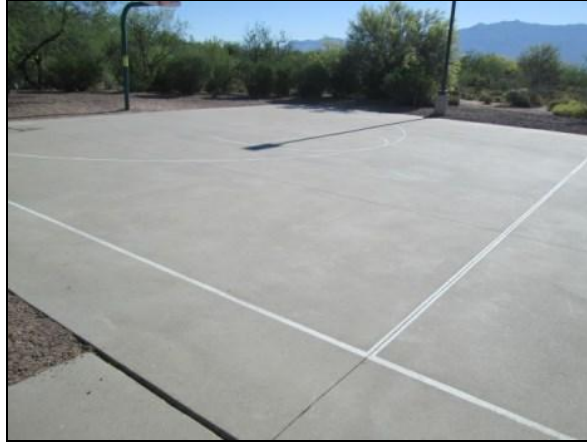
Comp #: 1140 Basketball Court - Replace**Quantity: (1) Full Court**

Comments: This is a concrete based court with no coating. This type of court is normally expected to last the life of the community. However, concrete surface exhibits wear and lots of hairline cracks. It is still fine for now, but it will likely continue to deteriorate, so replacement should be expected at some point.

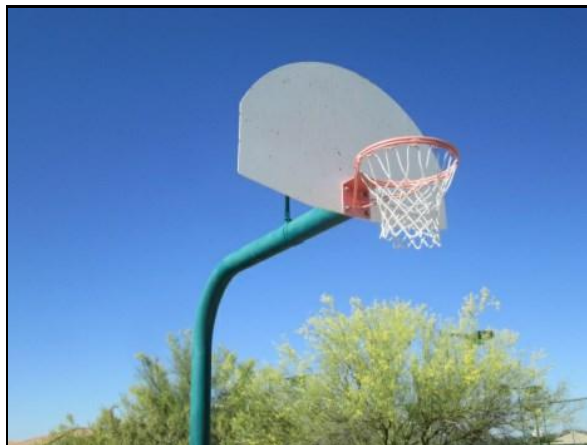
Comp #: 1141 Basketball Equip - Replace**Quantity: (2) Metal Backboards**

Funded?: No. The backboards are good quality metal pieces. Replacement cost is below the Reserve expense threshold.

Recommend replacing as needed with Operating funds.

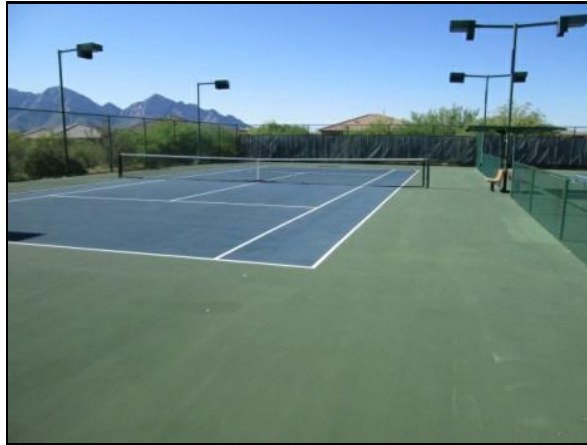
Comp #: 1150 Tennis Courts - Replace

Funded?: No. The post-tension concrete tennis courts are consider a permanent installation with no expectation to replace under normal circumstances, so no Reserve funding has been allocated for future replacement.

History: Replaced with post-tension concrete 6/2013 for \$107,900. Previously installed as asphalt based courts during 2002.

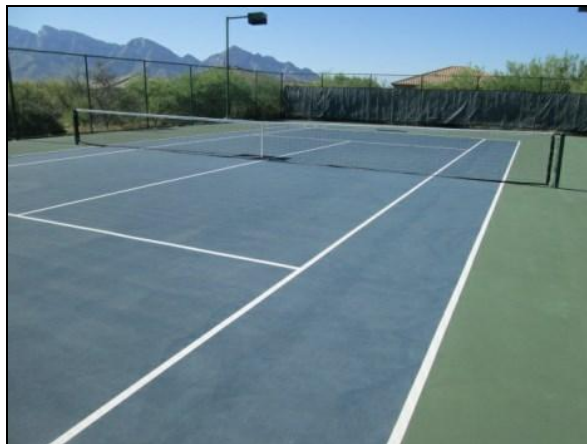
Comments: Surfaces look older and faded, but still in fair condition. Some hairline cracks have developed. This component funds to periodically resurface the court coating.

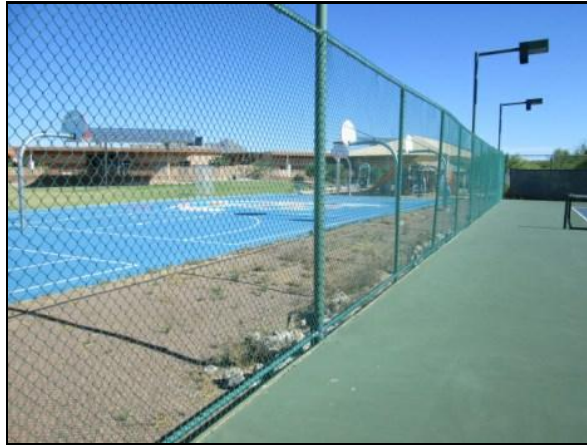
Comp #: 1152 Tennis Fence - Replace**Quantity: Approx 570 LF**

Comments: This is vinyl coated chain link fence. Original fence was retained when the courts were replaced. Still in good to fair condition. No signs of damage, but fence feels somewhat loose.

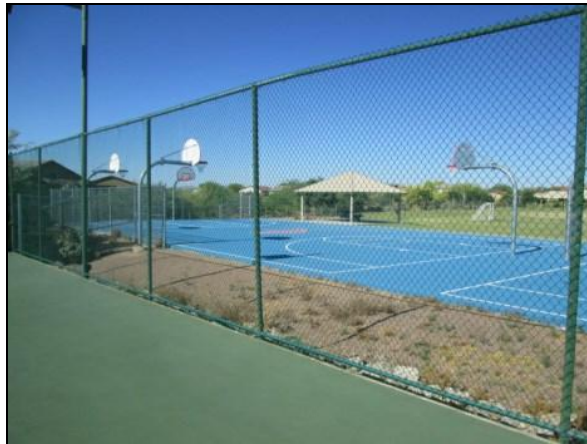
Comments: Paint surfaces on the tennis fence and lights already looks older. Surfaces are faded, and there is peeling paint.

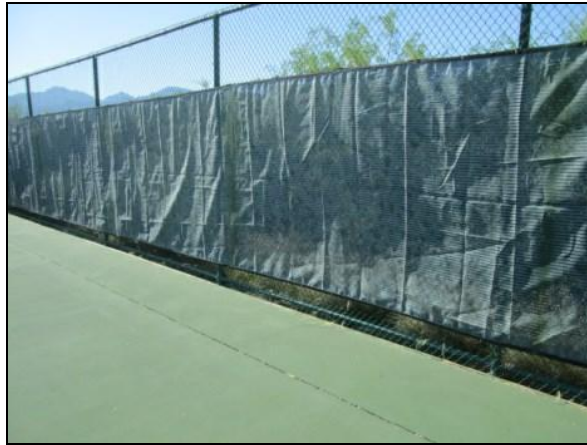
Comp #: 1156 Tennis Windscreen - Replace**Quantity: Approx 1,440 Sq Ft**

Comments: Screens look generally faded, but the material is not deteriorated. No holes or tears observed, but windscreen should be nearing time for replacement. Treat repairs or small replacements as a maintenance expense. This component funds complete replacement of the screens.

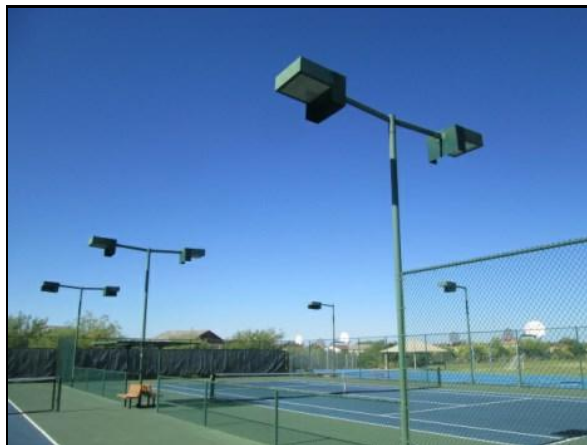
Comp #: 1158 Tennis Lights - Replace**Quantity: (12) Lights, (9) Poles**

Comments: Lights still appear to be in good condition. Overtime, light posts have been known to rust and rot below the court surface. Future replacement should be anticipated to update and modernize this lighting.

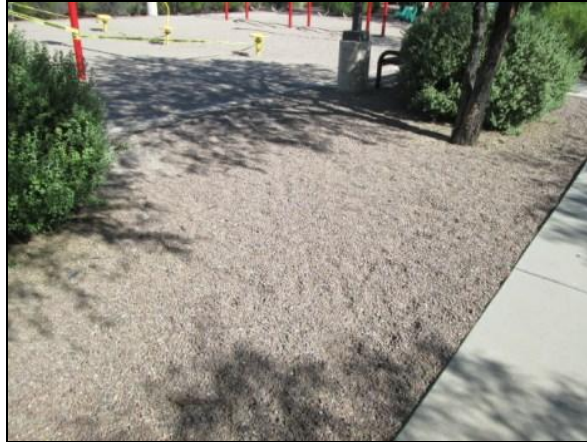
Comments: Conditions vary. Some spots have good, full coverage while other spots look low. There is no expectancy to completely replace the granite, but periodic replenishing should be planned to restore the appearance. Per the previous Reserve Study, the 2013 replenish project included:

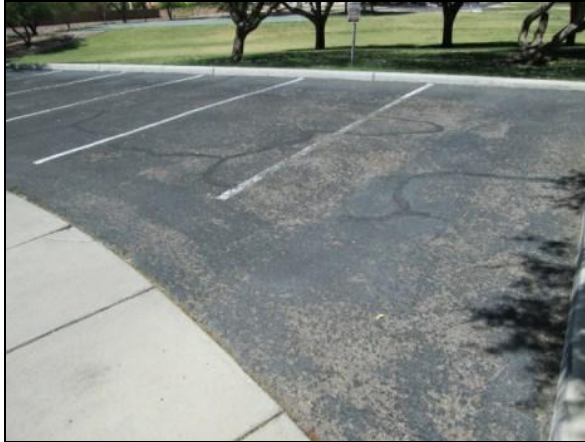
Comments: Surfaces are rough with a lot of exposed aggregate. Moderate cracking observed too. Life span is based on periodically sealing the asphalt.

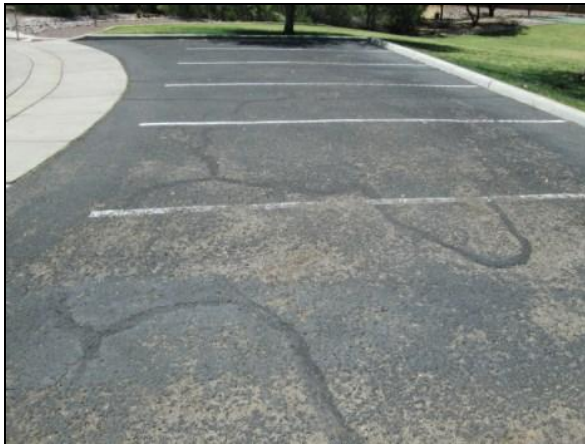
Comp #: 1201 Asphalt - Seal/Repair**Quantity: Approx 7,600 Sq Ft**

Comments: Surfaces look worn and are in poor condition.

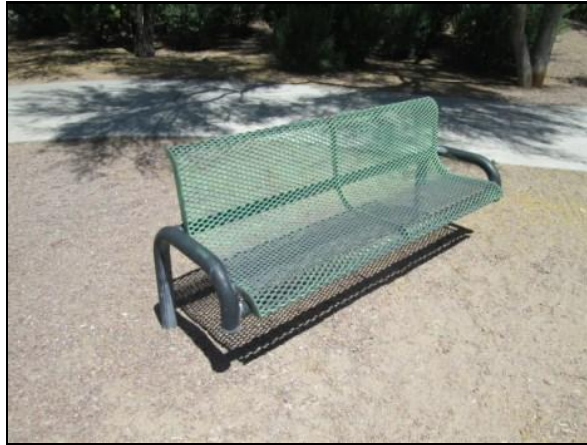
Comp #: 1206 Park Furniture - Replace (A)**Quantity: (7) Pieces**

Comments: Quantity includes (2) 6' benches, (3) trash cans and (2) BBQ grills. Furniture is old but still functional. It should be nearing time for replacement.

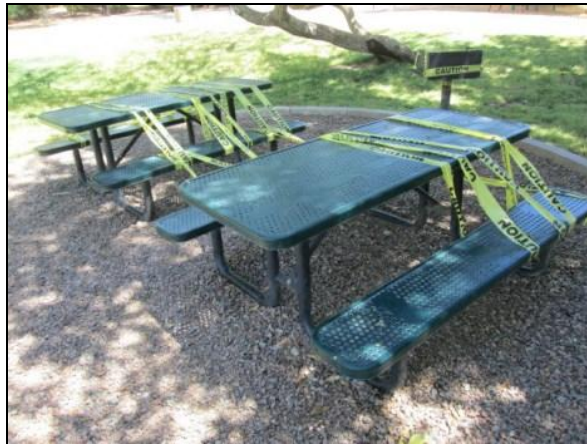
Comp #: 1206 Park Furniture - Replace (B)**Quantity: (3) Picnic Tables**

Comments: These are 6' picnic tables with portable frames. Still in good condition.

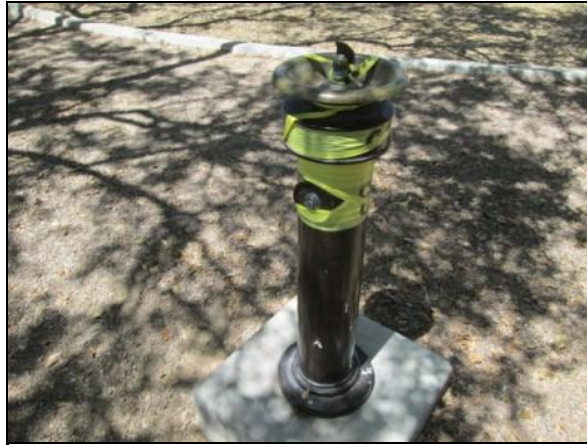
Comp #: 1210 Drinking Fountain - Replace**Quantity: (1) Fountain**

Comments: This is a decorative metal drinking fountain. Attractive and appears to be in good working condition.

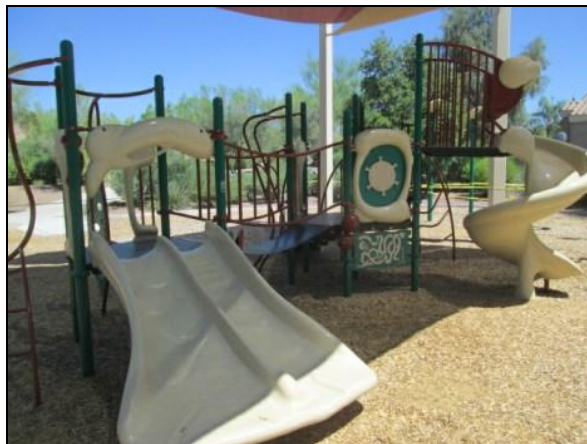
Comp #: 1214 Play Equipment - Replace**Quantity: (4) Pieces**

Comments: Cost of the 2015 replacement included demo of the old structure, installation of a Playworld Challengers #350-1401 structure plus (1) Spin Cup, (1) Spinami, and (1) Cruise Line. Equipment still appears to be in good condition.

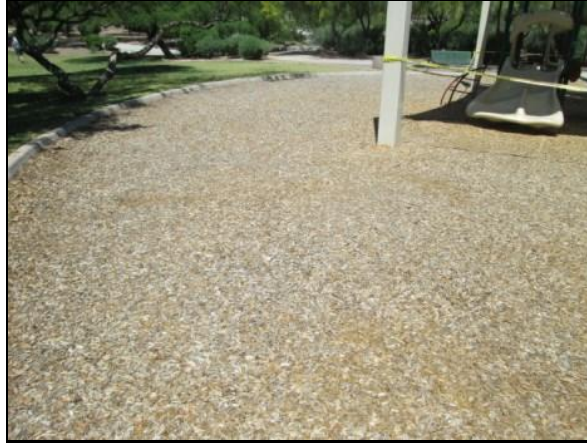
Comments: Cost of the 2015 work reflects the purchase and install of 200 cubic yards of engineered wood fiber surfacing. Per the contract, 200 cubic yards will cover the surface area at 12" deep. There is no expectancy to completely replace the wood surfacing, but periodic replenishing will be needed to maintain proper depths.

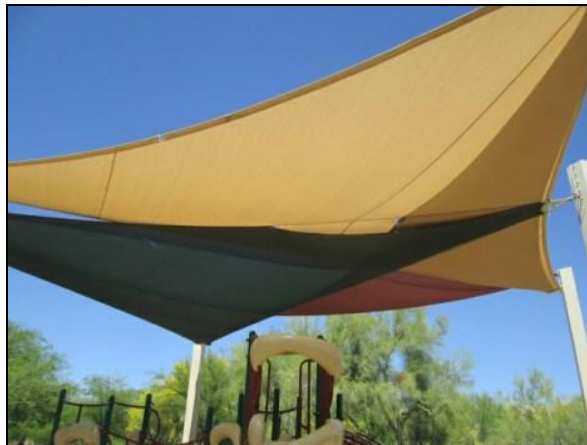
Comp #: 1218 Shade Sails - Replace**Quantity: (3) Sails: 870 Sq Ft**

Comments: Shade structure was added over the tot lot in 2010. It was described as a 30'x30'x12' structure. It has (3) sails mounted to (5) metal posts. One sail has multiple holes, but the other two still look fine. Recommend patching the holes as a maintenance expense. There is no expectancy to completely replace the structure. This component funds to periodically replace the shade sails. Painting the structure posts is included with the other park assets.

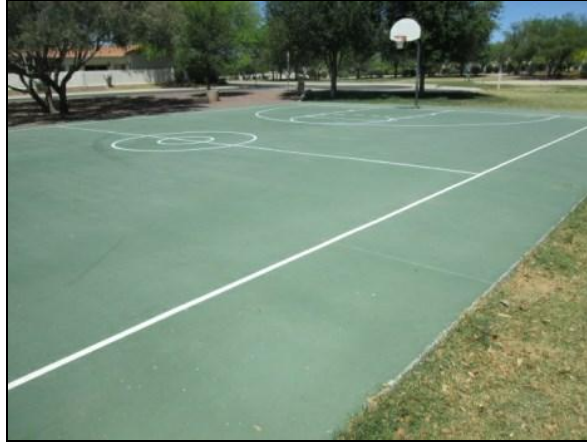
Comments: This is a concrete basketball court with sport coating. The refurbish project in 2008 reportedly including removing most of the court coating, pressure washing, acid etching, filling cracks, applying a primer coat followed by (3) coats of a finish surface. This is an extensive project that should not be needed every time the court is resurfaced. Court looks old with a lot of chipped spots and cracks, so refurbishing should be planned again soon.

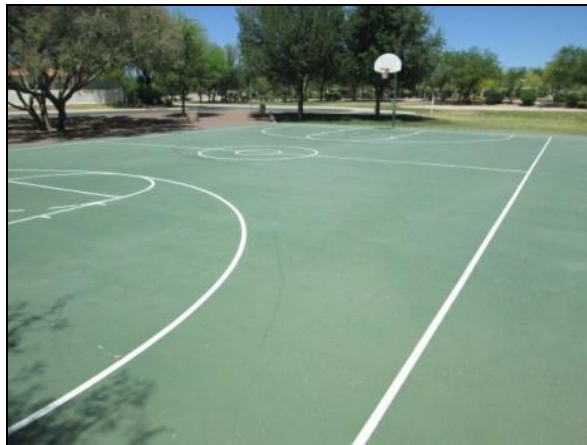
Comments: Timing of the last resurface project is unknown. Surface appears to be old and in poor shape. There are a number of cracks and a couple of chipped spots. This component is scheduled to offset the court refurbish allocation, so that work is scheduled on this court every 6-years.

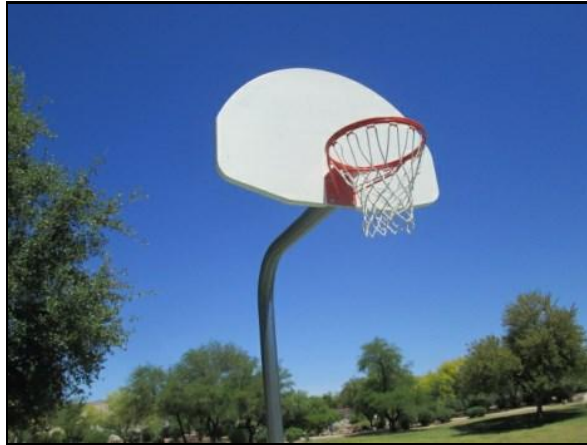
Comp #: 1222 Basketball Equip - Replace

Funded?: No. The backboards are good quality metal pieces. Replacement cost is below the Reserve expense threshold.

Recommend replacing as needed with Operating funds.

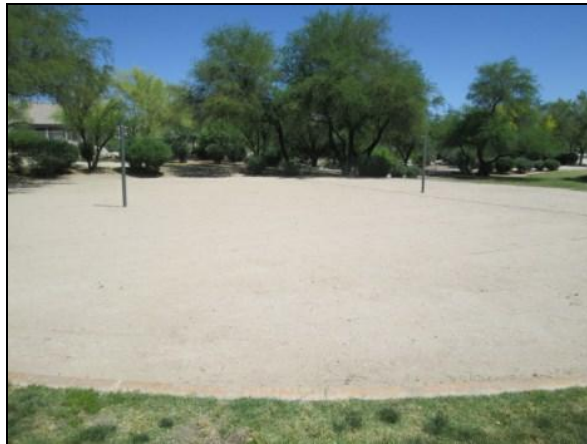
Funded?: No. There are no significant replacement issues to address with the volleyball court. Sand will need to be replenished periodically. Cost is below the Reserve expense threshold. Recommend replenishing as needed with Operating funds.

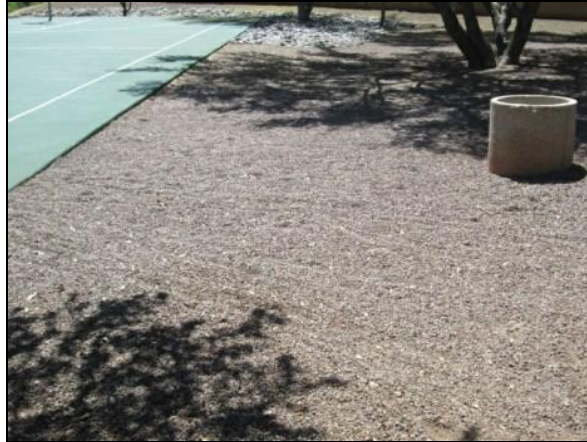
Comments: Conditions vary. Some spots have good, full coverage while other spots look low. There is no expectancy to completely replace the granite, but periodic replenishing should be planned to restore the appearance. Per the previous Reserve Study, the 2013 replenish project included:

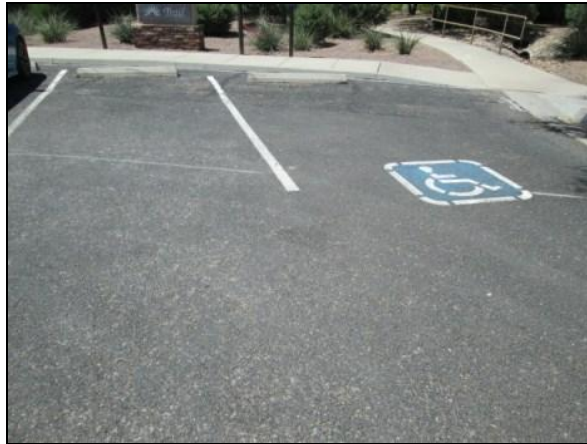
Comments: This small parking lot is located right off of Rancho Vistoso Blvd. Surface is rough with exposed aggregate plus some cracking. Life span is based on periodically sealing the asphalt.

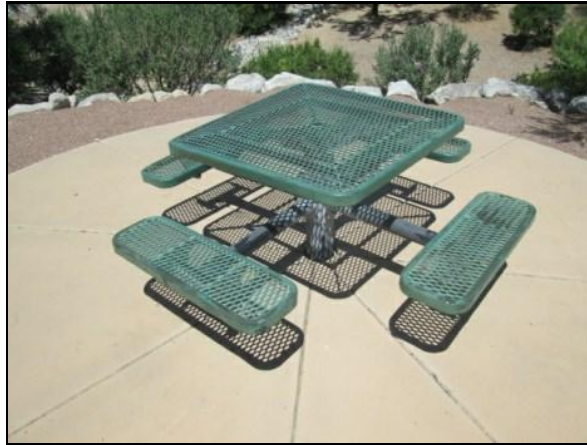
Comp #: 1244 Park Furniture - Replace**Quantity: (10) Pieces**

Comments: Quantity includes (3) 6' benches, (4) picnic tables, and (3) trash cans. These tables have a single pedestal with attached benches. They look old, and at least one has a bent top. Replacement should be anticipated in the near future.

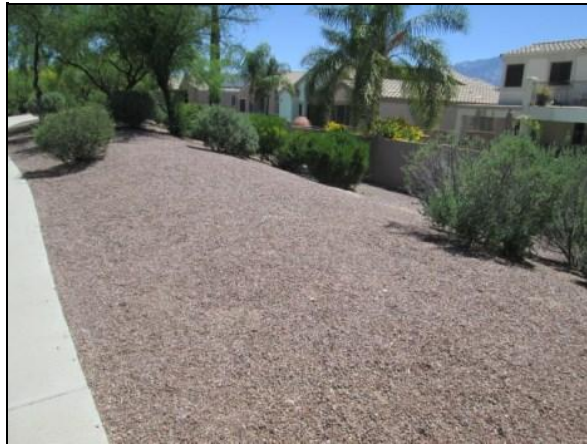
Comments: The 2013 replenish project only included ground cover up to the drainage basin; it did not include surfaces on the other side of the basin that border Vistoso Village. There is no expectancy to completely replace the granite, but periodic replenishing should be planned to restore the appearance. Per the previous Reserve Study, the 2013 replenish project included:

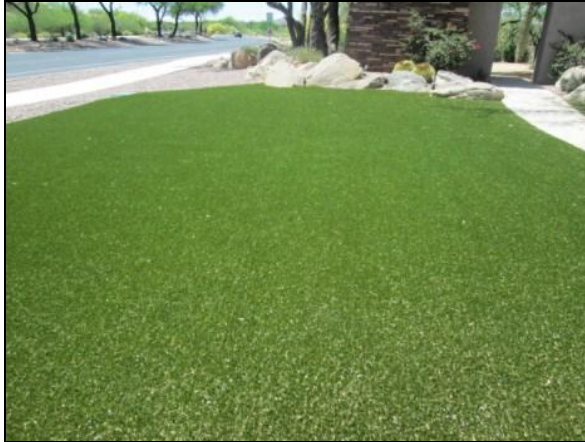
Comp #: 1300 Artificial Turf - Replace**Quantity: Approx 1,940 Sq Ft**

Comments: Artificial turf was installed as part of a landscape project around this intersection. Turf still looks nice and appears to be in good condition.

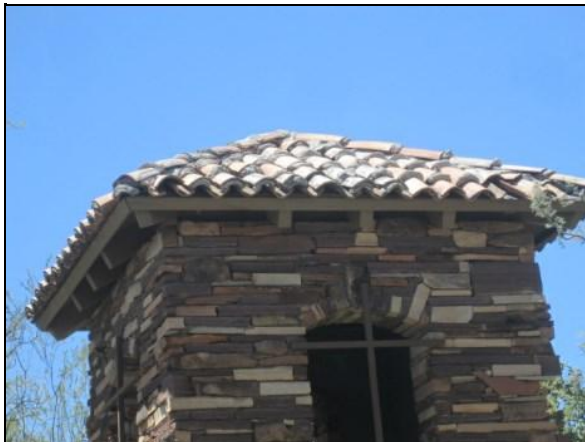
Comp #: 1306 Tile Roof - Replace**Quantity: Approx 130 Sq Ft**

Comments: There is a small section of clay tile roof on the Bell Tower. There is concrete between the tiles, so the entire roof will have to be replaced when the underlayment wears out. There appears to be a good amount of missing or broken tiles. This roof should be nearing time for replacement.

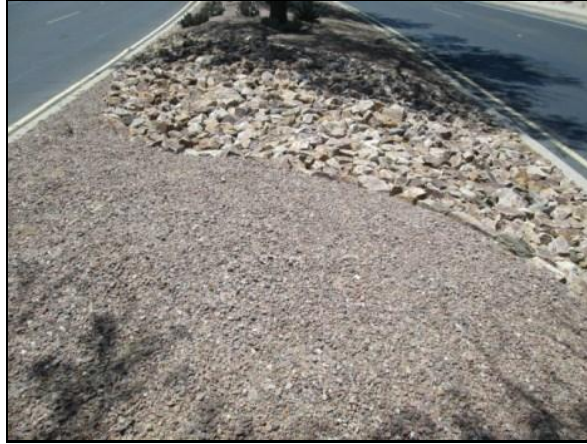
Comments: The 2016 renovation project involved replacing all of the irrigation and plants plus added 1" screened Wildcat Red granite to cover 155,000 sq ft and 4" to 8" Coronado Brown rip rap to cover 16,000 sq ft. Landscaping still looks attractive and is in good condition. This component funds for similar renovations in the future.

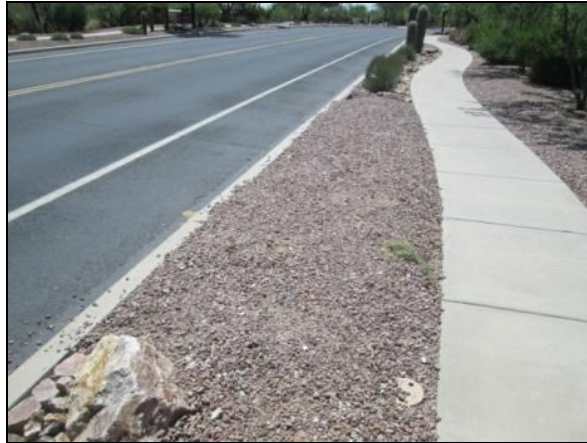
Comments: Granite coverage is new and in good condition. The granite will need replenishing sooner than scheduled under the landscape renovation project. This component funds to top dress or replenish the granite once between renovation projects.

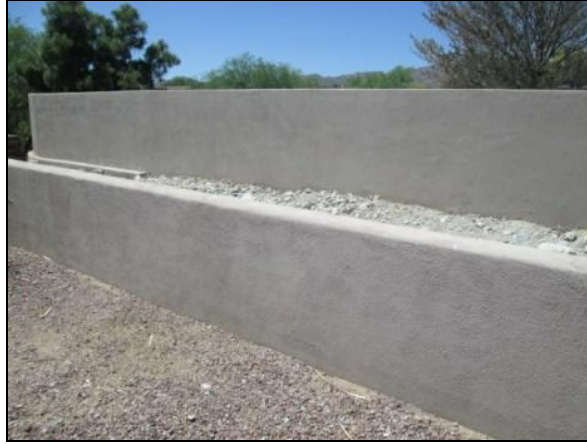
Comments: This component funds to paint ~13,530 sq ft of common stucco walls, ~1,400 sq ft of stucco at the Bell Tower, 136 LF of culvert rails, and 744 sq ft of decorative, tubular metal rails. Stucco surfaces look older, but are in fair condition. Metal surfaces were not repainted in 2013. They look old, chipped, and rusty. Recommend painting all common stucco and metal surfaces together.
