## **Update "With-Site-Visit" Reserve Study**

### **Vistoso Community Siena Neighborhood Oro Valley, AZ**

**Report #: 8973-8**

**Date Prepared: August 2, 2020**

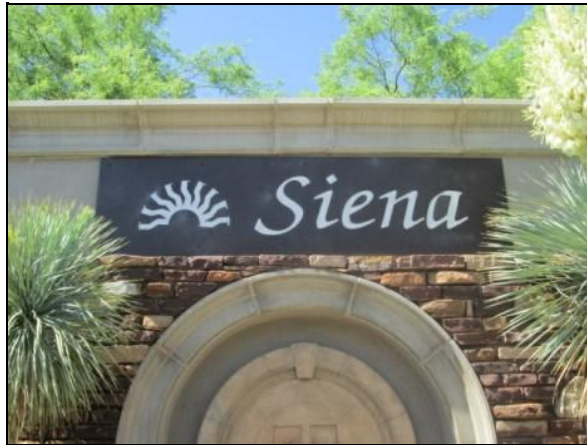
History: Replaced in 2015. Previously original from 2006.

Comments: Vistoso Community Association replaced this monument with the other community parcels. However, this monument is reportedly not VCA responsibility, so the parcel owners should be prepared for eventual replacement. We recommend planning to replace in conjunction with the VCA monuments.

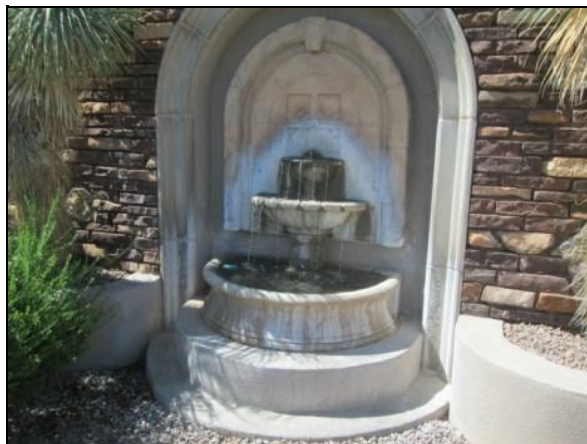
**Comp #: 2002 Fountain - Replace****Quantity: (1) Fountain**

Funded?: No. This is a concrete fountain mounted into the entry wall. There is no expectancy to replace the fountain. Repairs and maintenance should be addressed as an Operating expense.

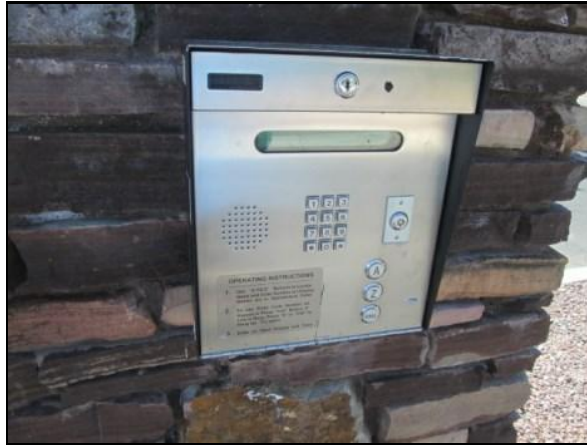
**Comp #: 2004 Entry System - Replace****Quantity: (1) DoorKing System**

Comments: Telephone entry system is still original. Appears to be functional and in good shape for its age. No signs of damage or vandalism. Based on age, it should be nearing time for replacement.

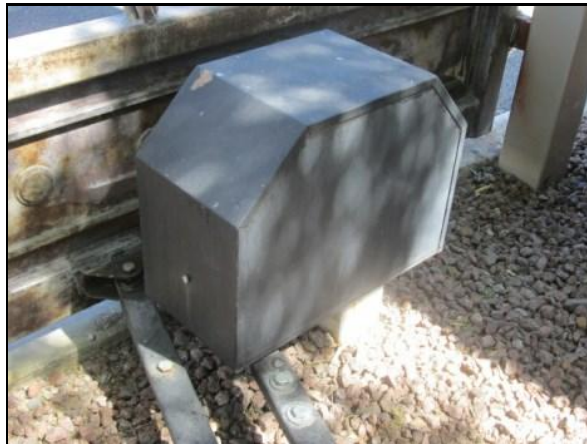
**Comp #: 2006 Gate Operators - Replace****Quantity: (4) Apollo Operators**

Comments: Gate operators are still original. They were not working the time of inspection due to a wiring issue. Motors themselves should be fine for now. Based on age, they should be nearing time for replacement.

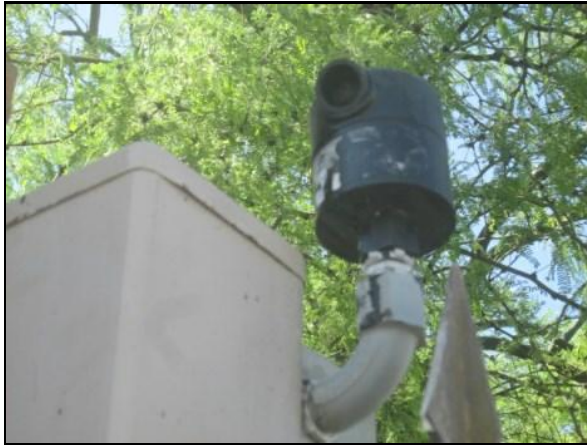
**Comp #: 2008 Strobe Detectors - Replace**

Funded?: No. These switches detect strobe signals from emergency vehicles and automatically open gate systems. Recommend replacing as needed with Operating funds.

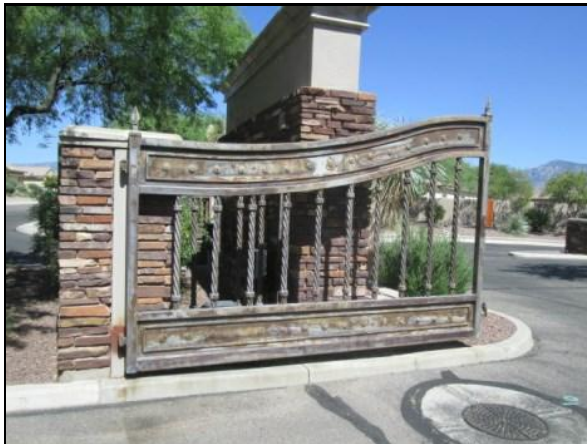
**Comp #: 2010 Vehicle Gates - Replace**

Comments: Vehicle gates have a long life expectancy under normal circumstances. They can often be repaired or rebuilt as needed. Replacement resulting from vehicle damage should be addressed as an insurance issue. These are attractive, heavy duty gates. Siena owners should anticipate replacing them eventually to update and restore the appearance.

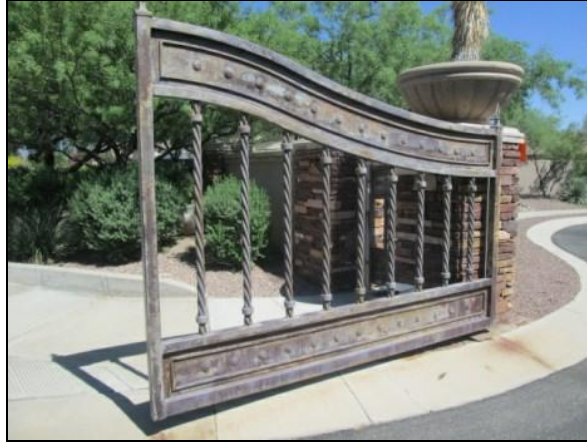
Comments: This component funds to paint ~800 sq ft of stucco walls, 46 LF of vehicle gates, 7 LF of pedestrian gates, and 7 LF of metal fence. Stucco is on the backside of the stone veneer walls. It has low visibility and still looks good. Metal surfaces originally had a rust finish and did not need painting. It appears to have a clear coat finish now. That finish was re-applied not long ago, but it looks old and is peeling. Surfaces should be painted or treated/sealed to restore the appearance.

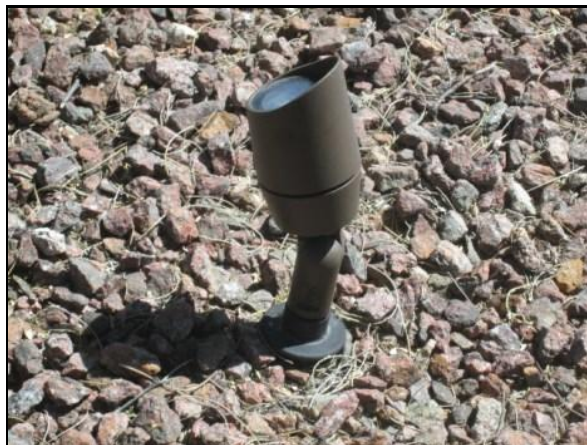
**Comp #: 2016 Landscape Lights - Replace****Quantity: (27) Light Fixtures**

History: Replaced 11/2015 for \$7,471. Previously original from 2006.

Comments: The original lighting on both sides of the entry gate and in the island were replaced with LED fixtures. A transformer and photo cell were also installed with the lights. Still appears to be in good shape and expected to be in good working condition.

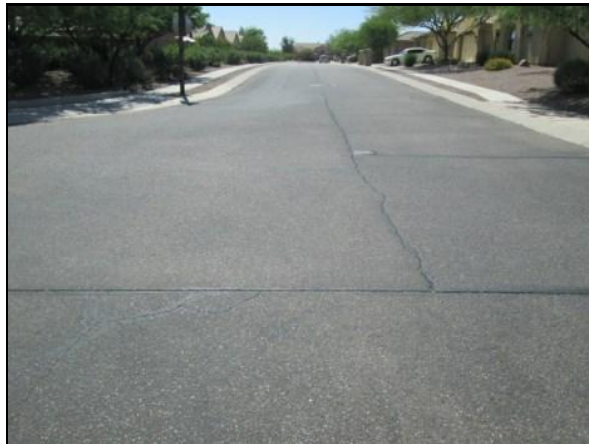
Comments: Surface still has a rough texture and cracking. That is likely due to not sealing often enough in the early years. There does not appear to be any signs of failure though. Life span is based on periodically seal coating and maintaining the surface.

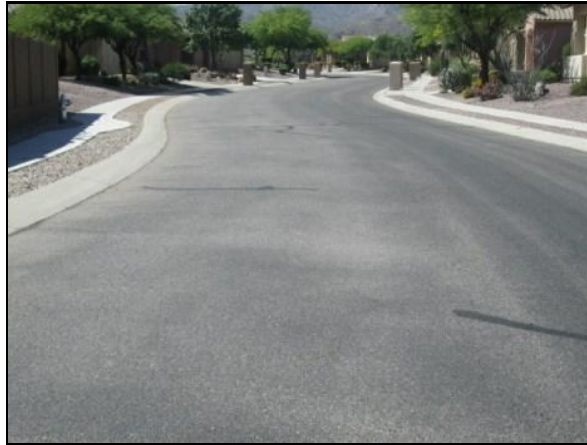
**Comp #: 2021 Asphalt - Seal/Repair****Quantity: Approx 118,000 Sq Ft**

Comments: The 2016 sealing project was the first seal coat application in a long time. That coating is just about gone now and is in poor condition. Seal coat asphalt surfaces periodically to prevent premature cracking and deterioration.

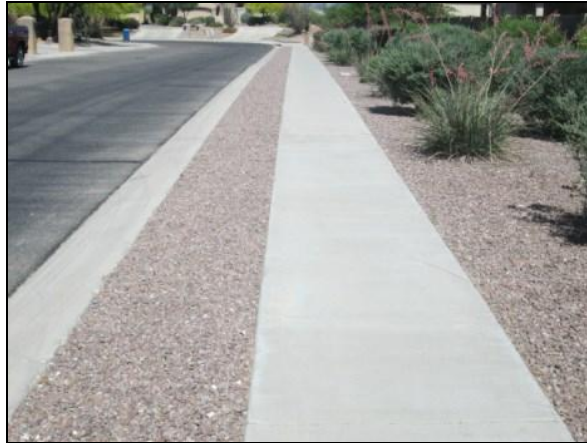
**Comp #: 2024 Concrete - Repair****Quantity: Numerous Sq Ft**

Comments: Owners are reportedly responsible for concrete sidewalks in front of their homes. That makes up the majority of concrete in this parcel. There is still some common area concrete. This component funds an allowance for periodic repairs and partial replacements as needed.

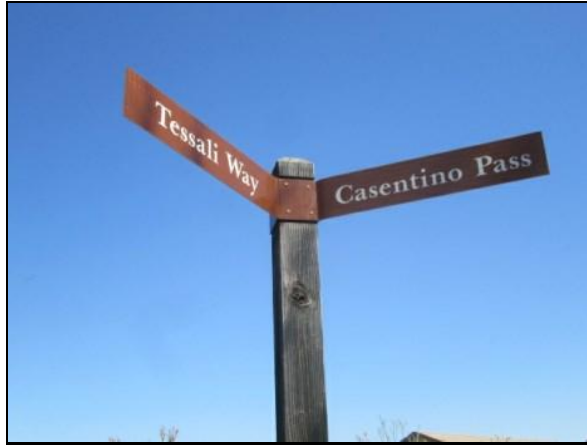
**Comp #: 2030 Street Signs - Replace****Quantity: (12) Signs**

History: Replaced 5/2020 for \$1,400. Previously installed in 2006.

Comments: Quantity includes (10) custom street signs and (2) stop signs. They are new and in good condition.
