Vistoso Community Association
Oro Valley, AZ

Report #: 8973-11
Beginning: January 1, 2024
Expires: December 31, 2024

RESERVE STUDY
Update "With-Site-Visit"

August 19, 2023

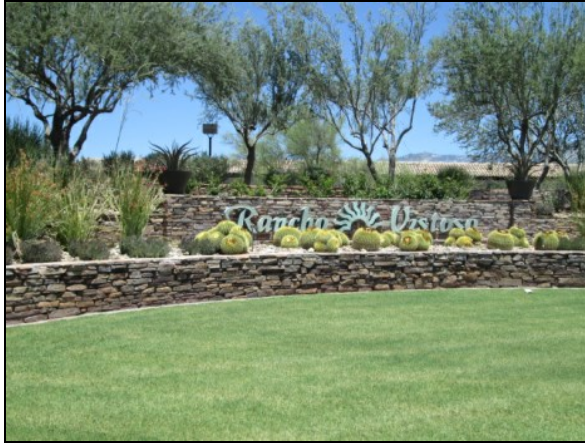
Useful Life:
20 years

Remaining Life:
19 years

Best Case: \$ 265,000

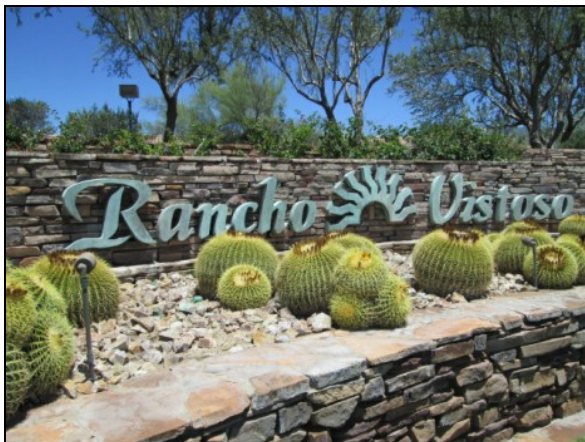
Useful Life:
20 years

Remaining Life:
9 years

Best Case: \$ 5,000

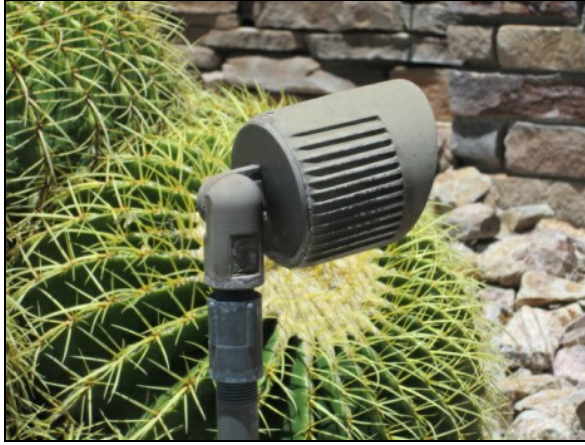
Comp #: 102 Monuments (Ph1) - Replace Lights**Quantity: Numerous Lights**

Comments: Existing monument lights are reportedly not functional. They will be replaced soon as part of the monument renovation project. This component funds an allowance to replace lighting once between renovation intervals.

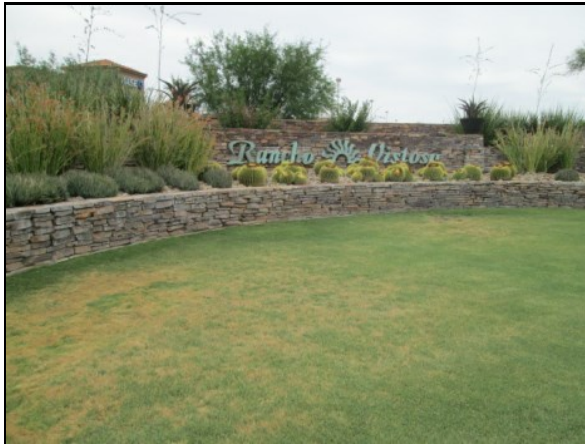
Comments: Monuments consist of metal lettering attached to walls covered with stone veneer. Lettering reads "Rancho Vistoso". These monuments will be renovated in the same manner as the Tangerine monuments, but the timing is being delayed until at least 2025. Treat repairs and maintenance as an Operating expense.

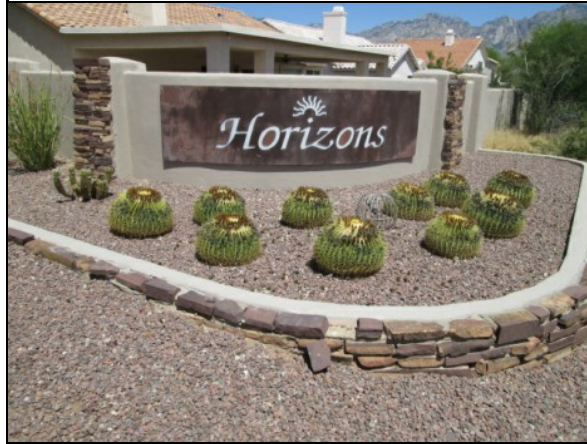
Comments: Parcel and park monuments were replaced and updated between 2012 and 2016. Style is consistent throughout the community and still looks nice. Some signs with high sun exposure look faded and are delaminating/peeling. Despite a slight age difference, we recommend the HOA plan complete replacement to update all signs at the same time.

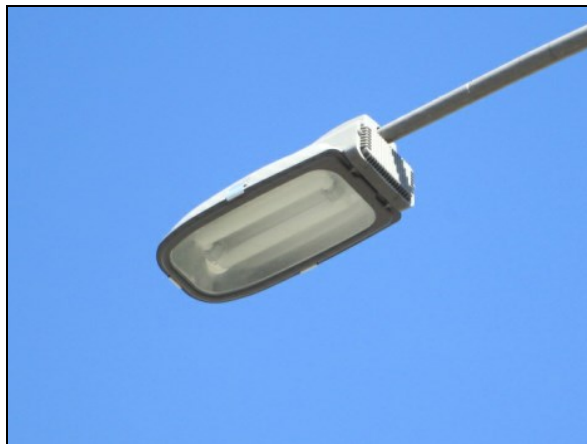
Comments: VCA owns these street lights. The fixtures were replaced with 480-volt induction cobra heads. In addition, the light fixtures were painted and 93 glare shields were installed. New street lights were added in 2016 at the Vistoso Highlands intersection. The age difference between these lights is minimal, so plan to replace all of them together in the future. Issues have been reported with parts already obsolete, so that could result in replacing prematurely. Remaining life has been accelerated somewhat in light of this problem. Repair or replace individually as an Operating expense if needed. There is no expectancy for widespread replacement of the light poles under normal circumstances, so this component only funds replacement of the fixture heads.

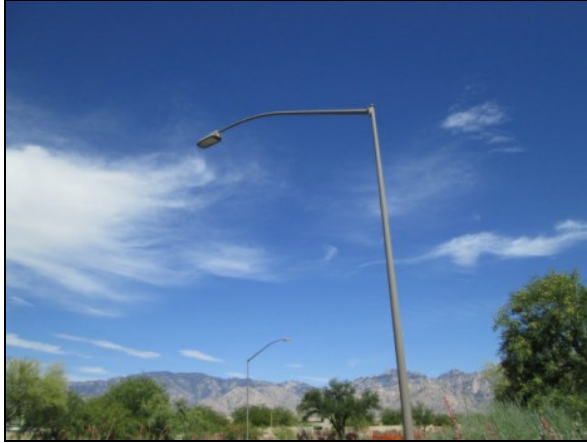
Useful Life:
8 years

Remaining Life:
3 years

Best Case: \$ 85,000

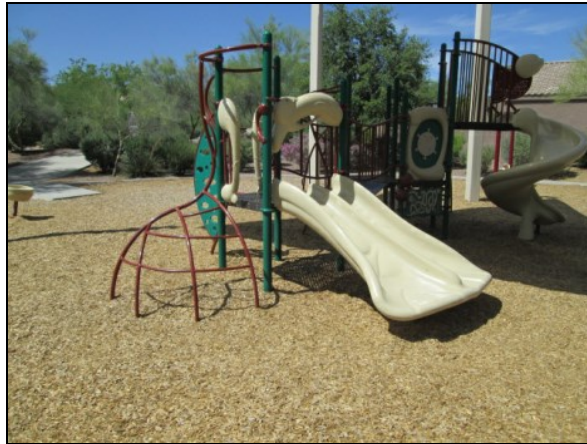
These are relatively expensive repair projects, so this component funds an allowance for periodic repair where needed throughout the community.

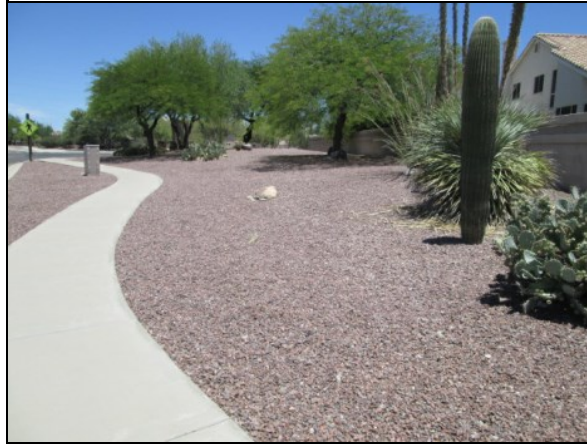
Useful Life:
20 years

Remaining Life:
16 years

Best Case: \$ 184,000

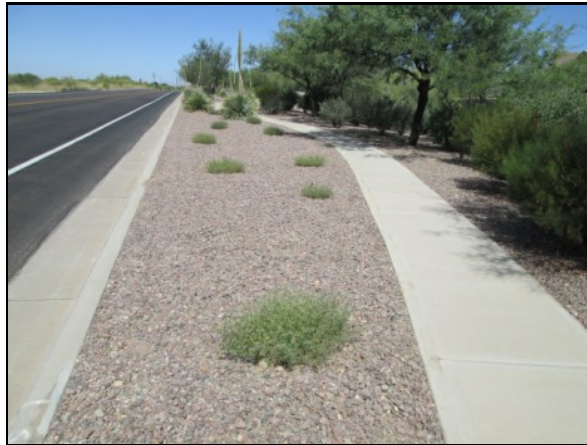
Useful Life:
20 years

Remaining Life:
1 years

Best Case: \$ 141,000

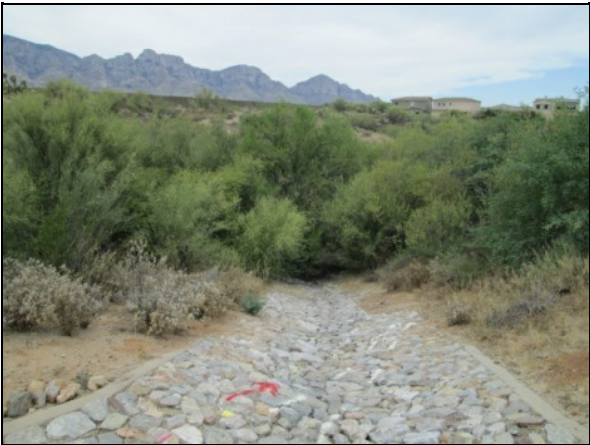
Useful Life:
1 years

Remaining Life:
0 years

Best Case: \$ 60,000

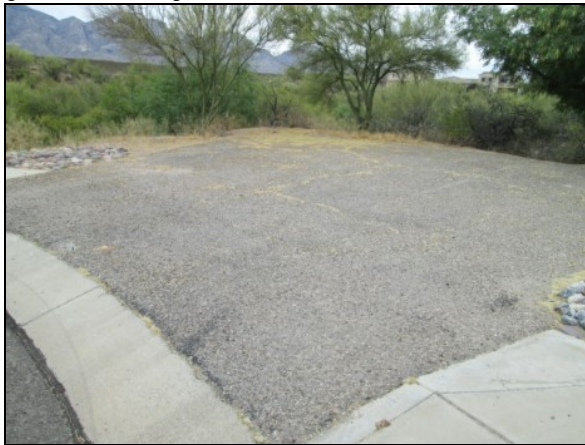
Comments: This is just a small parking pad that does not appear to receive much use. HOA is reportedly responsible to maintain it. Surface has not been maintained. It is rough and eroded. This component funds to remove and repave the asphalt. Life span is based on periodically seal coating and maintaining the surface.

Useful Life:
24 yearsRemaining Life:
0 years

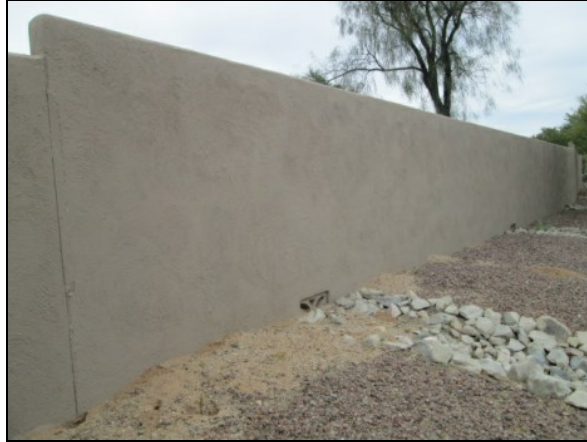
Comments: Cost of the 2021 paint project was low relative to the quantities that should have been painted at these parcels, so it is not being used as a benchmark for budgeting. This component funds to paint ~66,000 sq ft of common stucco walls, 65 LF of metal fence mounted at spillways, 280 LF of metal fence at Big Wash Park, 348 LF of culvert rails, and 266 sq ft of shade structure posts at the park. Wall surfaces are still clean and look uniform. Metal surfaces vary in condition. Recommend painting all common walls and metal surfaces together.

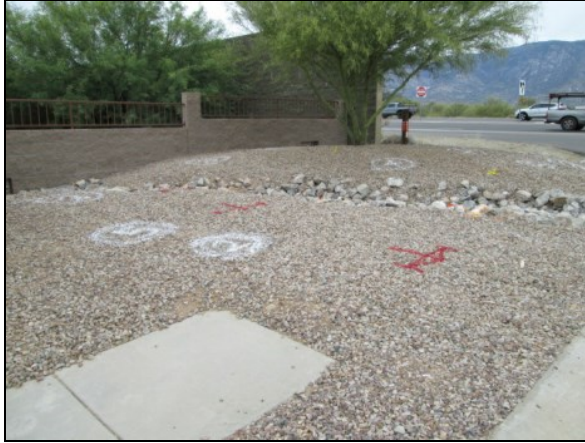
Comments: Entry granite looks recently replenished as part of the new gate system additions. This component funds an allowance to replenish landscape granite at the Vista Marbella parcel entrances.

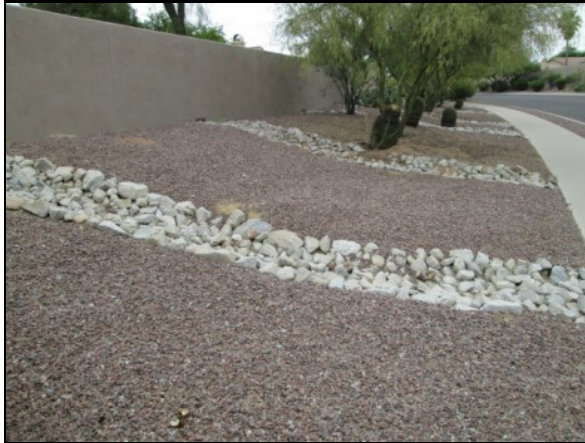
Comments: Vistoso Village Drive appears to be the only significant location of common area landscape granite in Neighborhood 2. VCA is reportedly only responsible for the section of granite between the curb and sidewalk; rest of the granite surfaces are considered responsibility of the homeowner lot that backs this area. However, VCA replenished all surfaces in 2018. Granite coverage is still full and looks good. This section of granite has high visibility and should be top dressed periodically to maintain the appearance.

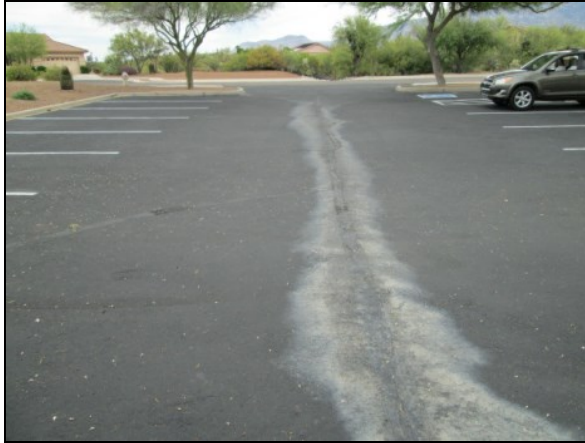
Comments: Still generally smooth and in fair condition overall. There are some cracks, and it has a rough texture. Minor erosion down the center of the parking lot due to water runoff. Pavement is older, but it does not need to be repaved yet. This component funds to remove and repave the asphalt. Life span is based on periodically seal coating and maintaining the surface.

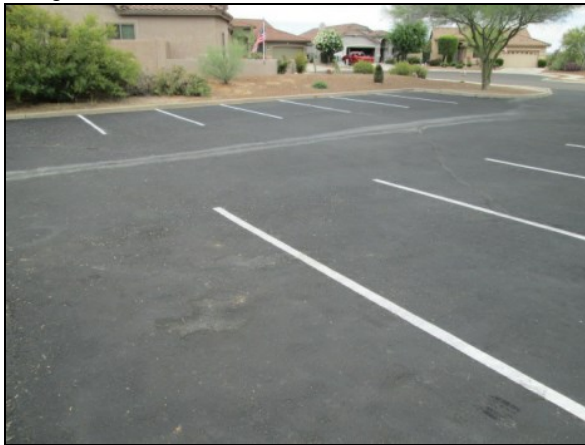
Comp #: 261 Asphalt - Seal/Repair**Quantity: Approx 4,860 Sq Ft**

Comments: Seal is new, dark, and in good condition.

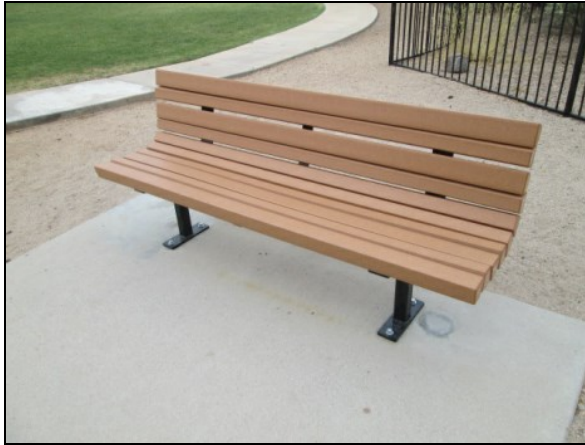
Comp #: 270 Park Furniture - Replace**Quantity: (4) Pieces**

Comments: Quantity includes (2) 6' benches, (1) picnic table, and (1) trash can. Furniture is from TimberForm and has metal frames with recycled plastic slats. Newer and in good condition. Replace broken slats as a maintenance expense when needed.

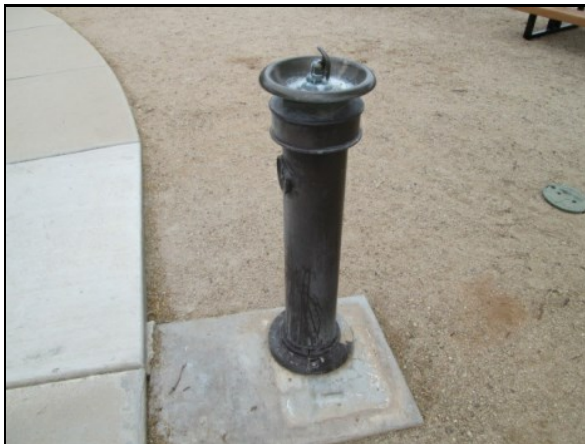
Comp #: 274 Drinking Fountain - Replace**Quantity: (1) Fountain**

Comments: This is a decorative metal drinking fountain. It was not working at the time of inspection but reportedly just needs a repair.

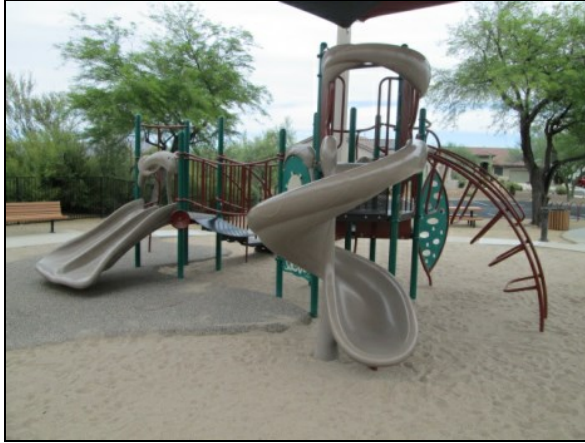
Comments: Cost of the 2015 replacement included demo of the old structure, installation of a Playworld Challengers #350-1401 structure, and 42 tons of new sand. Still in good condition. No signs of damage or vandalism.

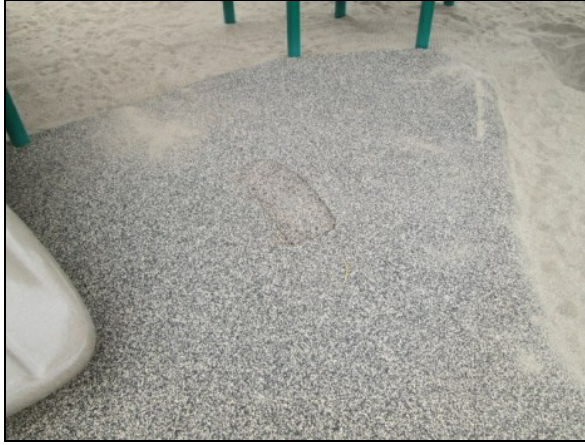
Comp #: 284 Playground Turf - Replace**Quantity: Approx 250 Sq Ft**

Comments: Rubberized turf was installed as part of the play structure replacement project. Fair condition. Still somewhat soft, but a gap has developed between the turf and sidewalk. One patched spot was noted too.

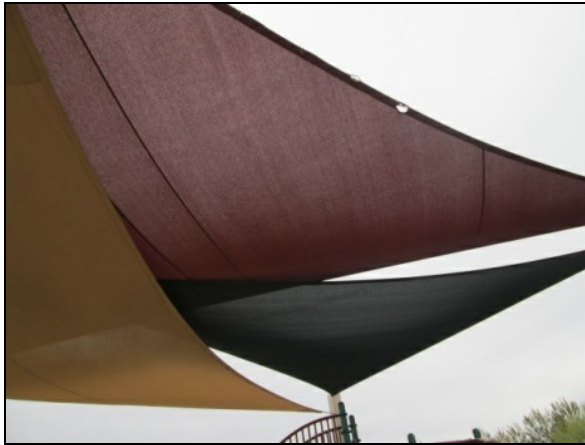
Comp #: 286 Shade Sails - Replace**Quantity: (3) Sails: 1,070 Sq Ft**

Comments: Shade structure was added in 2010 and was described as a 30'x30'x12' structure. These sails vary in condition. Top sail exhibits the most wear and tear with some fraying along the edges and multiple holes. New sails have been ordered and will be installed at some point in 2023. There is no expectancy to replace the structure. This component funds to periodically replace the shade sails. Painting the structure posts is included with the walls & fences under the Neighborhood 2 section of this report.

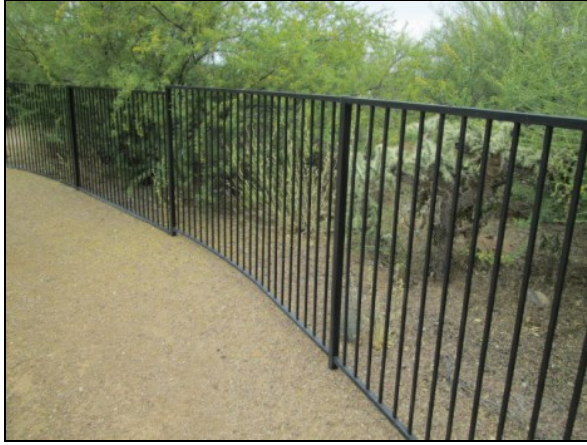
Comp #: 290 Metal Fence - Replace**Quantity: Approx 280 LF**

Comments: Fence is still holding up fine and looks decent overall. Support posts feel secure and solid. Periodic painting is included with the walls & fences under the Neighborhood 2 section of this report.

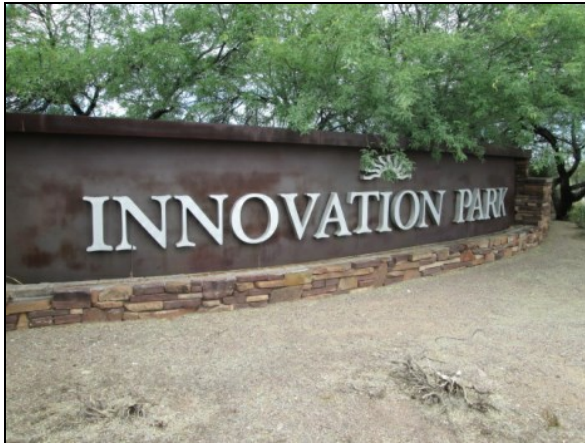
Comments: Although we were informed in the past that VCA is not responsible for these monuments, it is now believed that VCA is the only entity that would or could be responsible for them, so Reserve funding has been added. Each monument has (14) 20" reverse pan channel letters that read "Innovation Park" plus (1) logo and ~270 sq ft of rust finish metal.

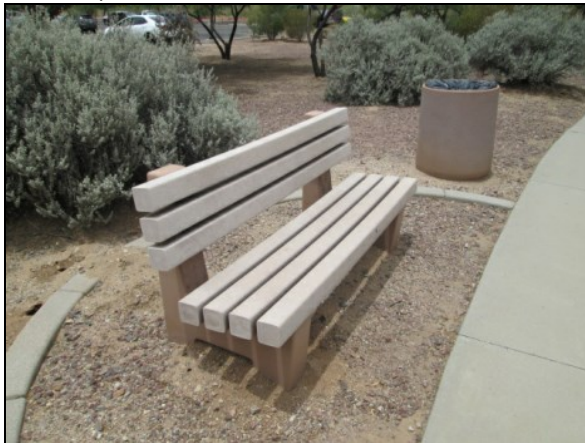
Comp #: 310 Park Furniture - Replace**Quantity: (4) Benches, (6) Trash**

Comments: Furniture is manufactured by Wassau Tile. Benches have concrete frames with recycled plastic seats and backs. Trash cans are concrete with flat, metal tops. Bench slats look weathered but intact. Overall fair condition, but getting old.

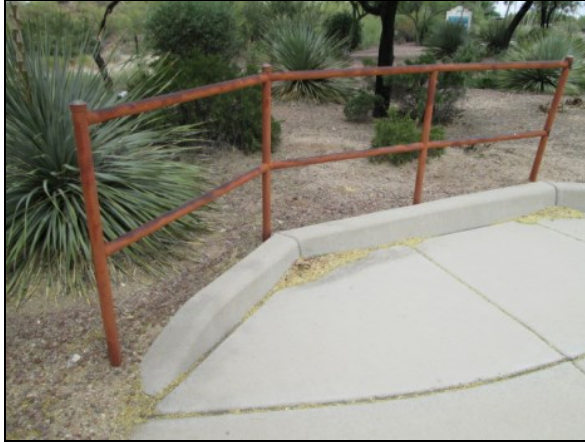
Comments: Paint surfaces are old, rusty, and generally in poor condition.

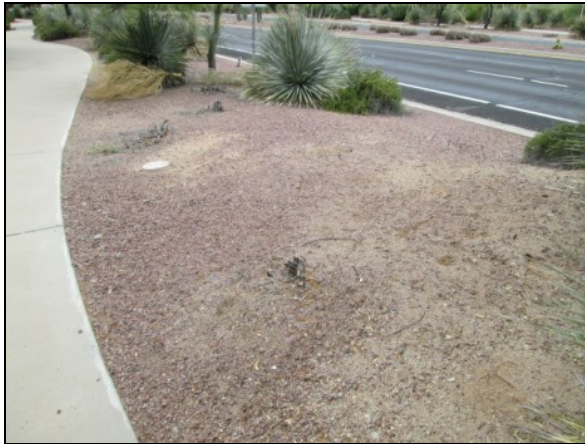
Comp #: 320 Irrigation System - Replace

Comments: It is beyond the scope of this Reserve Study to quantify and assess conditions of the irrigation system. System is reportedly in disrepair and needs replacing. AAA Landscape provided an estimate several years ago to replace the irrigation along both sides of Innovation Park Drive for ~\$194,000. This project is still anticipated in the near future.

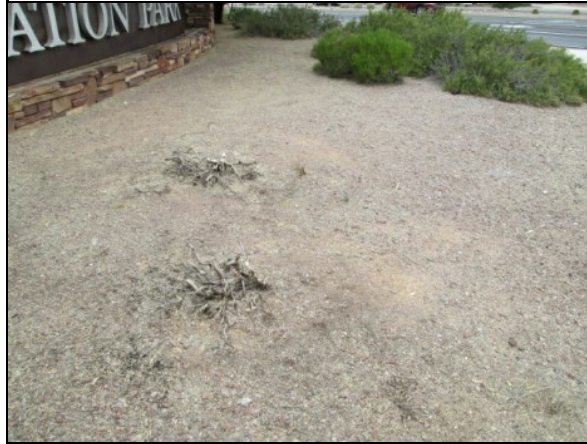
Comments: Granite coverage in planter areas along the sides of the road is aged and depleted. AAA Landscape provide a quote several years ago to replace this granite in conjunction with irrigation replacement for ~\$207,000. This cost is much higher than expected for just a top dress. Due to the depleted nature of the granite coverage, more rock is needed to restore the 2" layer than needed for the typical 1" top dress. This component is scheduled as a one-time expense.

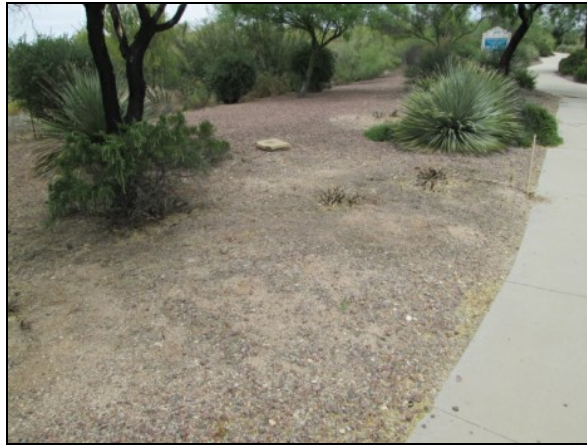
Comments: This component funds to periodically top dress with a new 1" layer of rock. We calculate ~1,100 tons is needed to accomplish the top dress. This is the component that will fund future replenishing work after the 2024 project.

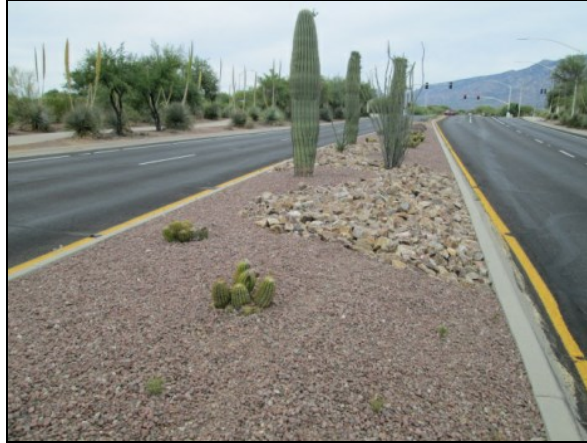
Comments: Medians were completely renovated with new plants, 364 tons of granite, 330 tons of rip rap, (10) 2-station irrigation controllers, and new irrigation lines. Landscaping still looks attractive, clean, and in good condition. This component funds for similar renovations periodically to update and restore the appearance.

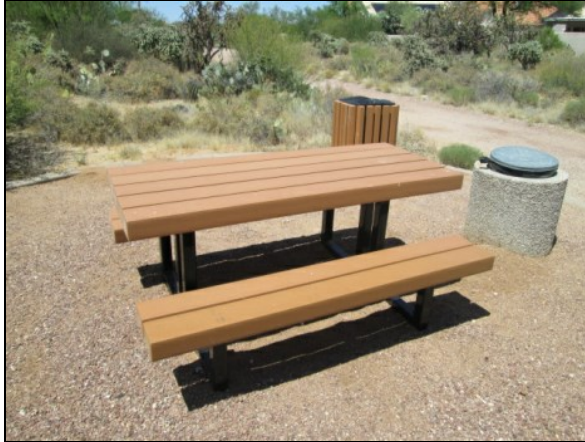
Comments: Quantity includes (4) 6' benches, (2) picnic table, and (6) trash cans. Furniture is from TimberForm and has metal frames with recycled plastic slats. Newer and in good condition. Replace broken slats as a maintenance expense when needed.

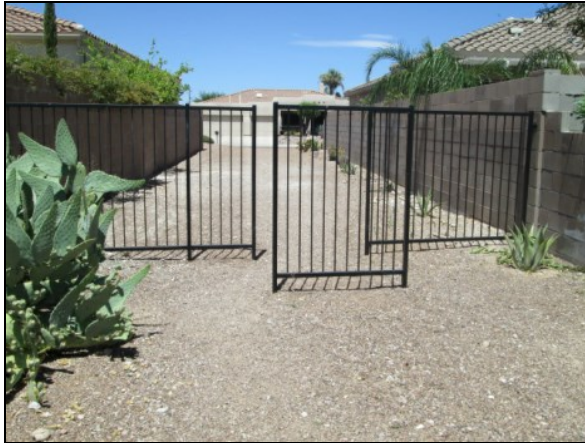
Comments: Metal fences are still securely mounted. They were recently painted, so surfaces no longer look old and rusty. Still in fair condition. Long life expectancy under normal circumstances, but replacement should be anticipated. These fences do not appear to serve a purpose, so HOA should consider removing them rather than funding replacement.

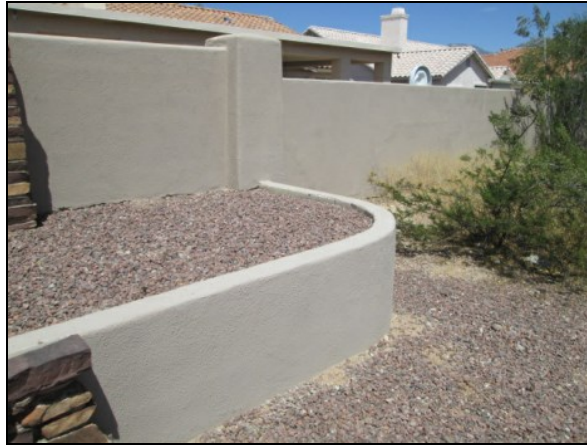
Comments: This component funds to paint ~21,800 sq ft of common stucco walls, 33 LF of metal fence in the Vistoso Heights parcel, and 217 LF of culvert rails. Surfaces appear to be clean and uniform. Some cracks are visible already. Recommend painting all common walls and metal surfaces together.

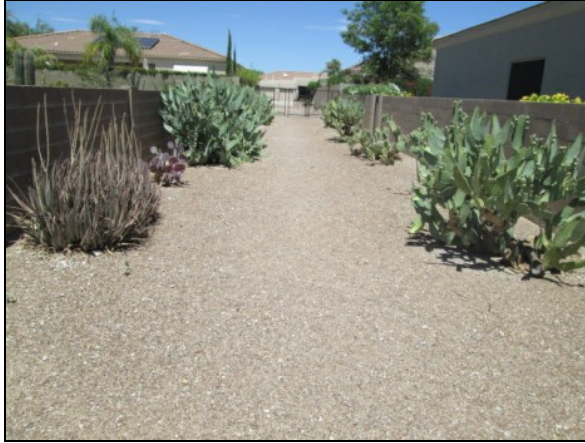
Comments: Common tracts at the Horizons and Vistoso Heights parcels appear to be in decent shape. Coverage still looks fine for now. This component funds to periodically top dress with a new 1" layer of rock, which we estimate will require 140 tons.

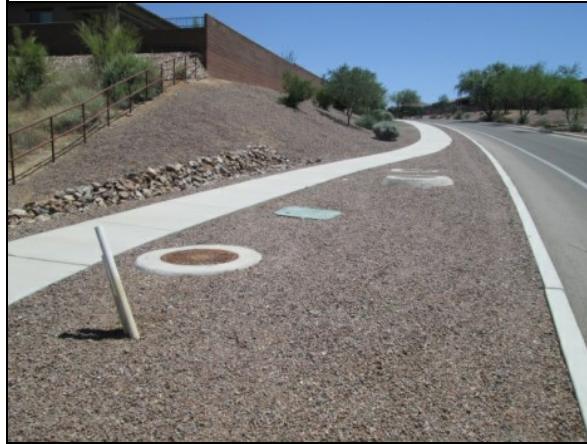
Comments: This section of the community is newer. Granite coverage is still in good condition where installed. This component funds to periodically top dress with a new 1" layer of rock, which we estimate will require 326 tons.

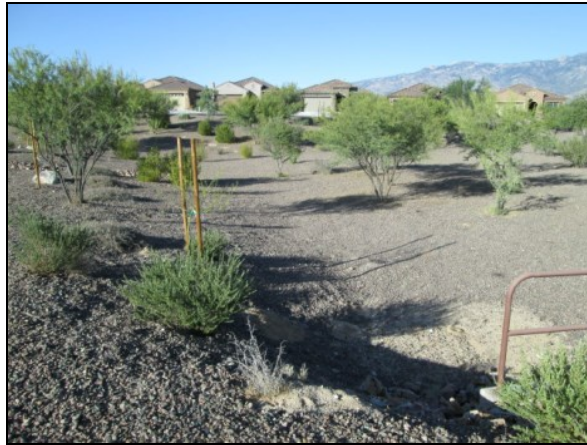
Comments: This section of the community is newer. There are large common tracts, so granite coverage is extensive. Still in good condition. This component funds to periodically top dress with a new 1" layer of rock, which we estimate will require 2,100 tons.

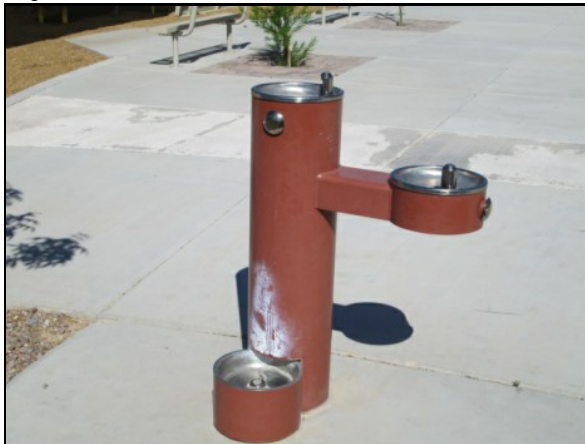
Comp #: 664 Drinking Ftn - Replace (B)

Comments: This is a pedestal drinking fountain with (2) dispensers and (1) pet dispenser. There is some water staining on the surface, but it still appears to be in good condition.

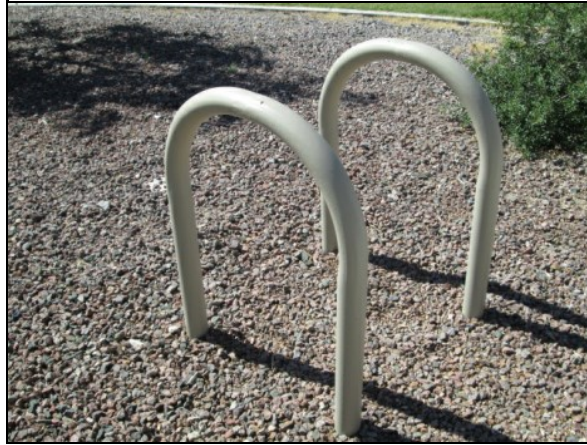
Comp #: 667 Bike Loops - Replace

Funded?: No. This component has an extended life span under normal circumstances. Recommend replacing as needed with Operating funds, if needed.

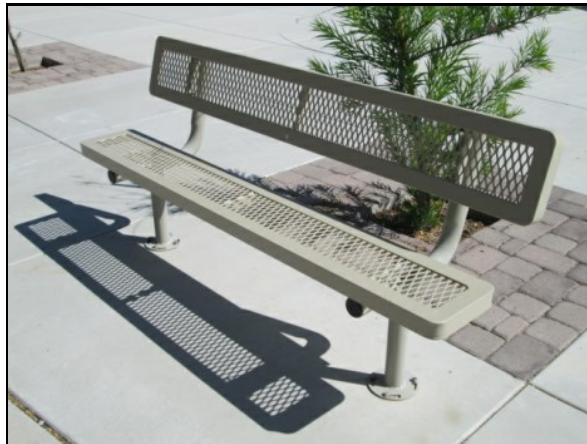
Comp #: 668 Park Furniture - Replace

Comments: Quantity includes (6) 6' benches, (8) picnic tables, (4) trash cans, and (3) BBQ grills. This furniture still looks newer and is in good condition.

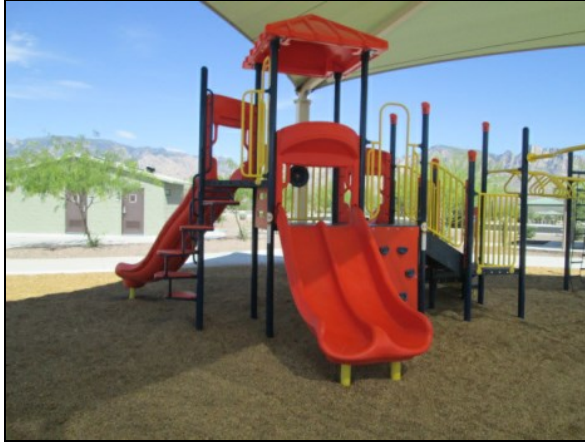
Comp #: 670 Play Equipment - Replace**Quantity: (6) Pieces**

Comments: Equipment includes (2) play structures, (1) single bay arched swing set, (1) double bay arched swing set, (1) spin cup, and (1) climbing boulder. No signs of damage or abuse. Still in good condition.

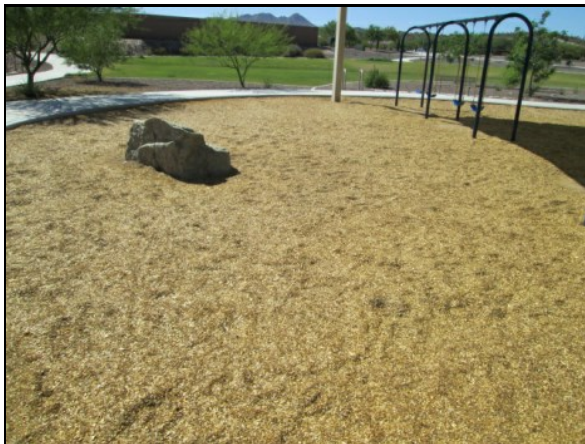
Comments: Both playground sections at this park have wood chip surfacing. There is no expectancy to completely replace the wood chips, but periodic replenishing will be needed to maintain proper depths. Coverage is still in fair condition. It is low under the swings and parts of the play structures.

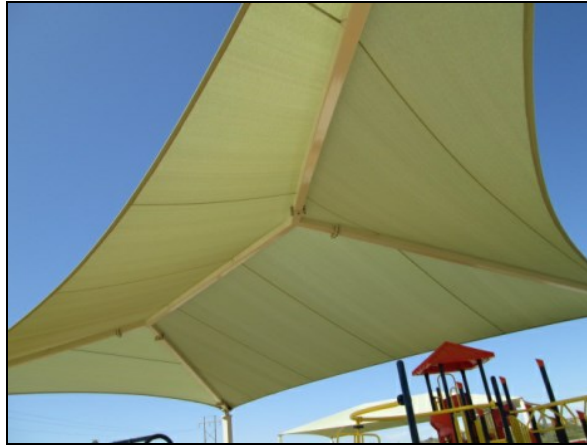
Comp #: 678 Shade Screens - Replace**Quantity: (2) Screens: 2,550 Sq Ft**

Comments: Shade screens are in good condition. No visible holes or tears noted. There is no expectancy to replace the structures. This component funds to periodically replace the shade screens only. Painting the structure posts is included with the other park assets.

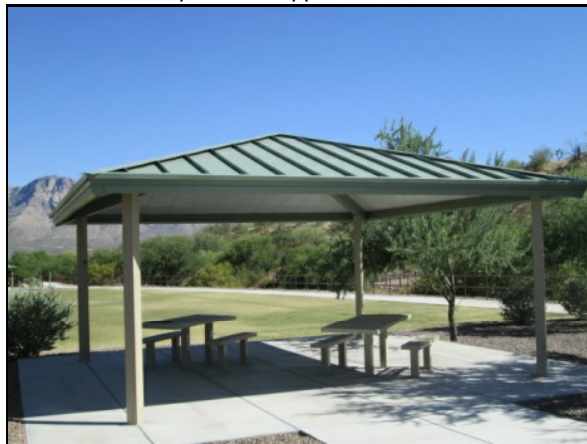
Comp #: 680 Ramada Roofs - Replace**Quantity: (4) Ramadas: 1,720 Sq Ft**

Comments: Ramadas have prefabricated metal roofs. Long life expectancy under normal circumstances. Replacement should be planned eventually due to either vandalism or to update the appearance.

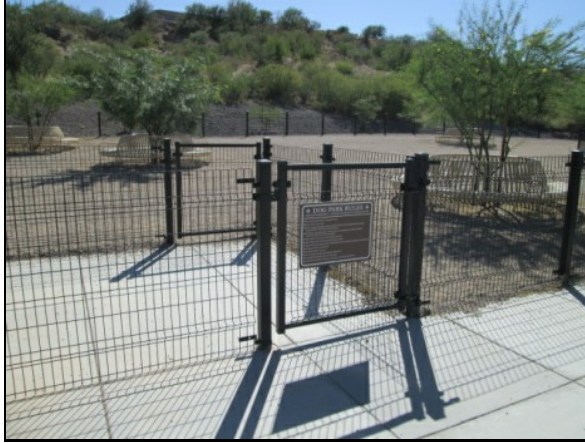
Comp #: 684 Dog Park Fence - Replace**Quantity: Approx 990 LF**

Comments: This is a 4.5' tall, in-ground, welded wire fence. Securely mounted and appears to be in good condition. There is no irrigation exposure, so a long life span anticipated.

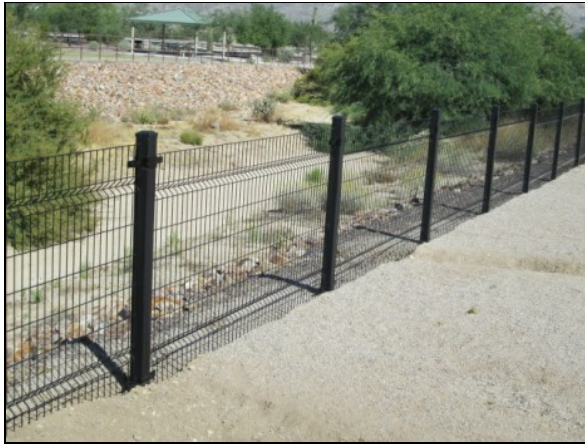
Comments: Fence and post surfaces appear to be in good condition. They will fade and weather over time. Periodic painting should be planned to restore the appearance and protect the metal.

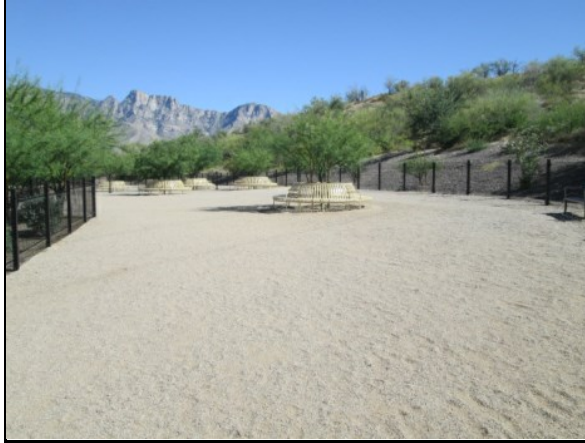
Comments: Dog park has a pea gravel surface. There is no expectancy to replace the gravel. There is no expectancy to replace the gravel, but replenishing it should be anticipated. This component funds to periodically top dress with a new 2" layer of gravel, which we estimate will require 230 tons.

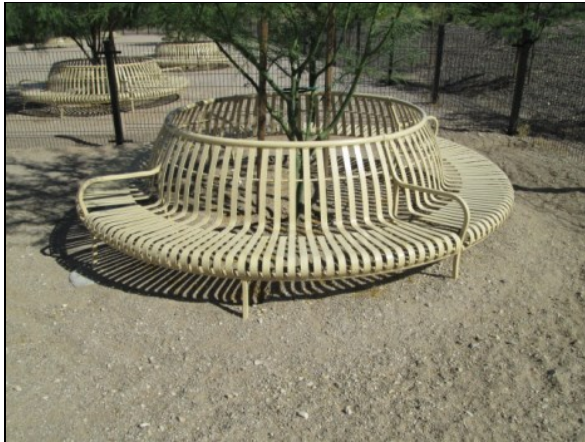
Comp #: 688 Dog Park Furniture - Replace**Quantity: (20) Pieces**

Comments: Quantity includes (7) 6' metal benches, (11) circular tree benches, and (2) Dogi-Pot pet stations. Two of the metal benches are mounted next to the grass area outside of the dog park. Furniture is still newer and in good condition.

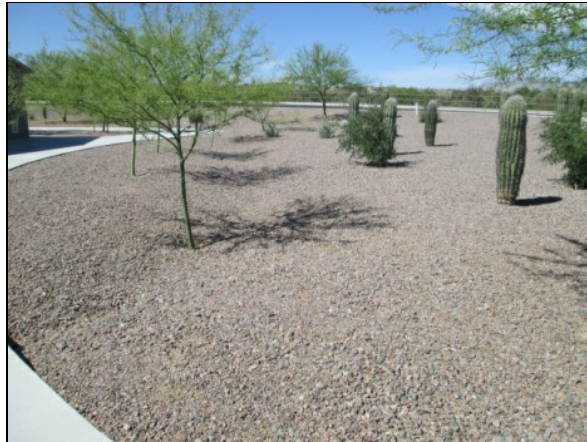
Comments: There is an extensive amount of granite coverage throughout the park. Surfaces appear to be full and in good condition. This component funds to periodically top dress with a new 1" layer of rock, which we estimate will require 350 tons.

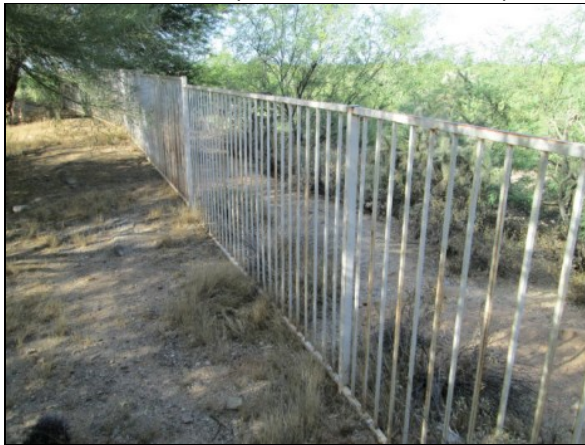
Comp #: 710 Metal Fence - Replace**Quantity: Approx 344 LF**

Comments: Fair condition, but it looks very old. Fence is a little flimsy, although posts still seem securely mounted. This fence has never been painted and exhibits surface a lot of rust. Replacement should be anticipated eventually.

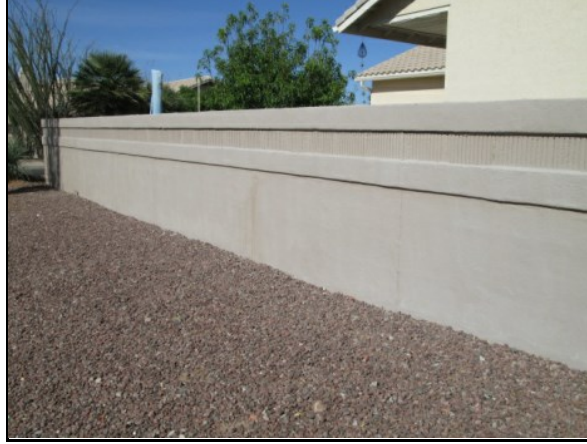
Comments: This component funds to paint ~103,140 sq ft of common stucco walls, 344 LF of metal fence, and 665 LF of culvert rails. Wall surfaces look faded and there is a good amount of discoloration too. Culvert rail surfaces look faded, plus there is some rust and chipped paint. Metal fence at the retention basin has never been painted; surfaces are old, rusting, oxidized, and generally in poor condition. Recommend painting all Neighborhood 7 walls, fences, and rails together.

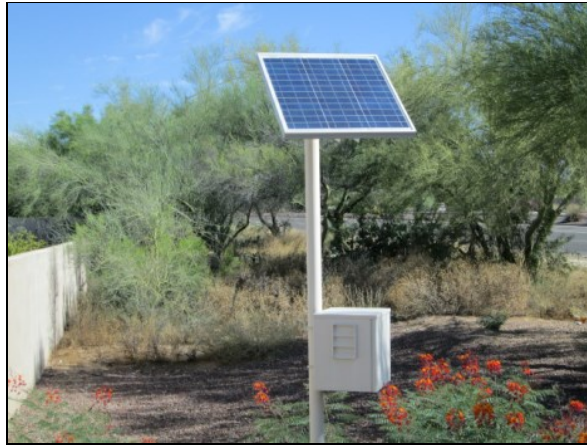
Comp #: 726 Solar Lighting - Replace**Quantity: (2) Lighting Systems**

Comments: Electric monument lighting at this location was replaced with solar lighting. Each system includes a post, 30 watt solar panel, vented enclosure with sealed deep cycle battery, solar controller, direct burial wiring, and (2) light fixtures.

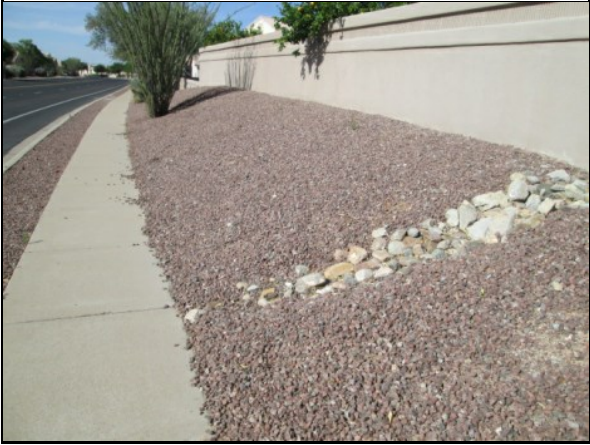
Comments: Granite throughout this Neighborhood still has decent coverage overall, but it is getting older. Some low spots were noted. This component funds to periodically top dress the existing granite.

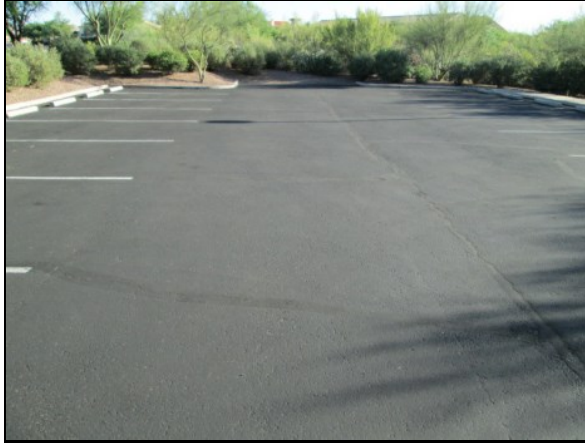
Comments: Parking lot asphalt is in fair condition. Some larger cracks visible, but they are well sealed currently. Most of the surface is still relatively smooth and not eroded. This component funds to remove and repave the asphalt. Life span is based on periodically seal coating and maintaining the surface.

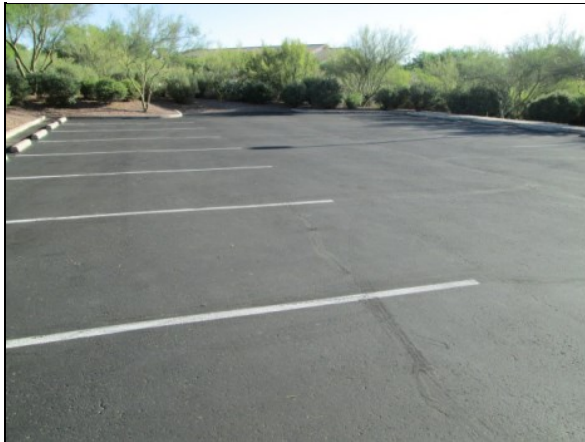
Comp #: 741 Asphalt - Seal/Repair**Quantity: Approx 8,650 Sq Ft**

Comments: Seal is new, dark, and in good condition. Seal coat asphalt surfaces periodically to prevent premature cracking and deterioration.

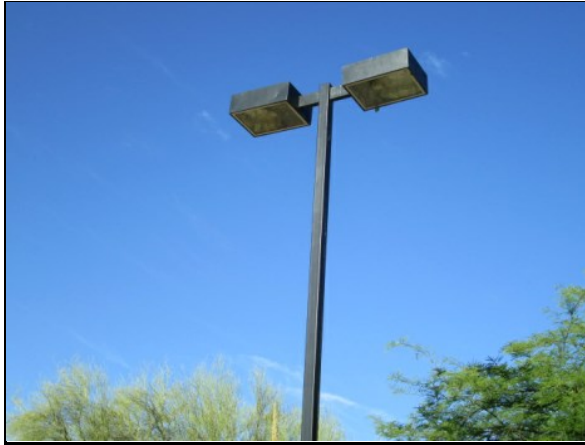
Comp #: 746 Pole Lights - Replace**Quantity: (12) Lights, (8) Poles**

Comments: These pole lights are mounted on top of elevated concrete pads. They are not directly exposed to irrigation. Anticipate future replacement or renovation.

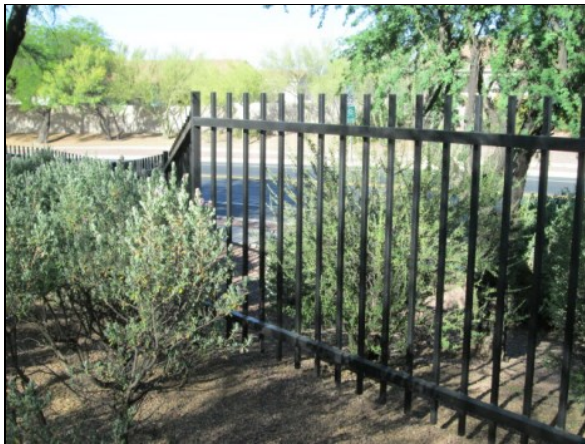
Comp #: 748 Metal Fence - Replace**Quantity: Approx 290 LF**

Comments: This fence is still solidly mounted and in good condition. It does not have any irrigation exposure, so that will help it achieve a long life span.

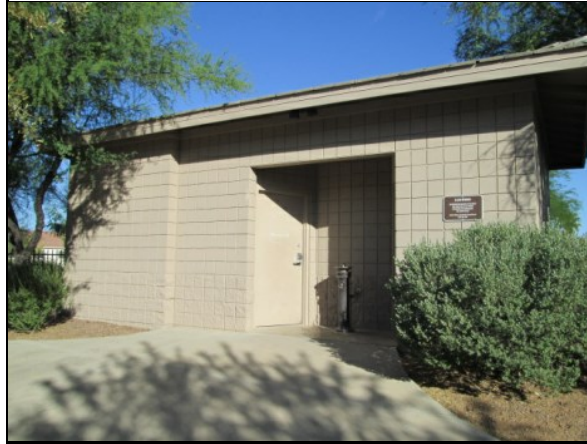
Comments: This component accounts for painting ~4,500 sq ft of building/block surfaces (walls, restrooms, ramada), 290 LF of metal fence, (8) light poles, metal bollards, (2) basketball posts, (2) volleyball posts, (1) bike rack, and (6) metal posts for the shade sails. All surfaces (block & metal) still appear to be in good shape. Repaint periodically to maintain the appearance and prevent rusting.

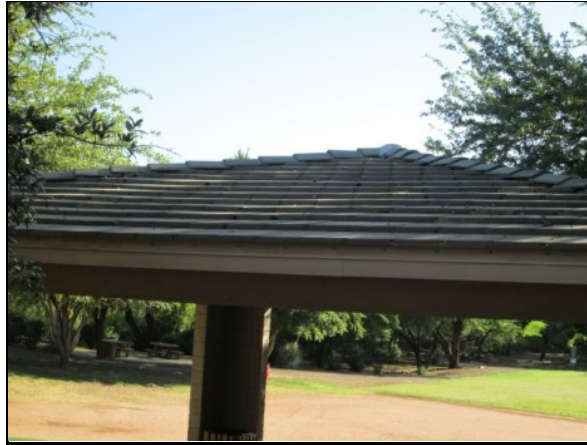
Comments: Tile roofs on the restroom building and ramada were refurbished with new underlayment in 2016. Project occurred much sooner than normally anticipated. Roofs are expected to be in good condition. This component funds periodic replacement of the underlayment.

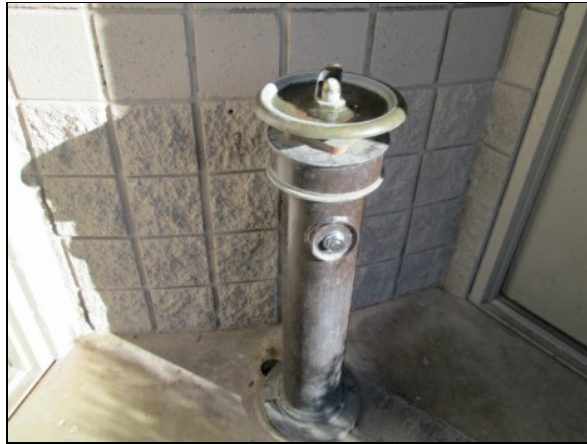
Comp #: 758 Drinking Fountain - Replace**Quantity: (1) Fountain**

Comments: This is a decorative metal drinking fountain. Appears to be in fair condition.

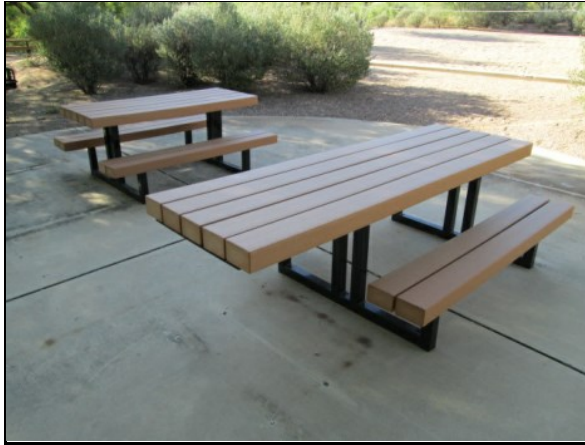
Comp #: 760 Park Furniture - Replace**Quantity: (17) Pieces**

Comments: Quantity includes (3) benches, (4) 6' picnic tables, (7) 8' picnic tables, and (3) trash cans. Furniture is from TimberForm and has metal frames with recycled plastic slats. Newer and in good condition. Replace broken slats as a maintenance expense when needed.

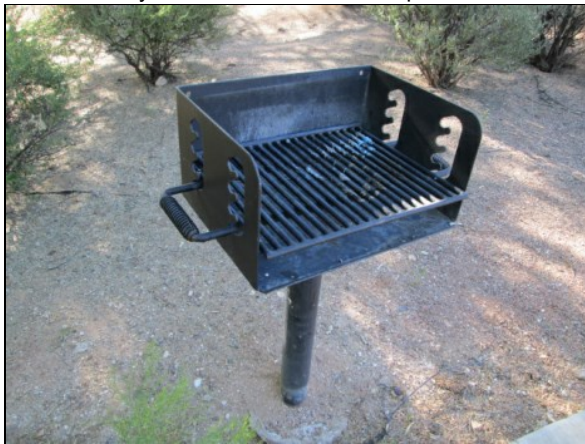
Comp #: 762 BBQ Grills - Replace**Quantity: (5) Grills**

Comments: Quantity includes (4) standard size grills and (1) double size grill. Although replacement was quoted with the park furniture, grills were not replaced in 2022. They are old but functional. Replacement does not appear to be a priority at this time.

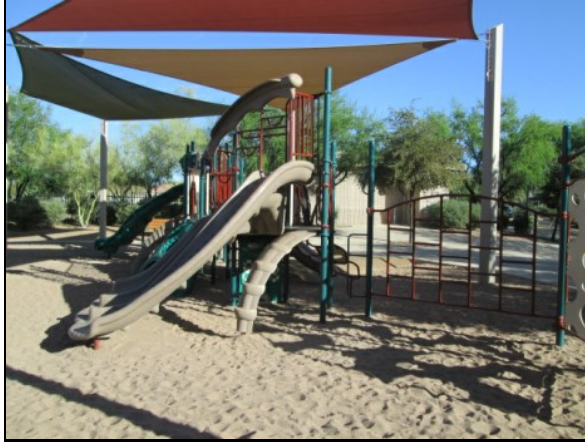
Comp #: 770 Play Equipment - Replace (A)**Quantity: (1) Play Structure**

Comments: Play structure is manufactured by Playworld Systems. It is fairly large with 4-slides plus multiple climbers and attachments. Still appears to be in good condition. No signs of damage or vandalism observed.

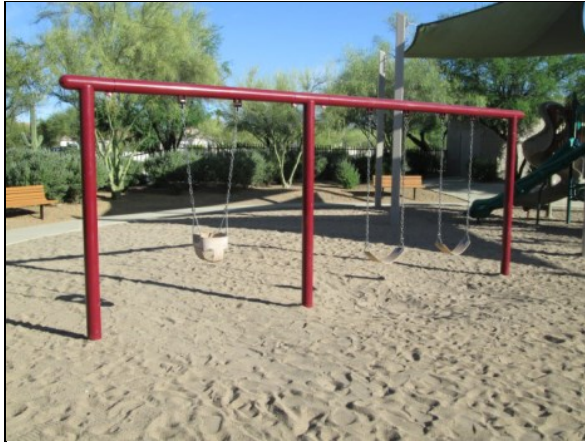
Comp #: 770 Play Equipment - Replace (B)**Quantity: (1) Swing Set**

Comments: This component accounts for replacement of the double bay swing set.

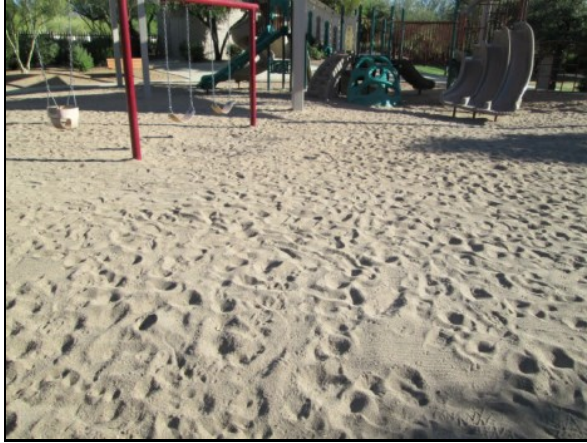
Comments: Sand looks full and is in good condition.

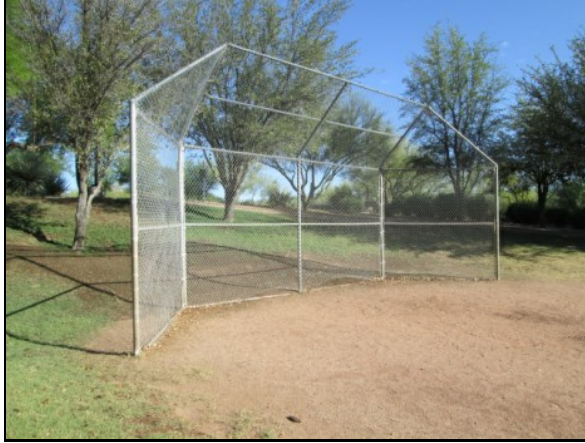
Comments: Backstop looks intact. Posts are secure, so the frame is good. Mesh looks old and is bent along the bottom. Treat repairs as a maintenance issue when needed.

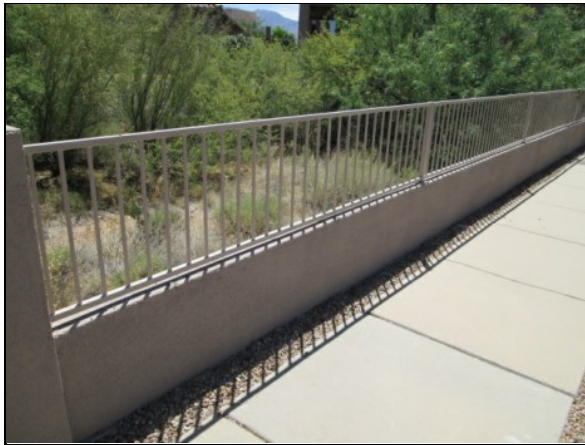
Comp #: 1002 Metal Fence - Replace (10-G)**Quantity: Approx 62 LF**

Funded?: No. This is a 2' metal fence mounted on top of a block wall base. Replacement is included with the other fences under component #1000.

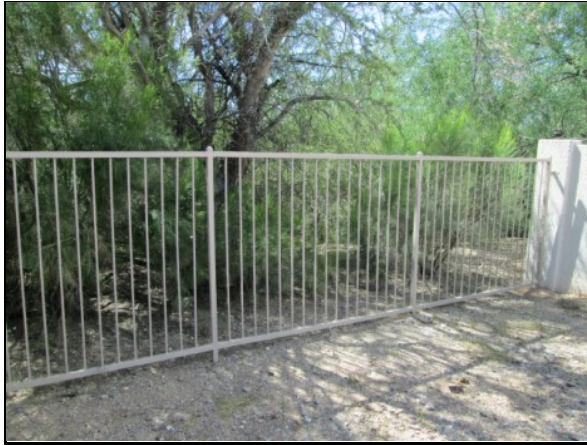
Comp #: 1003 Metal Fence - Replace (10-KL)

Location: Sunset Ridge (10KL): spillway between lots 13029 & 13041 Woodburne Ave
Funded?: No. Replacement is included with the other fences under component #1000.
History: Installed around 1996.
Comments:
