Vistoso Community Association
Oro Valley, AZ

Report #: 8973-11
Beginning: January 1, 2024
Expires: December 31, 2024

RESERVE STUDY
Update "With-Site-Visit"

August 19, 2023

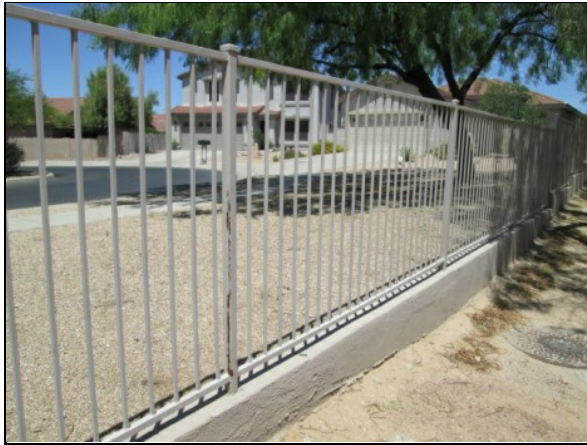
Comp #: 1004 Metal Fence - Replace (10-OP)

Location: St. Andrews Ph1 (10OP): bordering Hidden Springs Dr & spillway between lots 13137 & 13141 N Tanner Robert Dr
Funded?: No. Replacement is included with the other fences under component #1000.
History: Installed in 2001.
Comments: Fence on Hidden Springs Dr feels a little loose. Surfaces look faded plus exhibit rusting and peeling paint.

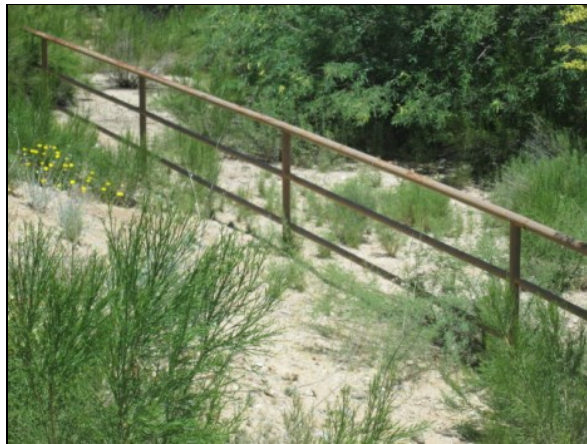
Comp #: 1010 Metal Rail - Replace

Funded?: No. This is an iron culvert rail mounted in the wash. It is surrounded by vegetation, so there is low visibility and access. There is no expectancy to replace it in the foreseeable future. It has never been painted and is not expected to be painted. Treat repairs or partial replacement as a maintenance expense if needed.

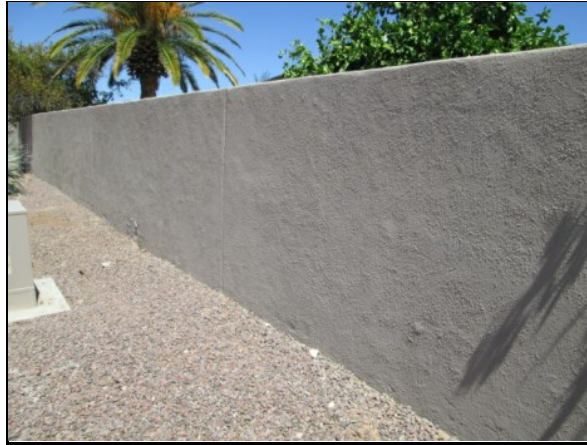
Comments: This component funds to paint ~36,250 sq ft of common stucco walls, 607 LF of metal fence, and 842 LF of culvert rails. Color still looks good. Some bubbled spots with peeling noted on Moore Rd. Cracks also noted in some locations.

Recommend painting all common walls and metal surfaces together.

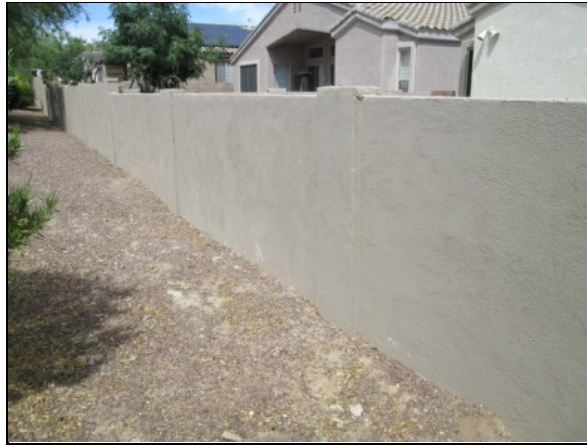
Comments: This component funds to paint ~48,660 sq ft of common stucco walls, 560 LF of metal fence, and 164 LF of culvert rails. Stucco walls still look clean and uniform. Recommend painting all common walls and metal surfaces together.

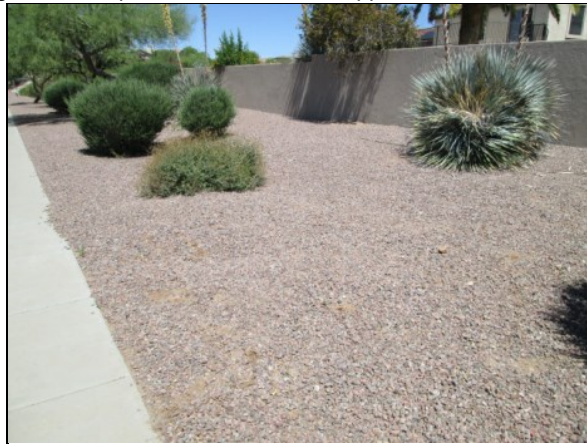
Comments: Common areas and tracts with granite coverage look full and in good shape. There is no expectancy to replace the granite, but periodic replenishing should be planned to restore the appearance.

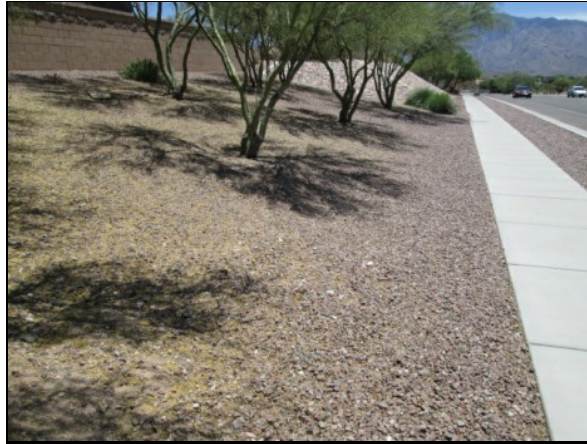
Comments: Quantity listed is based on the AAA quotes from 2019. Most of this work was completed in 2020. Scope of work involved spreading 1,454 tons of rock. Coverage still appears to be in good condition overall. There is no expectancy to replace the granite, but periodic replenishing should be planned to restore the appearance.

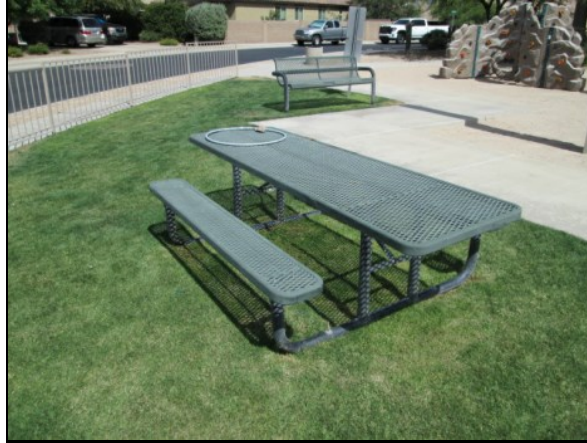
Comp #: 1040 Park Furniture - Replace**Quantity: (50) Pieces**

Comments: Quantity includes (21) benches, (8) picnic tables, (18) trash cans, and (3) BBQ grills. Furniture is still intact and functional but looking aged. Some of the furniture has irrigation exposure, so it looks stained and weathered. There are no signs of physical problems.

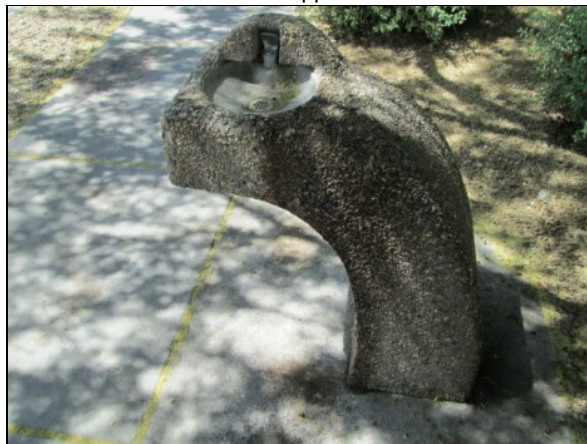
Comp #: 1043 Drinking Fountains - Replace**Quantity: (2) Fountains**

Comments: Park at Somerset Canyon has a Haws brand (model 3500) metal drinking fountain with two dispensers. It looks weathered and aged but still intact. It was not functional at the time of inspection and was likely just turned off. Park in the Torreno parcel has a concrete drinking fountain that is functional and appears to be in fair condition.

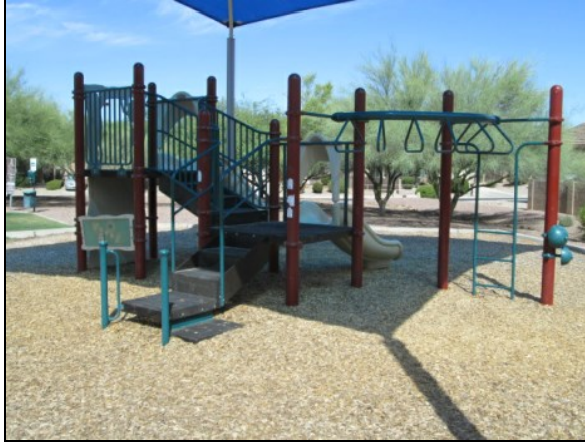
Comp #: 1046 Play Equip - Replace (Somerset)**Quantity: (1) Play Structure**

Comments: This is a smaller structure by Playworld Systems. It has two landings, two slides, a curved horizontal ladder and a couple of play panels. It is intact and functional but looking older and dated. Replacement does not appear to be a priority yet.

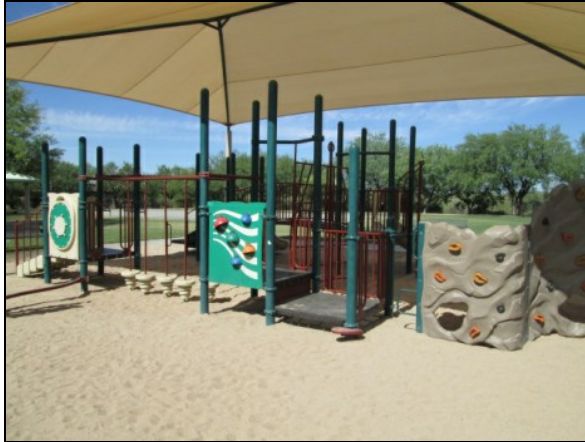
Comp #: 1048 Play Equip - Replace (Monticello)**Quantity: (3) Pieces**

Comments: This park has a large Playworld Systems play structure, a rock climbing wall, and a swing set. Still appears to be in fair condition. Normal wear and tear noted as well as some fading. No signs of damage or abuse.

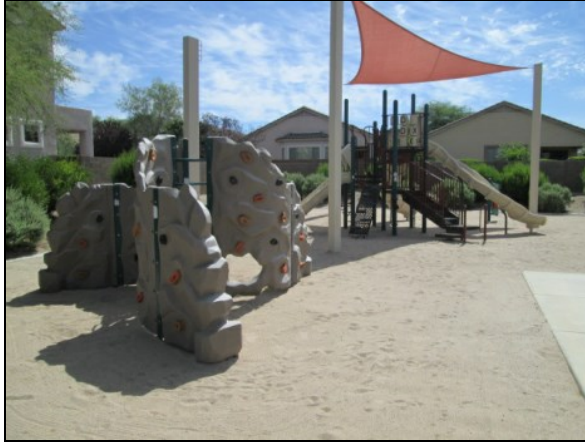
Comp #: 1050 Play Equip - Replace (Torreno)

Comments: This park has a play structure with 2 large slides and a double wavy slide. There is also a climbing wall and another metal climber. Equipment is still in fair condition. Some weathering and wear noted.

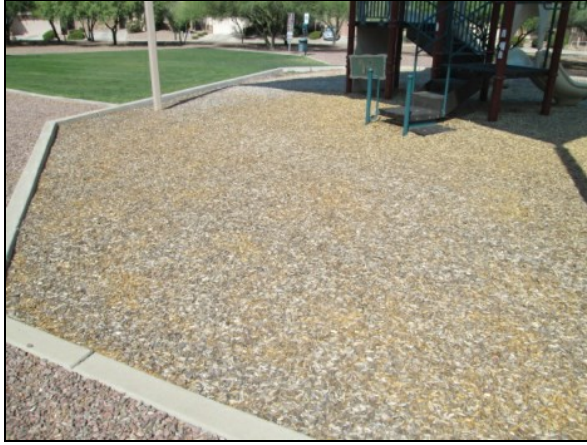
Comments: This playground has wood fiber surfacing. The 2021 project installed 50 cubic yards of new wood chips. Still appears to be adequately filled. This component funds to periodically replenish wood surfacing in the future.

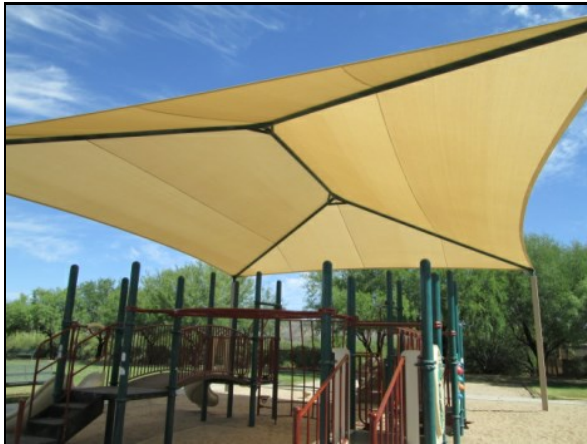
Comp #: 1054 Shade Screens - Replace**Quantity: (2) Screens: 2,130 Sq Ft**

Comments: Shade screens have both been replaced and are in good condition. There is no expectancy to completely replace the structures. This component funds to periodically replace the shade screens. Painting the structure posts is included with the walls & fences.

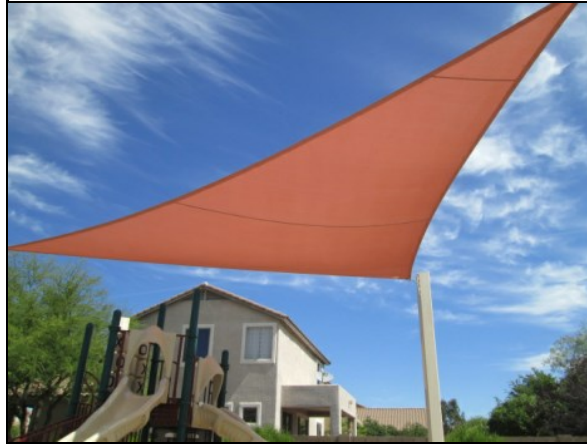
Comp #: 1056 Shade Sails - Replace**Quantity: (3) Sails: 900 Sq Ft**

Comments: Shade structure was added in 2010 and was described as a 35'x35'x12' structure. It has (3) sails mounted to (5) metal posts. Sails were recently replaced, but two were missing at the time of inspection. There is no expectancy to replace the structure. This component funds to periodically replace the shade sails. Painting the structure posts is included with the walls & fences.

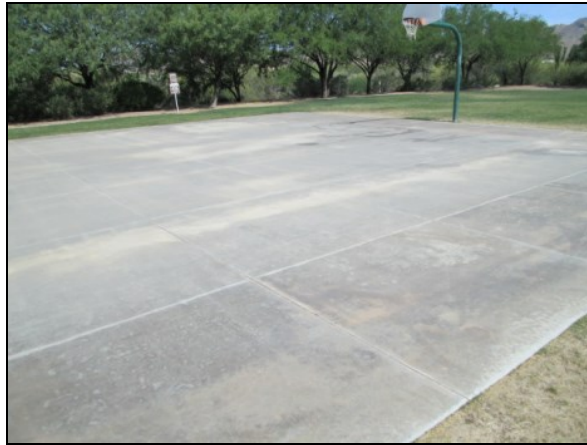
Funded?: No. These are concrete courts with no coating. The concrete is expected to last the life of the development under normal circumstances. Re-stripe and repair the courts as needed with Operating funds.

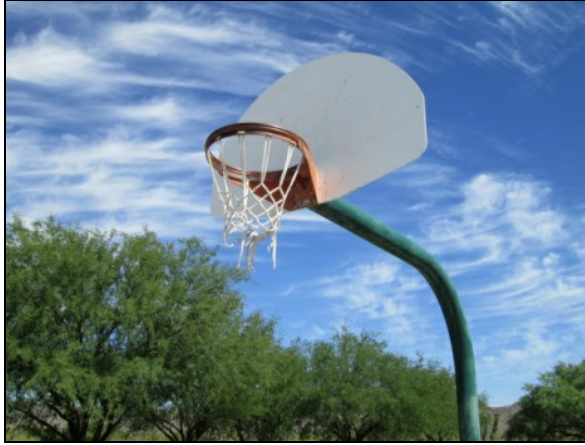
Comp #: 1060 Basketball Equip - Replace**Quantity: (4) Metal Backboards**

Comments: They are good quality, metal backboards and rims. Manufactured by PW Athletics. No signs of damage or abuse. Still appear to be in good shape.

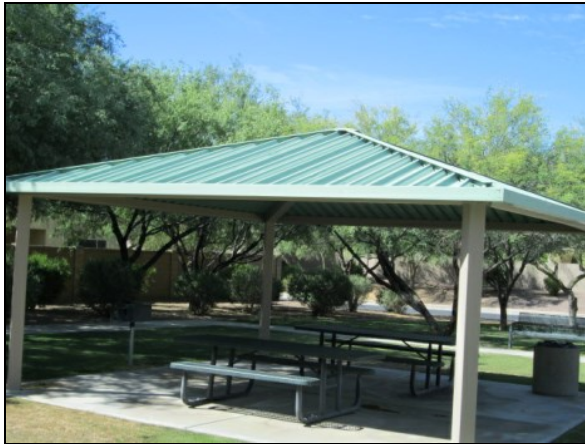
Comp #: 1062 Ramada Roofs - Replace**Quantity: (3) Ramadas: 1,050 Sq Ft**

Comments: Ramadas have prefabricated metal roofs. Long life expectancy under normal circumstances. Replacement should be planned eventually due to either vandalism or to update the appearance. There are some visible dents and cracks.

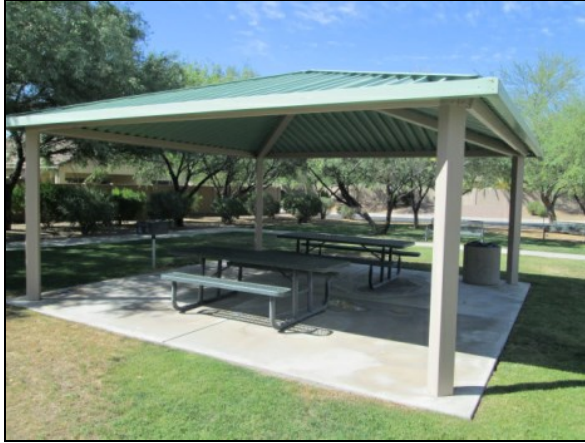
Comments: This component budgets to repaint metal posts and beams on the ramadas. Paint work in 2021 included posts and beams plus both sides of the roofs.

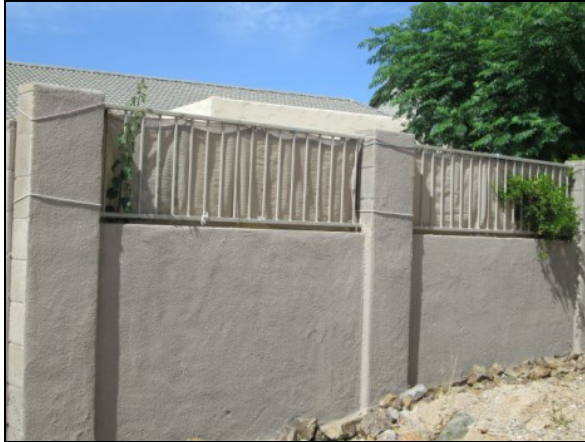
Comp #: 1070 Metal Fence - Replace (Somerset)**Quantity: Approx 147 LF**

Comments: These sections of view fence border visible common areas, so we believe VCA is responsible for them. Fences are mounted high off the ground and not exposed to sprinklers, so a long life span is anticipated.

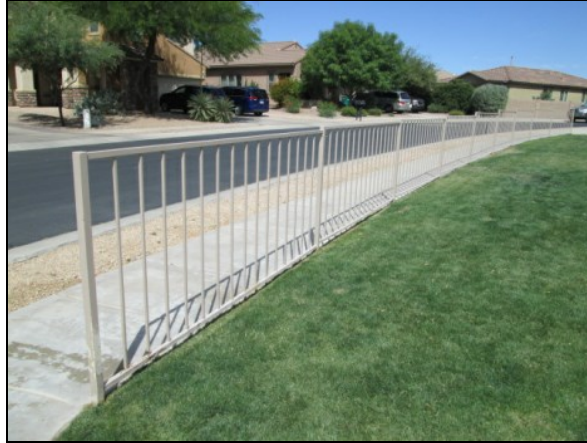
Comp #: 1072 Metal Fence - Replace (Torreno)**Quantity: Approx 74 LF**

Comments: This is a 3.5' high section of metal fence mounted between the park and the street. It is mounted in the grass and exposed to sprinklers regularly. Still securely mounted, but only minimal rust due to recent painting. Periodic painting is included with the walls & fences component but likely needs painting more frequently due to the sprinkler exposure.

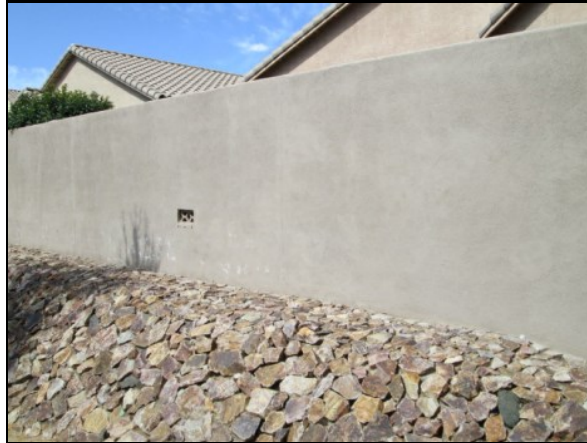
Comments: This component funds to paint ~51,800 sq ft of common stucco walls, 147 LF of metal fence, 575 LF of culvert rails, and 224 sq ft of metal shade structure posts at the parks. Surfaces are still in fair condition overall. Some faded spots noted, and there is more discoloration in areas with higher sun exposure. Recommend painting all common walls and metal surfaces together.

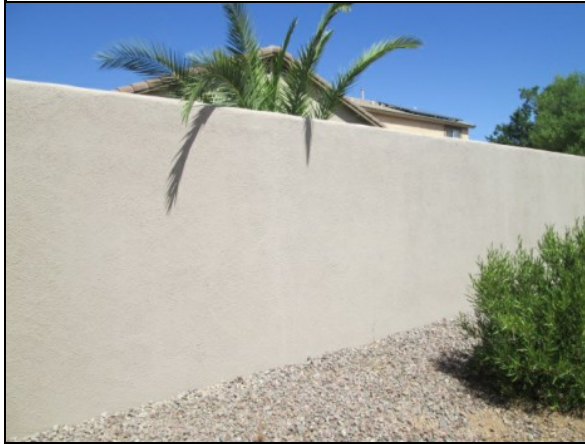
Comments: This component funds to paint ~35,800 sq ft of common stucco walls, 74 LF of metal fence, 424 LF of culvert rails, and 300 sq ft of metal shade structure posts at the park. Walls still look good and uniform overall. Recommend painting all common walls and metal surfaces together.

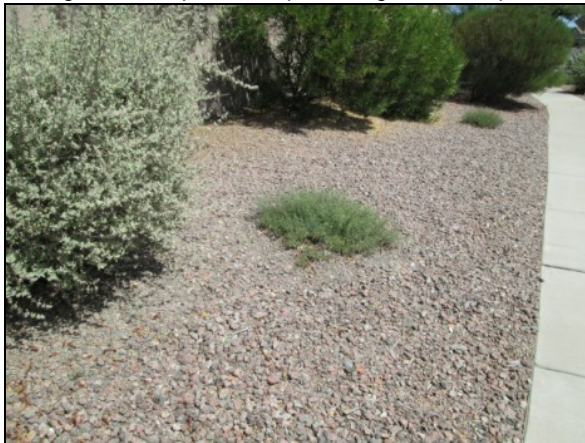
Comments: Most of this work was completed in 2020, but the section on Moore Rd was completed in 2019. Quantity is based on proposals from AAA Landscape, and project involved spreading 1,266 tons of rock. Coverage looks full and is in good condition. There is no expectancy to replace the granite, but periodic replenishing should be planned to restore the appearance.

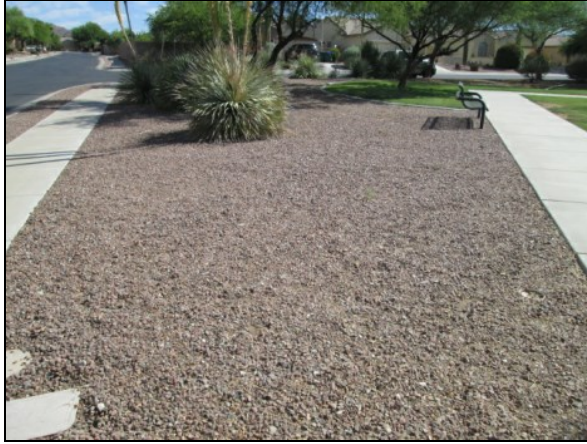
Comments: Common tracts within parcels (excluding La Canada & Moore Rd) are in good to fair condition. They have been replenished, but timing and cost are unknown. This component funds to periodically top dress with a new 1" layer of rock, which we estimate will require 1,960 tons.

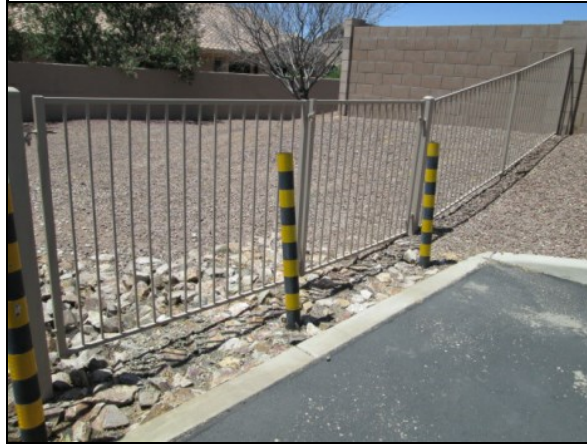
Comp #: 1084 Metal Fence - Replace (A)**Quantity: Approx 270 LF**

Comments: This is 4' high metal fence mounted around the retention basin. Fence was recently painted and is still in good condition.

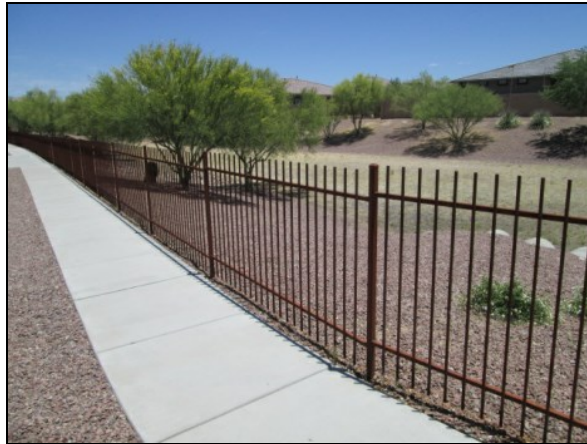
Comments: This is 4' high metal fence mounted around the retention basin. It has a rust finish and will not need to be painted. It feels solidly mounted and is in good condition.

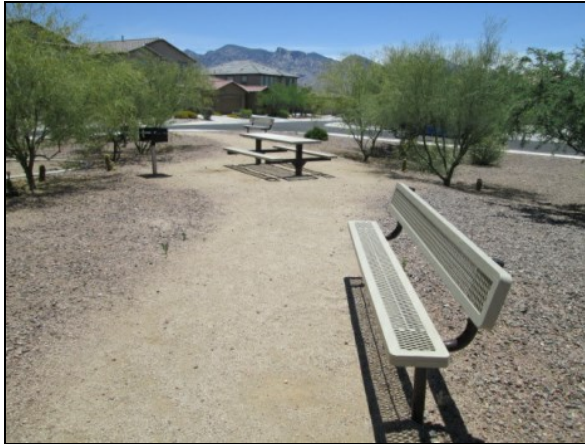
Comp #: 1086 Park Furniture - Replace**Quantity: (4) Pieces**

Comments: Quantity includes (2) benches, (1) picnic table, and (1) BBQ grill. Still looks clean and is in good condition.

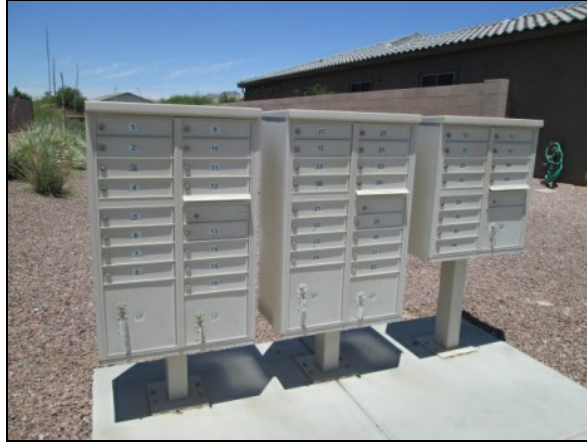
Comp #: 1088 Mailboxes - Replace (A)**Quantity: (7) Clusters**

Comments: Clusters include (5) 16-box and (2) 12-box. Due to the recent installation timing, these mailboxes are expected to be VCA's responsibility. They are still in good condition, but surfaces are fading. Replacement should be anticipated eventually.

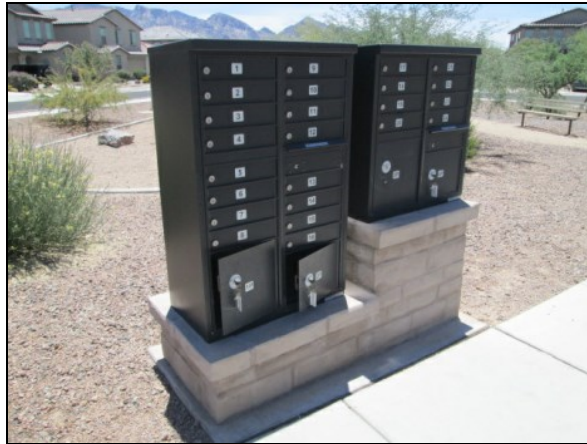
Comp #: 1088 Mailboxes - Replace (B)**Quantity: (2) Clusters**

Comments: Clusters include (1) 16-box and (1) 8-box. They look new and are in good condition. Replacement should be anticipated eventually.

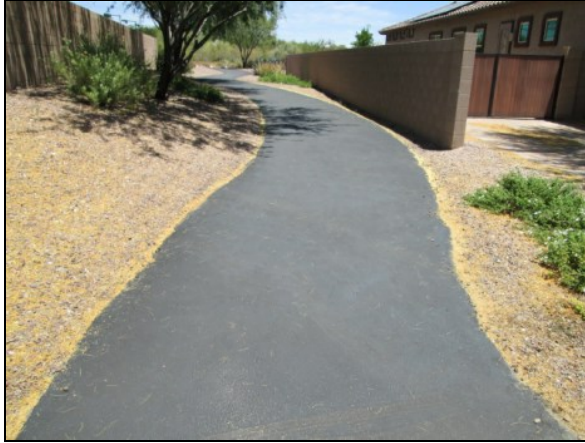
Comments: This asphalt path is still smooth and in good condition. A few cracks were noted. VCA is reportedly responsible to maintain this path. Long term replacement/repaving should be anticipated.

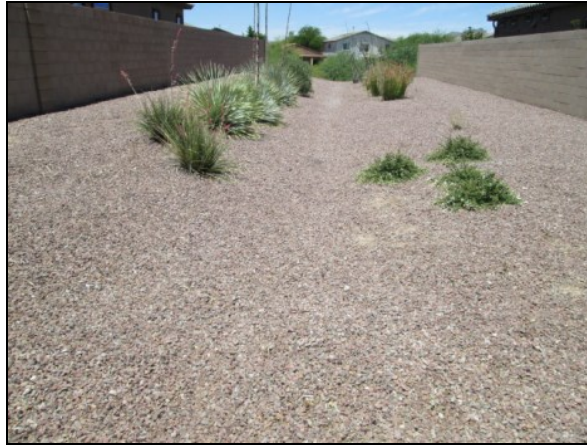
Comments: Granite varies in condition. In the Discovery parcel, coverage is thinning but still fine. Eagles Summit tracts still appear to be in good shape. This component funds to periodically top dress with a new 1" layer of rock, which we estimate will require 688 tons.

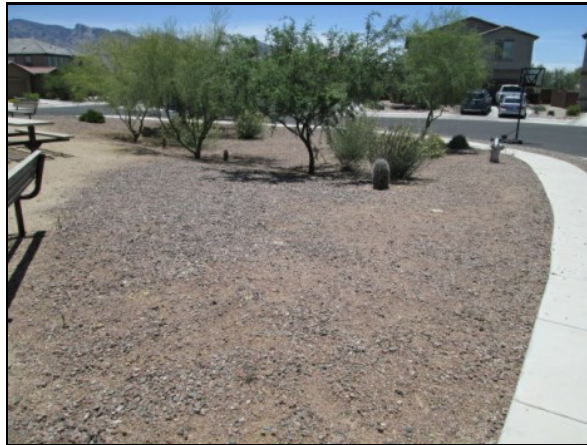
Comments: Surface area accounts for common tracts and around perimeter areas of this parcel. Coverage is fair but thinning. Granite at this parcel has a high percentage of small rock content, so it will not last as long as other areas of the community. Remaining life was decreased to reflect this condition. This component funds to periodically top dress with a new 1" layer of rock, which we estimate will require 210 tons.

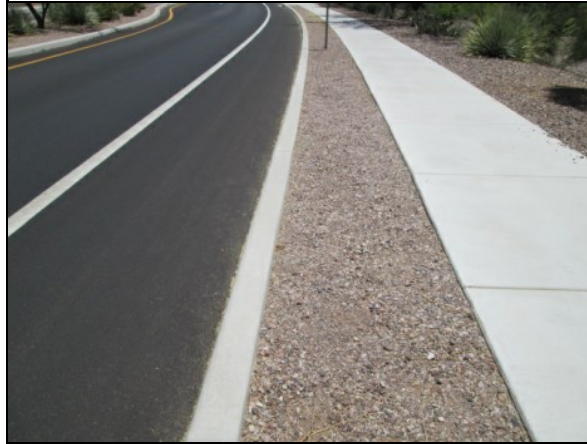
Comments: Surface area only accounts for the space between curb and sidewalk in the Center Pointe section of the community. VCA is not responsible for landscaping beyond the sidewalk in this area of the community. Granite coverage is low and depleted, generally in poor condition. This component funds to periodically top dress with a new 1" layer of rock, which we estimate will require 140 tons.

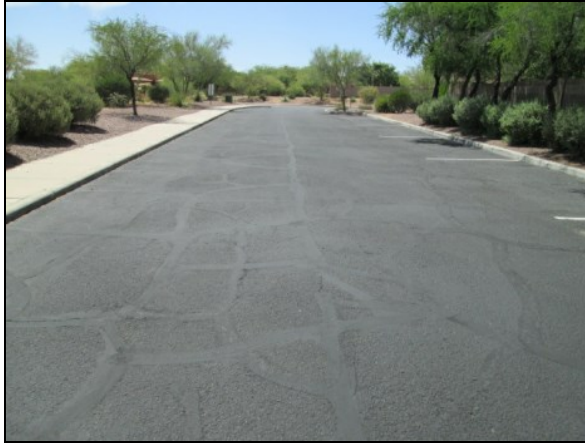
Comments: Surface is rough with a lot of exposed aggregate. There is moderate surface cracking too, but cracks look well sealed at this time. This component funds to remove and repave the asphalt. Life span is based on periodically seal coating and maintaining the surface.

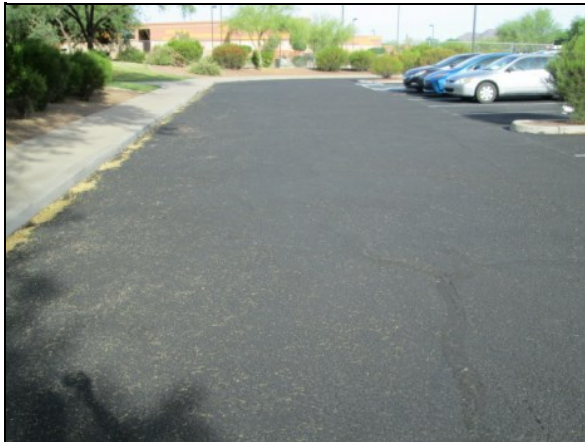
Comp #: 1102 Asphalt - Seal/Repair

Comments: Seal is new, dark, and in good condition. Seal coat asphalt surfaces periodically to prevent premature cracking and deterioration.

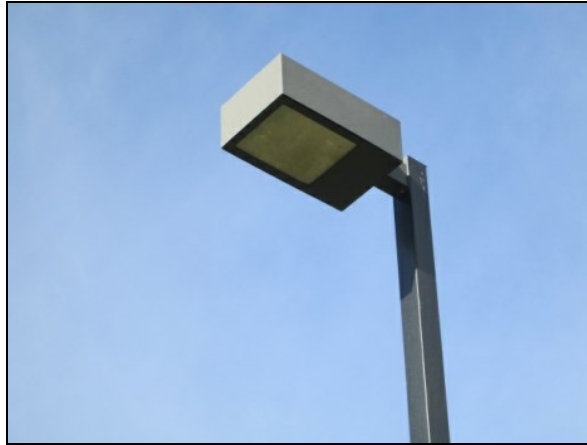
Comp #: 1106 Pole Lights - Replace**Quantity: (19) Lights, (17) Poles**

Comments: These pole lights are mounted on top of elevated concrete pads. They are not directly exposed to irrigation. Anticipate future replacement or renovation of the lights and poles.

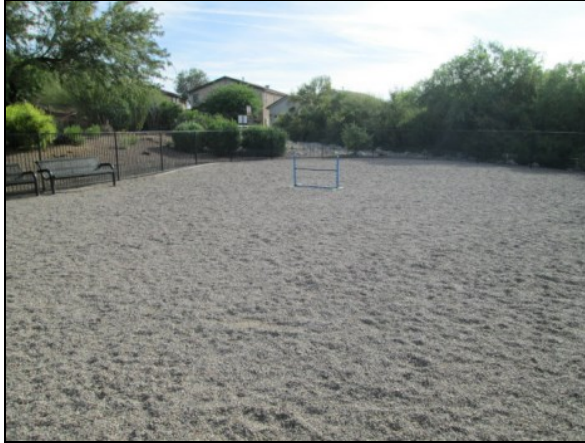
Comments: Dog park originally had grass surfacing. The 2015 project involved removing the grass and installing pea gravel in its place. There is no expectancy to replace the gravel, but replenishing it should be anticipated. This component funds to periodically top dress with a new 2" layer of gravel, which we estimate will require 52 tons.

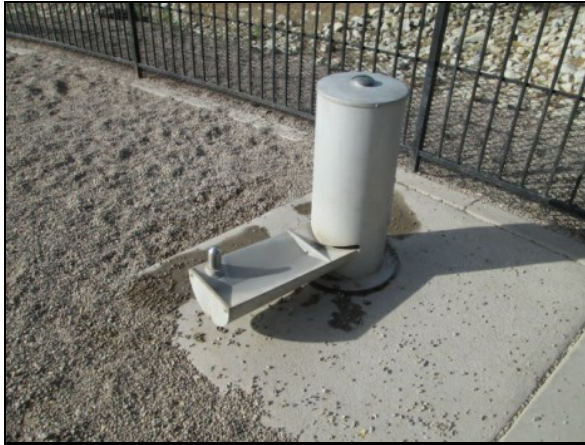
Comp #: 1112 Dog Park Fountain - Replace**Quantity: (1) MDF Fountain**

Comments: This MDF pet fountain was a new addition in 2014. Fair condition. It looks older but still functional.

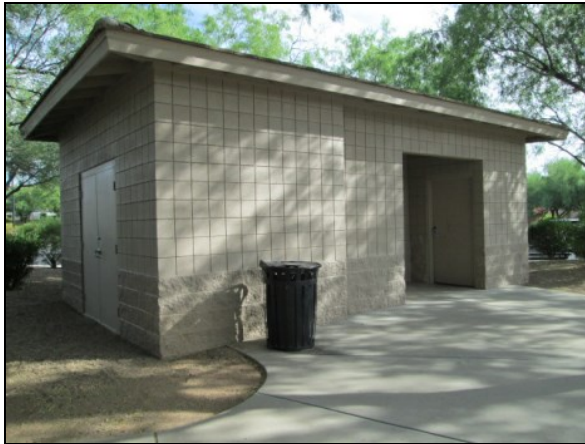
Comments: This component accounts for painting ~11,000 sq ft of building/block surfaces (walls, restrooms, ramadas), 310 LF of metal fence, (17) light poles, (2) basketball posts, and (10) metal posts for the shade sails. All surfaces (block & metal) still appear to be in good shape. Repaint periodically to maintain the appearance and prevent rusting.

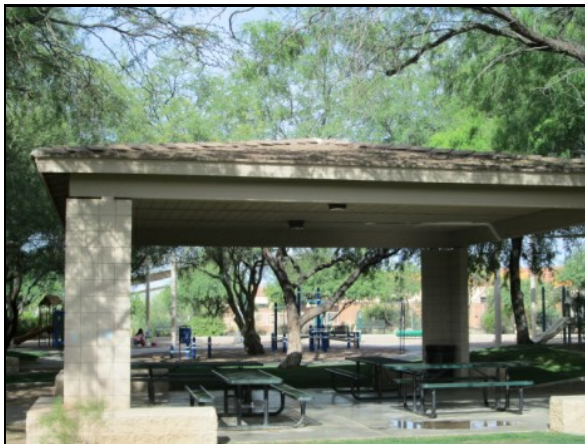
Comments: Tile roofs on the restroom building and ramadas were refurbished with new underlayment in 2016. Project occurred much sooner than normally anticipated. Roofs are expected to be in good condition. This component funds periodic replacement of the underlayment.

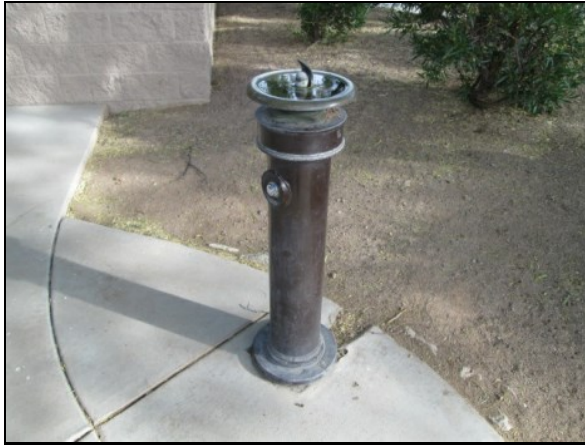
Comp #: 1119 Drinking Fountain - Replace**Quantity: (1) Fountain**

Comments: This is a decorative metal drinking fountain. Appears to be in fair condition, but the surface is faded and looks old.

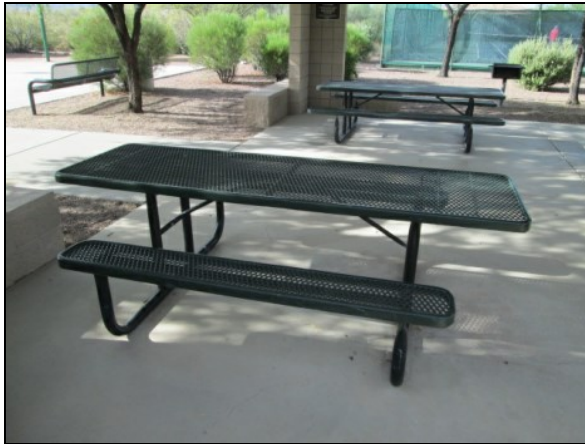
Comp #: 1120 Park Furniture - Replace (A)**Quantity: (39) Pieces**

Comments: Quantity includes (14) benches, (16) picnic tables, (4) concrete trash cans, (3) metal trash cans, and (2) BBQ grills. Furniture is older but still in overall fair condition. Some surface marks and wear, but replacement does not appear to be necessary yet.

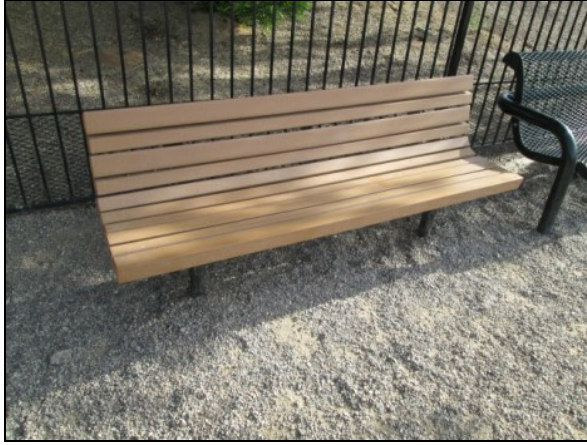
Comp #: 1120 Park Furniture - Replace (B)**Quantity: (4) Benches**

Comments: These benches have metal frames with recycled plastic slats. There are (3) 4' benches and (1) 6' bench. They are in good condition. Replace broken slats as a maintenance expense when needed.

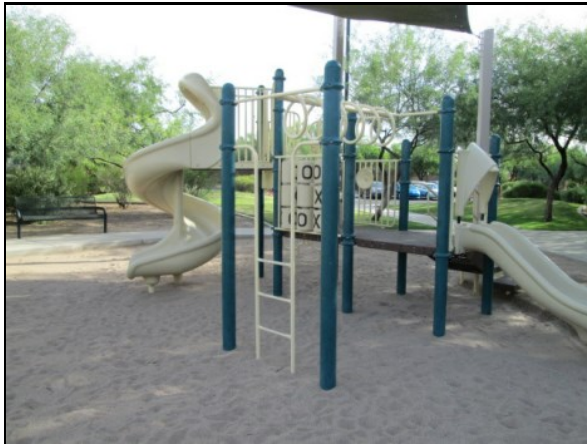
Comp #: 1130 Play Equipment - Replace (A)**Quantity: (7) Pieces**

Comments: Equipment includes (2) play structures, (1) glide slide, (1) Ground Zero U-Bounce, (1) extreme climber, (1) balance beam, and (1) bench with rotating seats. Intact and functional but looking aged and weathered. Remaining life was increased to reflect repairs and parts replacements in 2021.

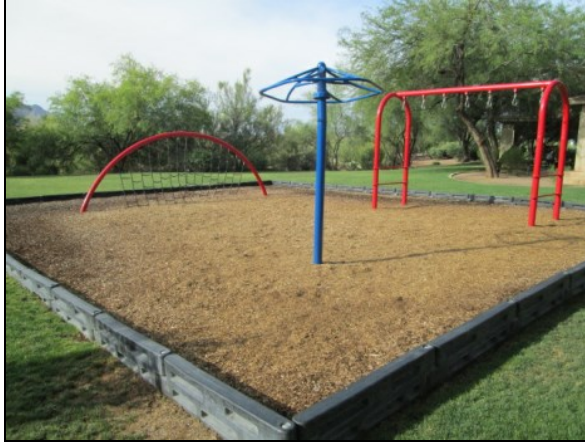
Comp #: 1130 Play Equipment - Replace (B)**Quantity: (13) Pieces**

Comments: Equipment includes (1) horizontal ladder, (1) 1/2 circle arched climber, (1) large spinner, (3) in-ground spinners, (2) spring riders, (1) triple bay arched swing-set (4-swings + Jenn Swing), (1) swing-set (2-posts, 2-swings), (1) arched tire swing, extreme climber, and (2) fitness stations with signs. There is also 624 LF of plastic playground border. This equipment still appears to be in good condition.

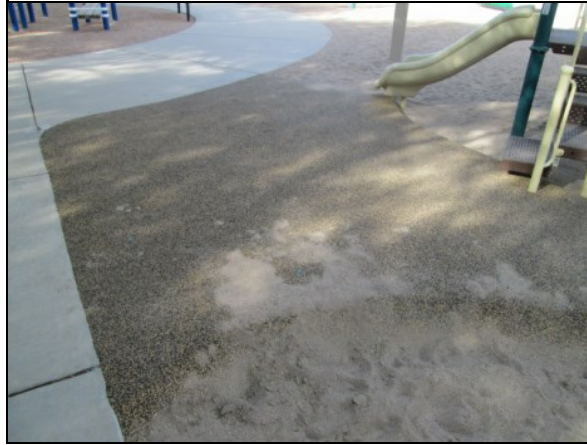
Comp #: 1134 Playground Turf - Replace**Quantity: Approx 350 Sq Ft**

Comments: This surface is used to help absorb the impact of a child's fall. It also provides handicap children with access to the play structures. Repairs were made in the past along the turf edges.

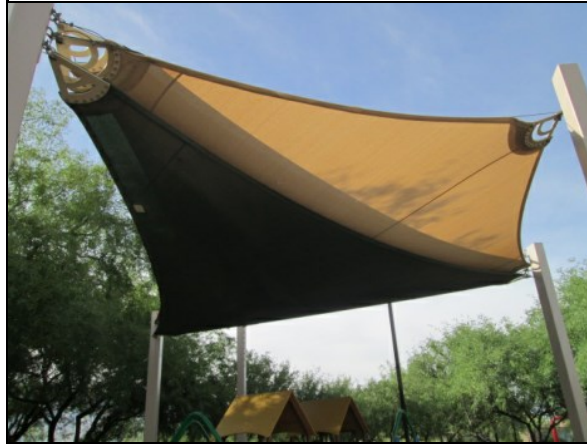
Comp #: 1138 Shade Sails - Replace**Quantity: (6) Sails: 1,880 Sq Ft**

Comments: Shade structures were added in 2010 and were described as a 25'x25'x12' structures. Each one has (3) sails mounted to (5) metal posts. New sails were purchased in 2022, but the old sails were still in place at the time of inspection. They will be replaced in 2023 when the manufacturer delivers the new sails. There is no expectancy to replace the structures. This component funds to periodically replace the shade sails. Painting the structure posts is included with the other park assets.

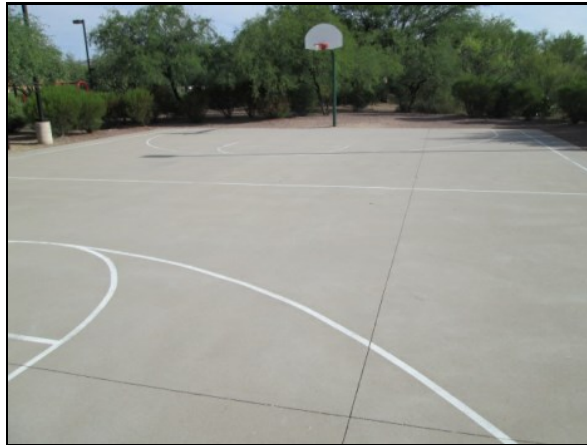
Comp #: 1140 Basketball Court - Replace**Quantity: (1) Court, ~3,700 Sq Ft**

Comments: This is a concrete court with no coating. This type of court is normally expected to last the life of the community. However, concrete surface exhibits wear and lots of hairline cracks. It is still fine for now, but it will likely continue to deteriorate, so replacement should be expected at some point.

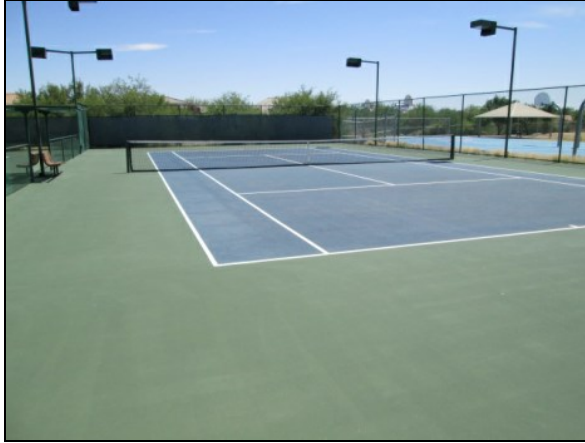
Comments: Fair condition. Color is faded, especially in the blue sections. There is a lot of hairline cracking and a few larger cracks, but courts are still playable. This component funds to periodically resurface the court coating.

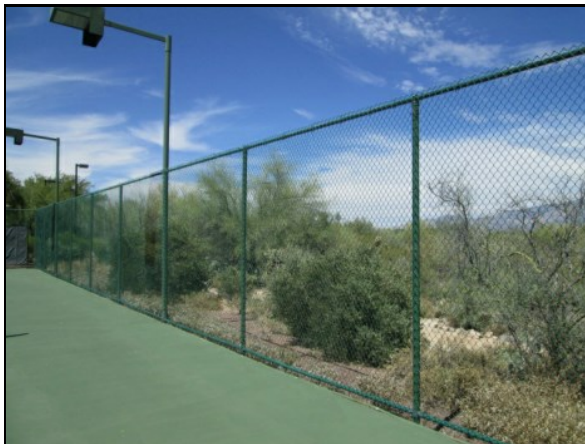
Comp #: 1152 Tennis Fence - Replace**Quantity: Approx 570 LF**

Comments: This is vinyl coated chain link fence. There is ~500 LF of 10' fence and 70 LF of 4' fence. Original fence was retained when the courts were replaced in 2013. Still in good to fair condition. Posts feel solidly mounted, but the chain link mesh is fairly loose.

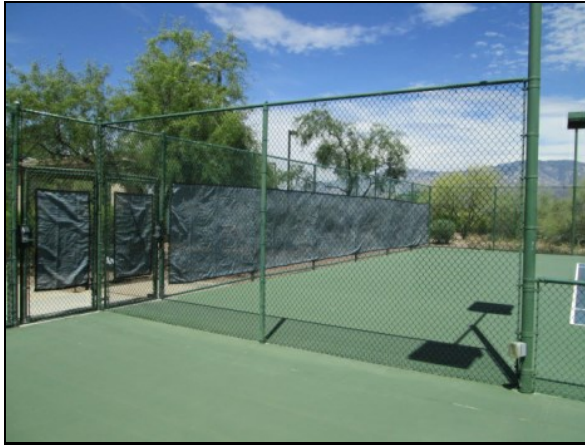
Comments: Paint surfaces on the tennis fence and lights are older, faded, and chipped.

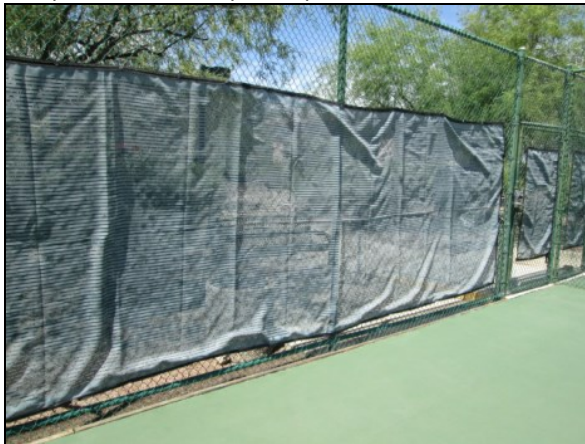
Comp #: 1156 Tennis Windscreen - Replace**Quantity: Approx 1,440 Sq Ft**

Comments: Screens look generally faded and weathered, but the material is not deteriorated. Treat repairs or small replacements as a maintenance expense. This component funds complete replacement of the screens.

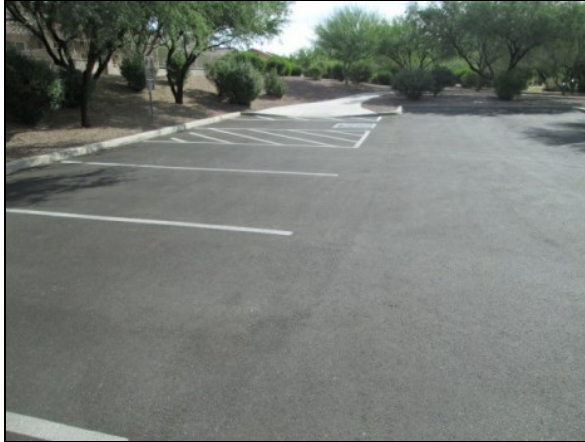
Comments: All 3 parking areas were recently repaved. Surfaces still look near new and are in good condition. This component funds to remove and repave the asphalt. Life span is based on periodically seal coating and maintaining the surface.

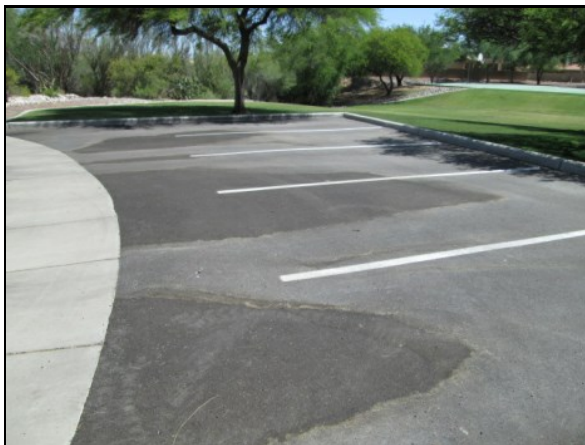
Comments: New asphalt at this park should be sealed soon. Seal coat asphalt surfaces periodically to prevent premature cracking and deterioration.

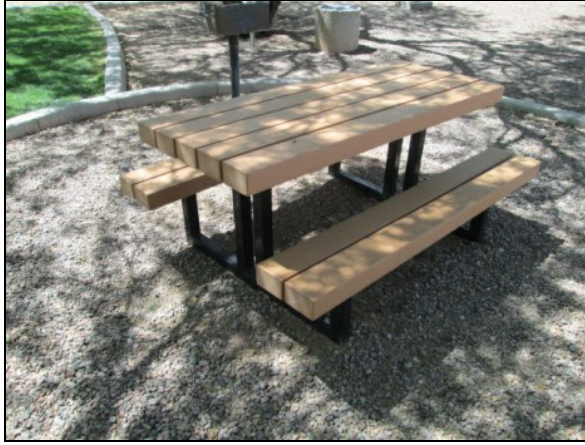
Comp #: 1206 Park Furniture - Replace (A)**Quantity: (3) Picnic Tables**

Comments: Only the picnic tables were replaced at this park. Furniture is from TimberForm and has metal frames with recycled plastic slats. Newer and in good condition. Replace broken slats as a maintenance expense when needed.

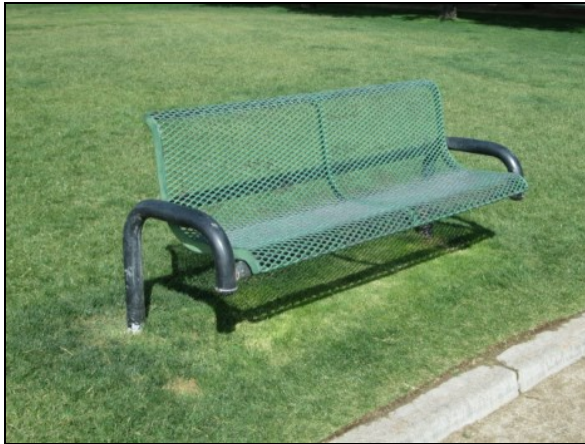
Comp #: 1206 Park Furniture - Replace (B)**Quantity: (7) Pieces**

Comments: Quantity includes (2) 6' benches, (3) trash cans, and (2) BBQ grills. Furniture is old but still functional. It should be nearing time for replacement.

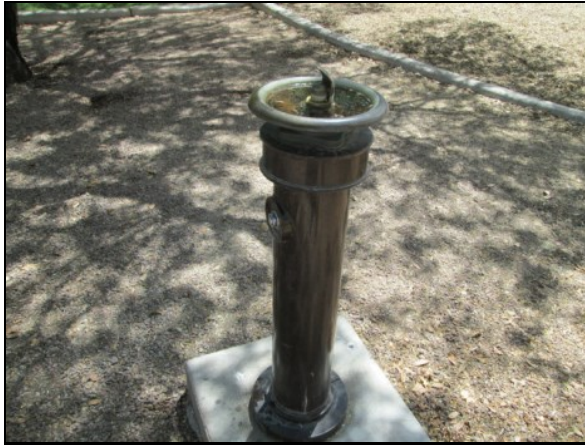
Comp #: 1210 Drinking Fountain - Replace**Quantity: (1) Fountain**

Comments: This is a decorative metal drinking fountain. Appears to be in fair condition.

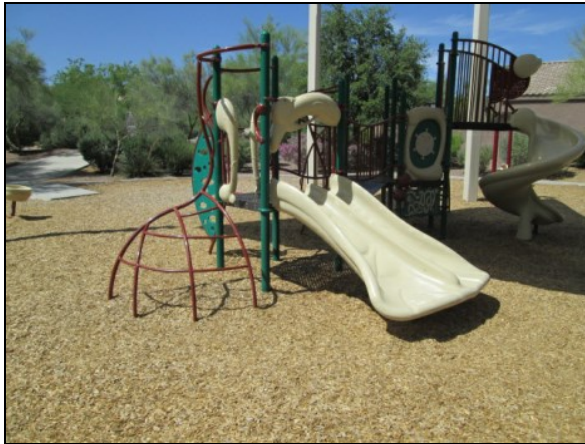
Comp #: 1214 Play Equipment - Replace (A)**Quantity: (3) Pieces**

Comments: Cost of the 2015 replacement included demo of the old structure, installation of a Playworld Challengers #350-1401 structure plus (1) Spin Cup, (1) Spinami, and (1) Cruise Line. Cruise Line piece was recently replaced with a swing set.

Equipment still appears to be in good condition overall. Normal wear and tear noted.

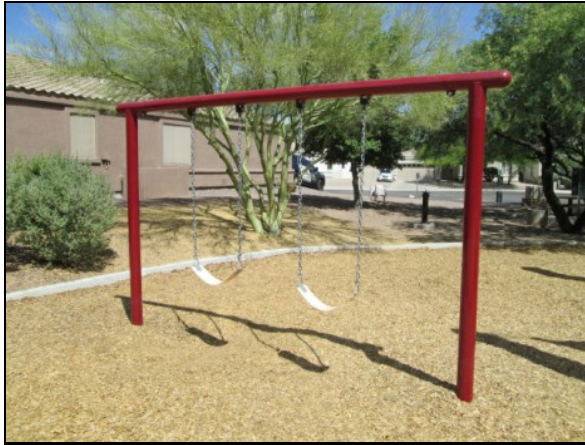
Comp #: 1214 Play Equipment - Replace (B)**Quantity: (1) Swing Set**

Comments: This swing set was installed in place of a prior piece of equipment. It is newer and appears to be in good condition.

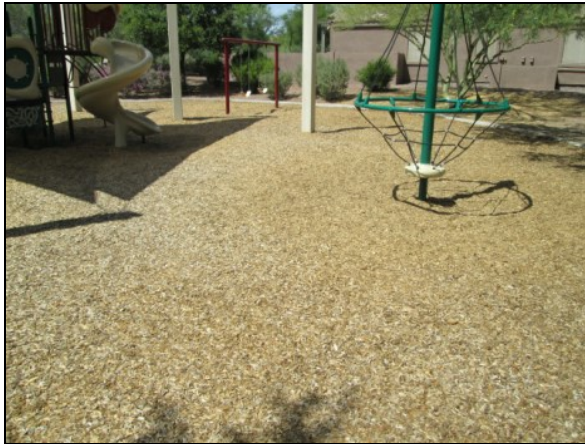
Comments: Cost of the 2015 work reflects the purchase and install of 200 cubic yards of engineered wood fiber surfacing. Per the contract, 200 cubic yards will cover the surface area at 12" deep. There is no expectancy to completely replace the wood surfacing, but periodic replenishing will be needed to maintain proper depths.

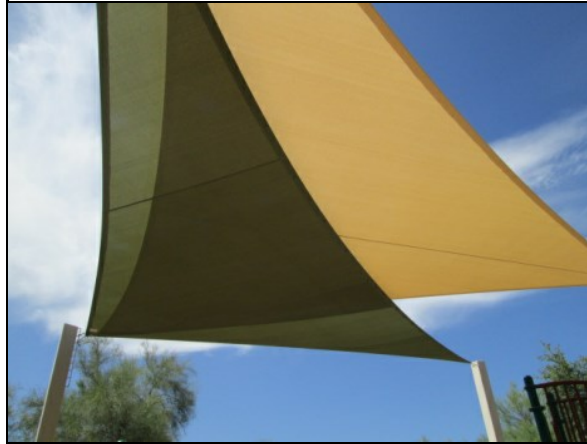
Comp #: 1218 Shade Sails - Replace**Quantity: (3) Sails: 870 Sq Ft**

Comments: Shade structure was added in 2010 and was described as a 30'x30'x12' structure. It has (3) sails mounted to (5) metal posts. One sail was missing at the time of inspection, but the other two appeared to be in good shape. There is no expectancy to replace the structure. This component funds to periodically replace the shade sails. Painting the structure posts should be addressed as a maintenance expense or included with other paint projects.

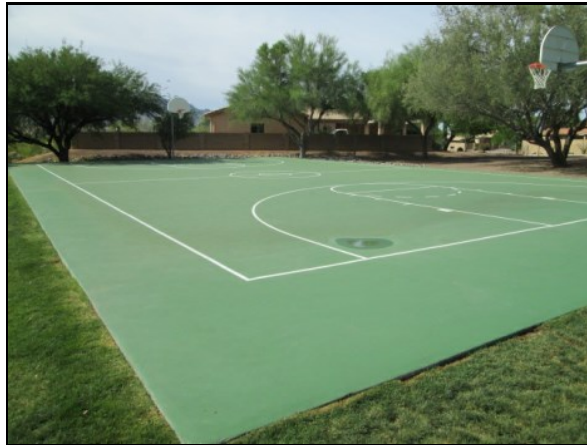
Comments: This is a concrete basketball court with sport coating. The refurbish project in 2008 reportedly including removing most of the court coating, pressure washing, acid etching, filling cracks, applying a primer coat followed by (3) coats of a finish surface. This is an extensive project that should not be needed every time the court is resurfaced.

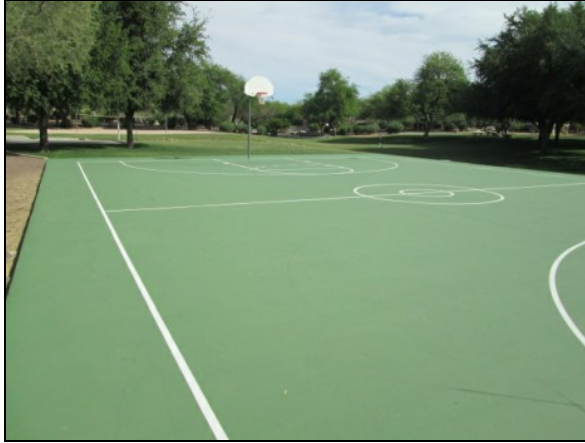
Comments: Surface looks clean and bright. There are still some visible cracks. This component is scheduled to offset the court refurbish allocation, so that work is scheduled on this court every 7-years.

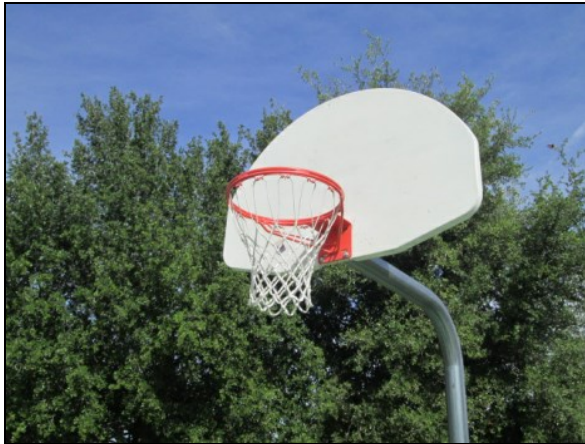
Comp #: 1222 Basketball Equip - Replace**Quantity: (2) Metal Backboards**

Funded?: No. Individual costs are below the Reserve expense threshold. HOA plans to replace as needed with Operating funds, so no Reserve funding has been allocated.

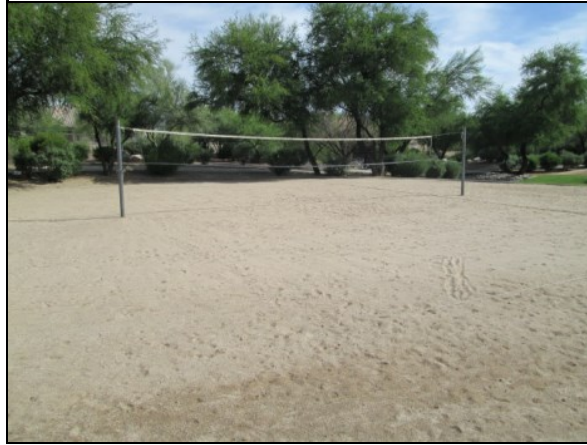
Funded?: No. There are no significant replacement issues to address with the volleyball court. Sand will need to be replenished periodically. HOA plans to replenish as needed with Operating funds.

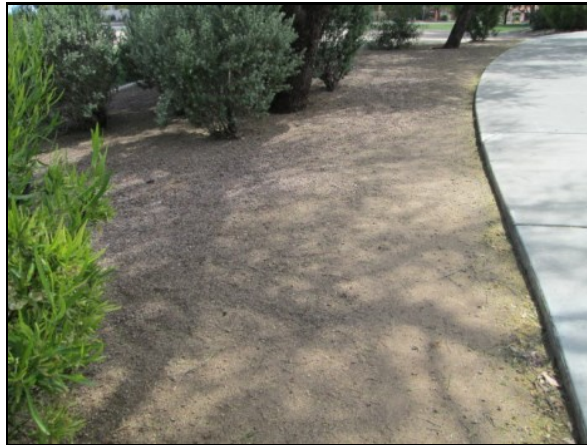
Comments: Conditions vary. Some spots have decent coverage while other spots look low. There is no expectancy to replace the granite, but periodic replenishing should be planned to restore the appearance. Per past information, the 2013 replenish project included:
