Vistoso Community Association
Oro Valley, AZ

Report #: 8973-11
Beginning: January 1, 2024
Expires: December 31, 2024

RESERVE STUDY
Update "With-Site-Visit"

August 19, 2023

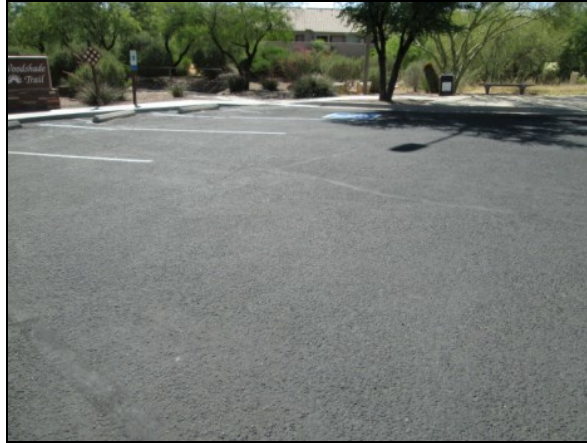
Comments: This small parking lot is located right off of Rancho Vistoso Blvd. Surface is rough with exposed aggregate plus some cracking. This component funds to remove and repave the asphalt. Life span is based on periodically seal coating and maintaining the surface.

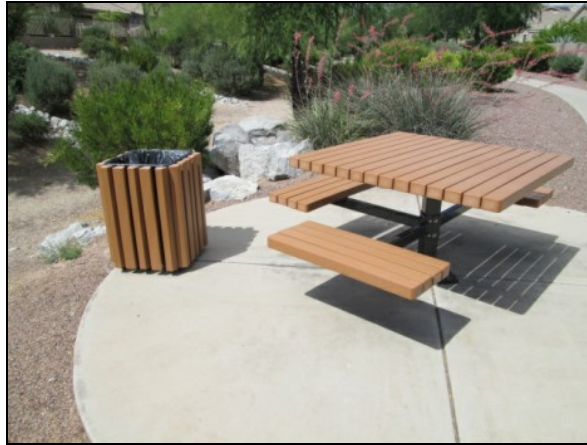
Comp #: 1244 Park Furniture - Replace**Quantity: (10) Pieces**

Comments: Quantity includes (3) 6' benches, (4) picnic tables, and (3) trash cans. Tables have a single pedestal with attached benches. Furniture is from TimberForm and has metal frames with recycled plastic slats. Newer and in good condition. Replace broken slats as a maintenance expense when needed.

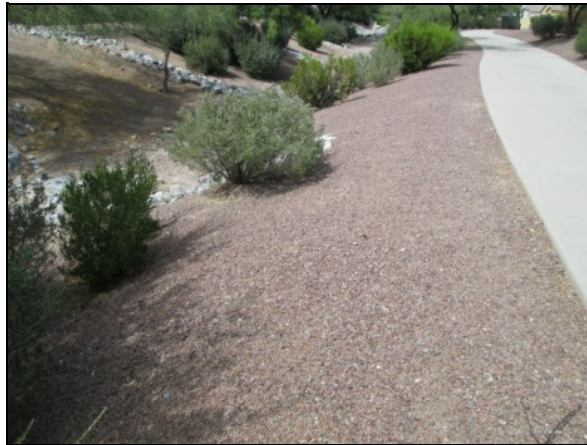
Comments: The 2013 replenish project only included ground cover up to the drainage basin; it did not include surfaces on the other side of the basin that border Vistoso Village. There is no expectancy to replace the granite, but periodic replenishing should be planned to restore the appearance. Per past information, the 2013 replenish project included:

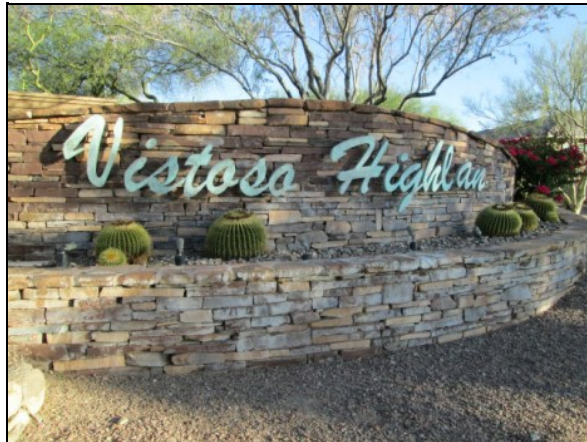
Comp #: 1302 Monument - Replace

Comments: Monument consists of metal lettering attached to walls covered with stone veneer. Lettering reads "Vistoso Highlands". Letters are still attached, but some of the mounting points are broken or loose. This component funds to replace (15) letters and (1) logo to update or modernize the monument, plus ~(16) landscape lights. Treat repairs and maintenance as an Operating expense.

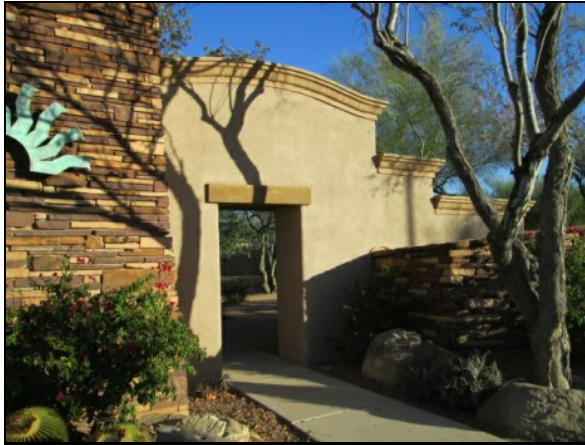
Comments: This component funds to periodically repaint stucco surfaces at the Bell Tower location.

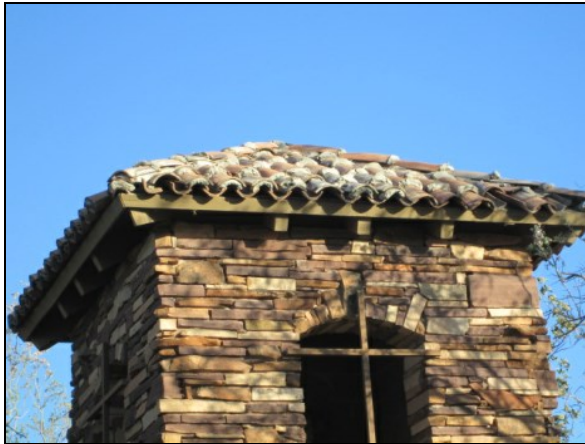
Comp #: 1306 Tile Roof - Replace**Quantity: Approx 130 Sq Ft**

Comments: There is a small section of clay tile roof on the Bell Tower. There is concrete between the tiles, so the entire roof will have to be replaced when the underlayment wears out. There appears to be a good amount of missing or broken tiles. This roof should be nearing time for replacement.

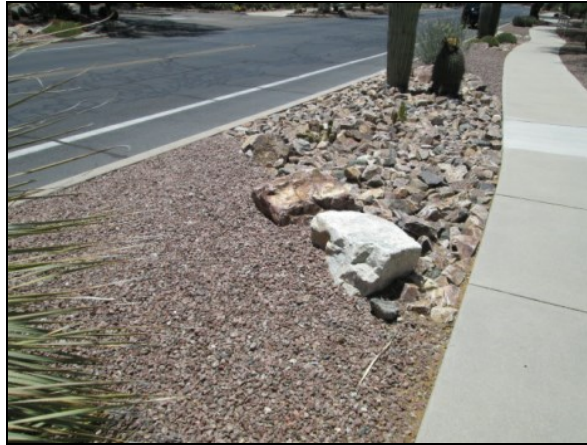
Comments: The 2016 renovation project involved replacing all of the irrigation and plants plus added 1" screened Wildcat Red granite to cover 155,000 sq ft and 4" to 8" Coronado Brown rip rap to cover 16,000 sq ft. Landscaping still looks attractive and is in good condition. This component funds for similar renovations in the future.

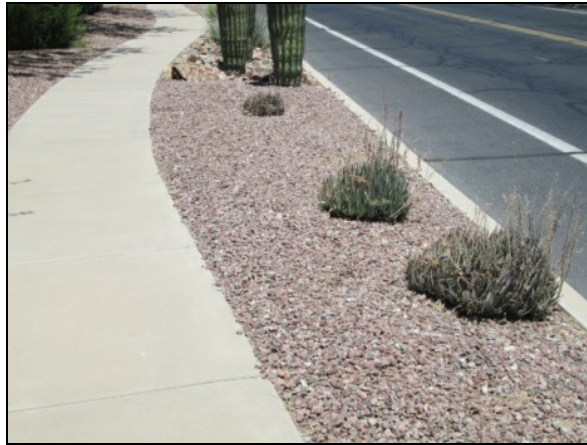
Comments: Granite coverage is still in good condition. The granite will need replenishing sooner than scheduled under the landscape renovation project. This component funds to top dress the granite once between renovation projects with a new 1" layer, which we estimate will require ~1,000 tons.

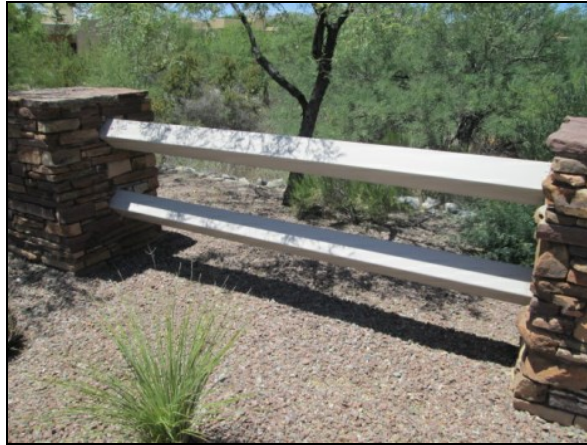
Comments: This component funds to paint ~744 sq ft of decorative, tubular metal rails and 136 LF of culvert rails. These rails are mounted at drainage tracts and bordering sidewalks, so we expect VCA is responsible to maintain and paint them. Surfaces are newer and in good condition.
