Vistoso Community Association  
Oro Valley, AZ

Report #: 8973-13  
Beginning: January 1, 2026  
Expires: December 31, 2026

**RESERVE STUDY**  
Update "No-Site-Visit"

July 1, 2025

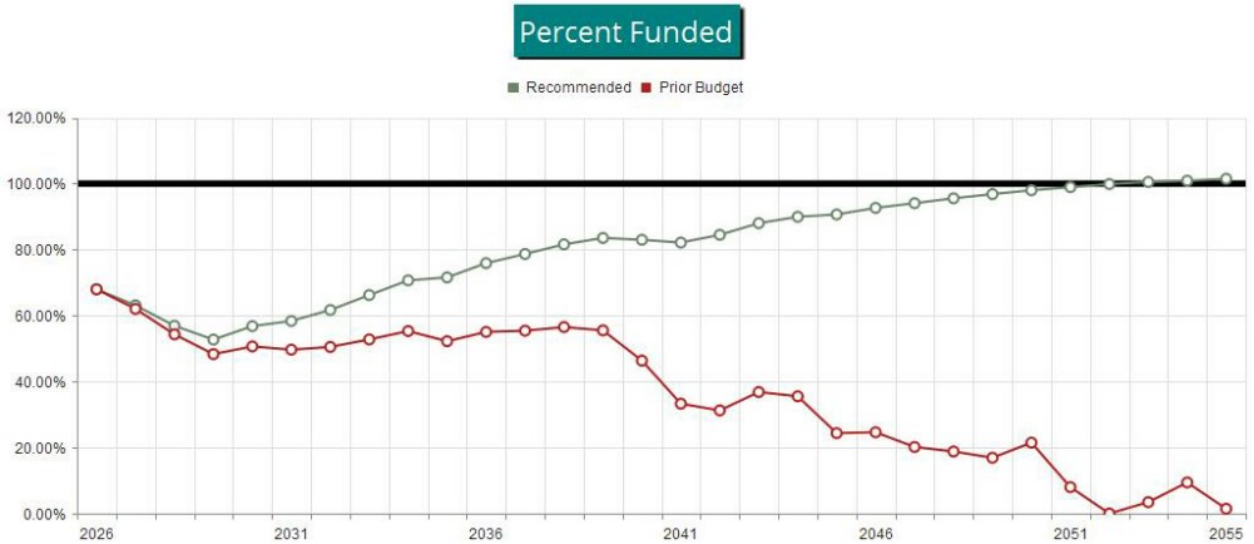
Figure 4

This chart shows the same information plotted on a Percent Funded scale. It is clear here to see how your Reserve Fund strength approaches the 100% Funded level under our recommended multi-year Funding Plan.
