FINAL 11-16-20

MAP 'AA' - AREAS WITHIN ASSOCIATION RESPONSIBILITY

RANCHO VISTOSO COMMUNITY ASSOCIATION - DRAINAGE FACILITIES INVENTORY MAP 'ES' - EAGLE SUMMIT

2020.03.xx
WLB No. 185050-V-A06

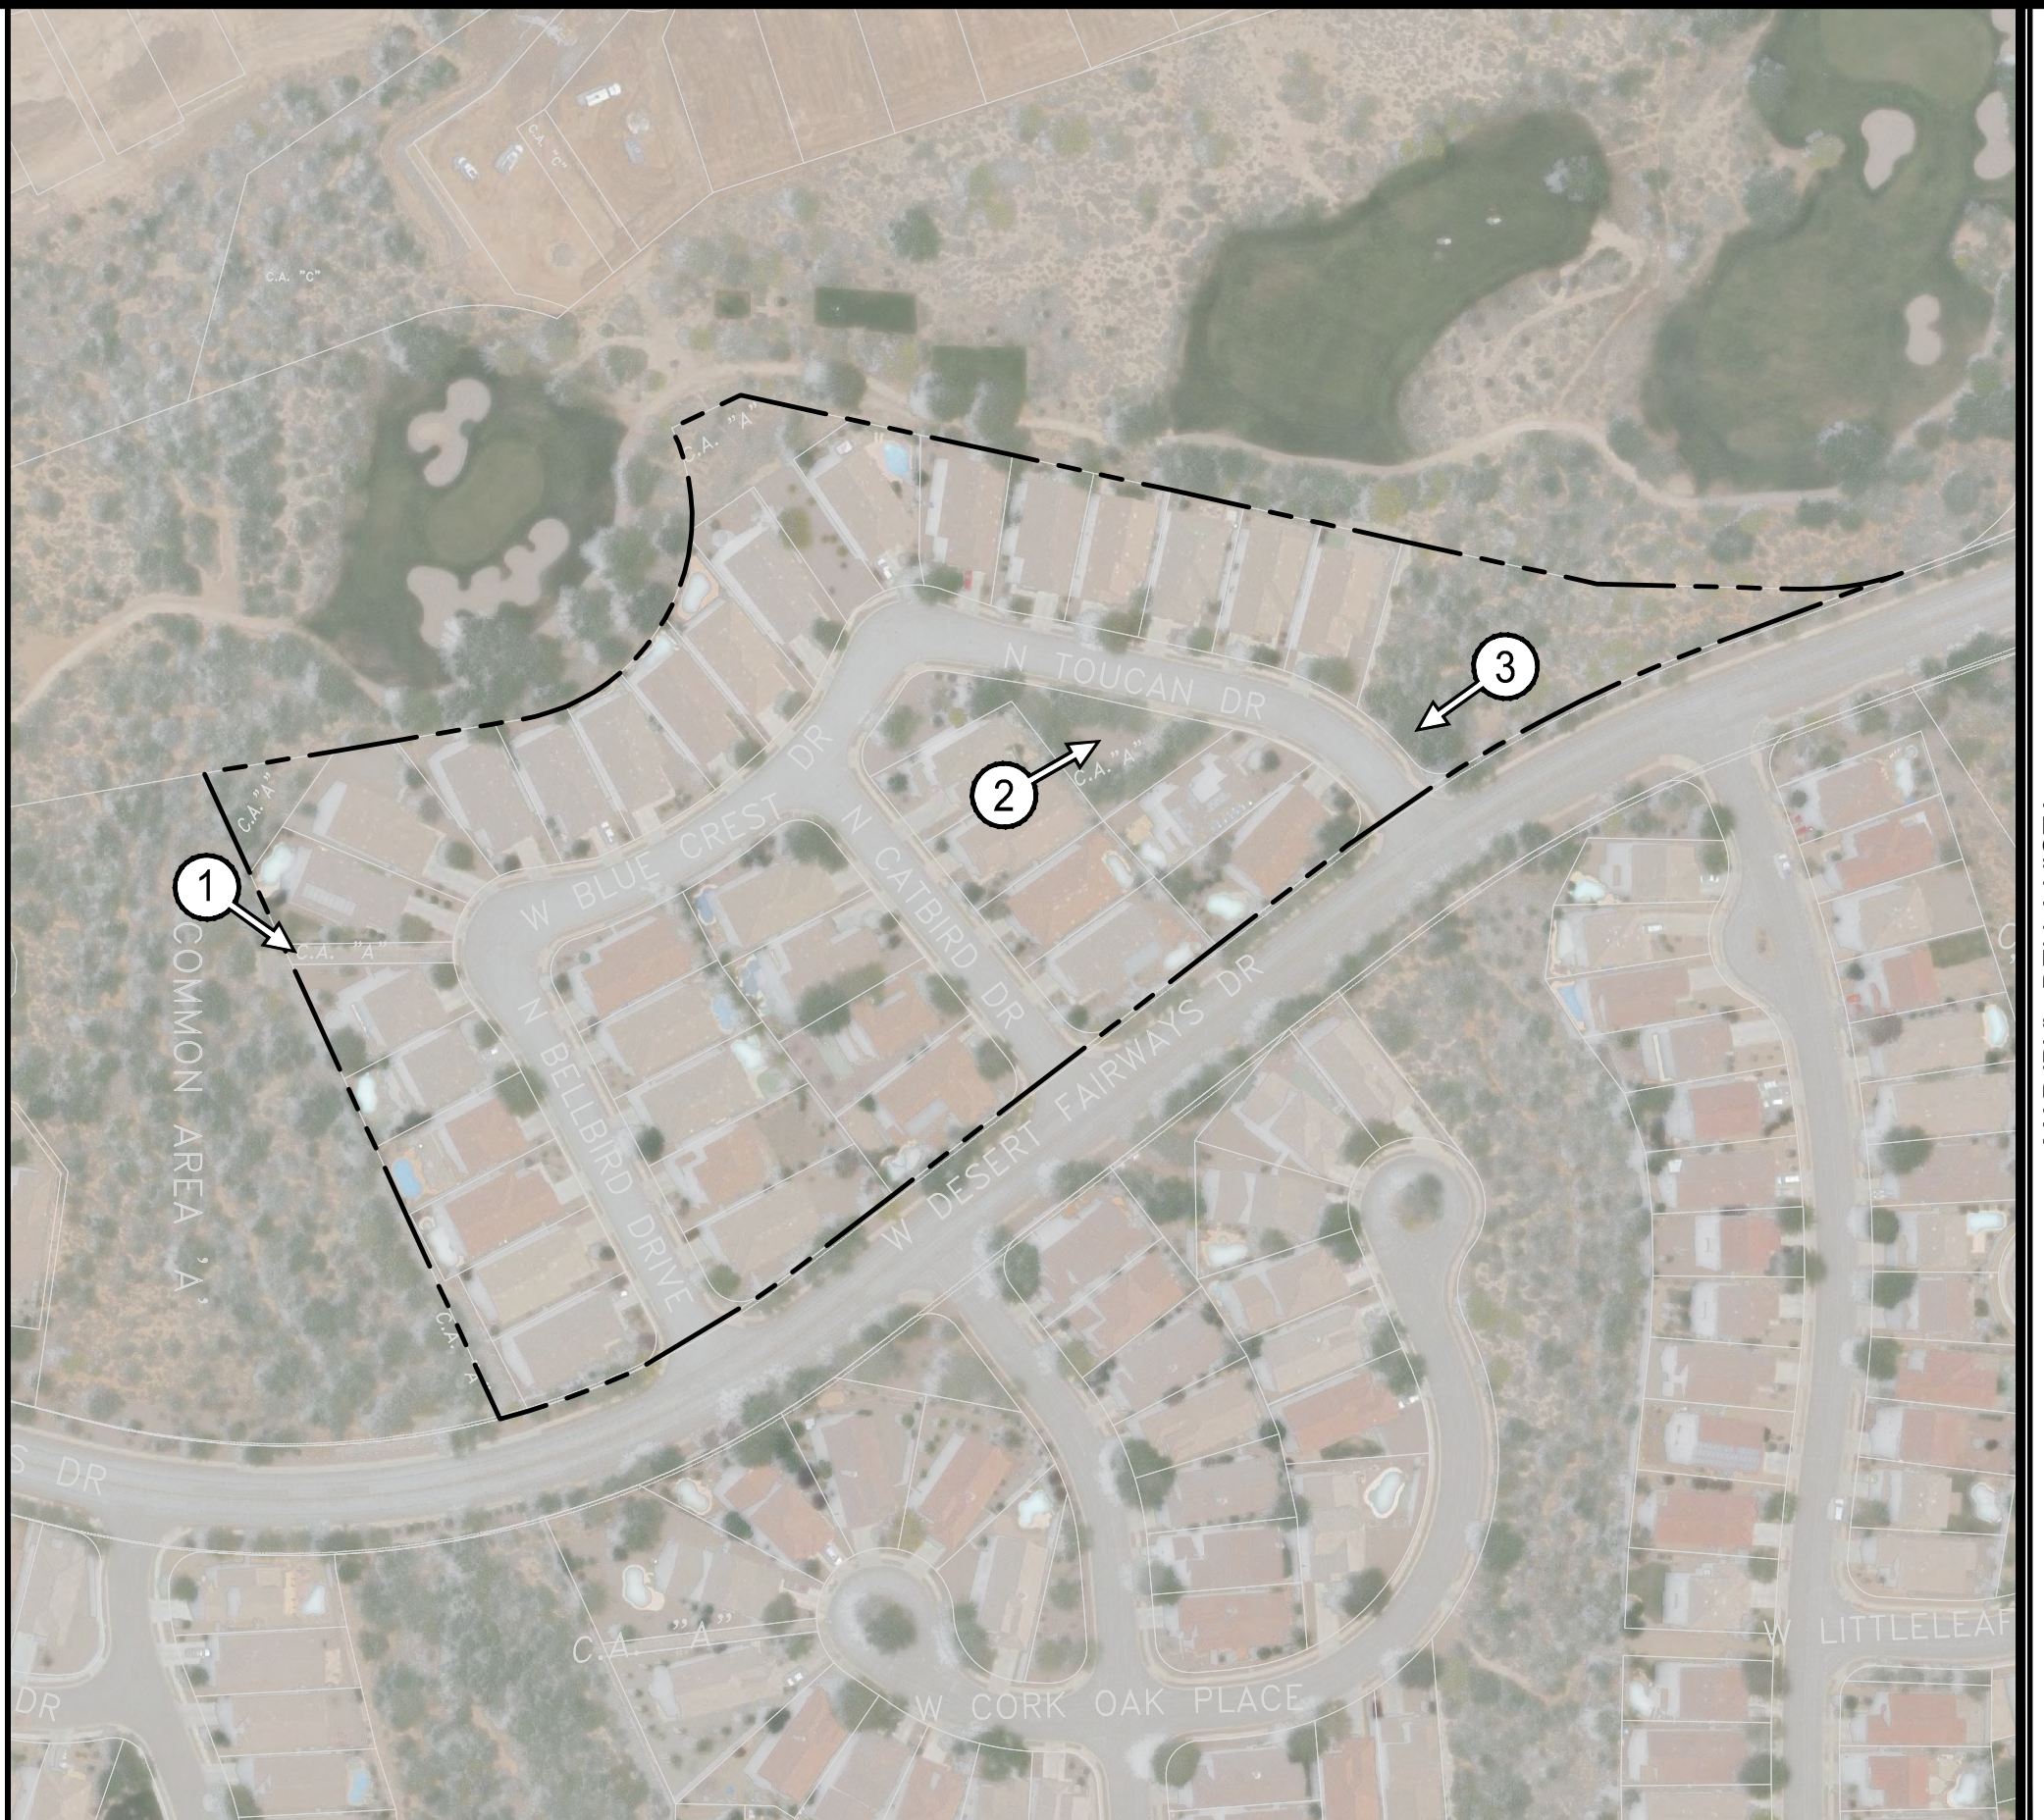
RANCHO VISTOSO MASTER ASSOCIATION				
Subdivision/Facility ID	Date/Description	Field Observations	Priority	Recommendations
Bella Vista (BV)	March 2020			PRIORITY: Red - Urgent, Blue - 0 to 6 months, Yellow - 6 to 12 months, Clear - Monitor
Site 1	Grate Inlet to Pipe	Grate structure clear of debris, minimal sedimentation within channel bottom		
Site 2	Pipe Outlet and Channel/Scupper Inlet and Detention/Retention Basin	Pipe clear of debris, minimal sedimentation within channel bottom, scupper clear of debris, minimal sedimentation within basin bottom		
Site 3	Scupper Inlet/Scupper Splash Pad	Scupper clear of debris, minimal sedimentation within splash pad, structure intact

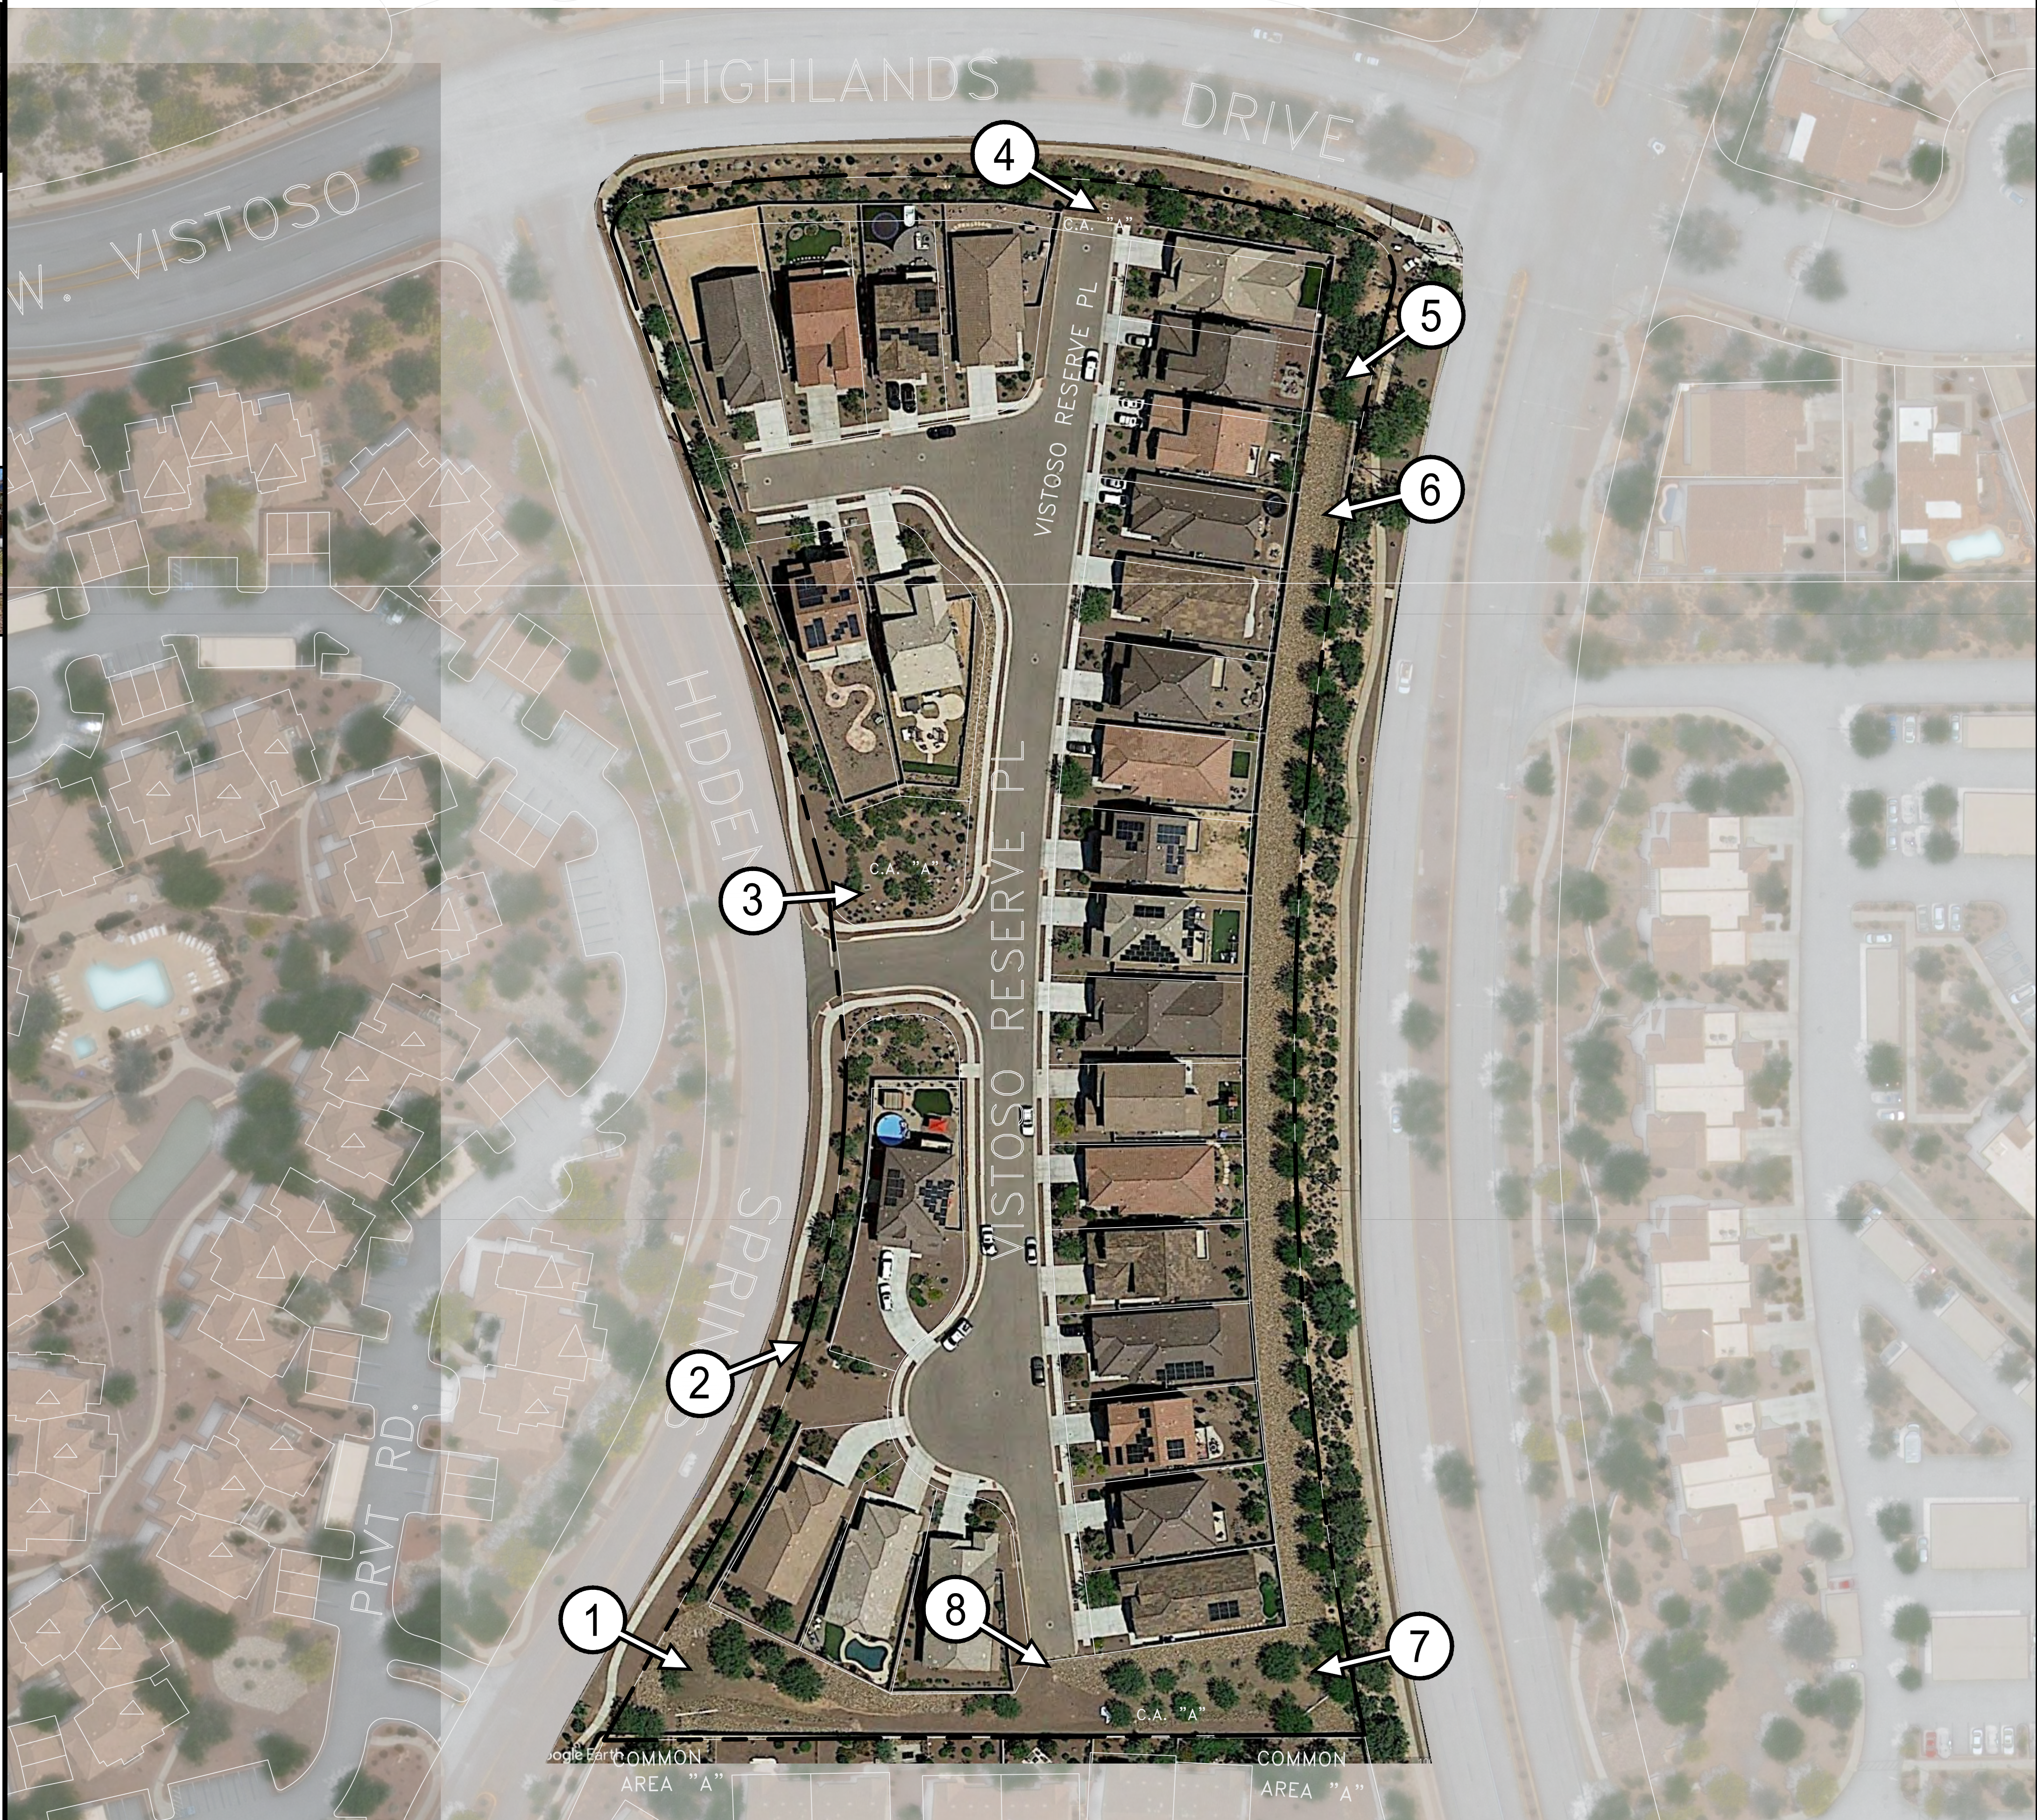
RANCHO VISTOSO MASTER ASSOCIATION - DRAINAGE INVENTORY - NOVEMBER 2020				
Subdivision/Facility ID	Date/Description	Field Observations	Priority	Recommendations
Cortona (CT)	June 2020			PRIORITY: Red - Urgent, Blue - 0 to 6 months, Yellow - 6 to 12 months, Clear - Monitor
Site 1	Channel	Channel in good condition		
Site 2	Scupper Inlet, Scupper and Channel	Scupper inlet in good condition, scupper and channel in good condition		
Site 3	Channel	Channel in good condition		
Site 4	Detention/Retention Basin, Scupper and rock-lined Spillway	Basin in good condition, scour and erosion at outlet, scupper and rock spillway in good condition		Repair scour and erosion at outlet
Site 5	Detention/Retention Basin	Basin in good condition		
Site 6	Scupper and Basin/pipe inlet	Structures in good condition		
Site 7	Scupper and Channel; Channel and pipe outlet from CT-06	Scupper and channel in good condition, downstream sediment accumulation, channel and pipe outlet has excess vegetative growth and debris with scour and erosion		Remove channel sedimentation, remove excess vegetation/debris and repair scour/erosion

Site 8	Scupper and Channel	Scupper inlet in good condition with sediment build-up at the outlet, channel has excess vegetative growth		Remove channel sedimentation, remove excess vegetation
Site 9	August 2020/Basin	basin and rip-rap slopes appear in good condition/heavy vegeatation is present		Remove/clear vegetation, trim trees, inpect slopes and repair if necessary

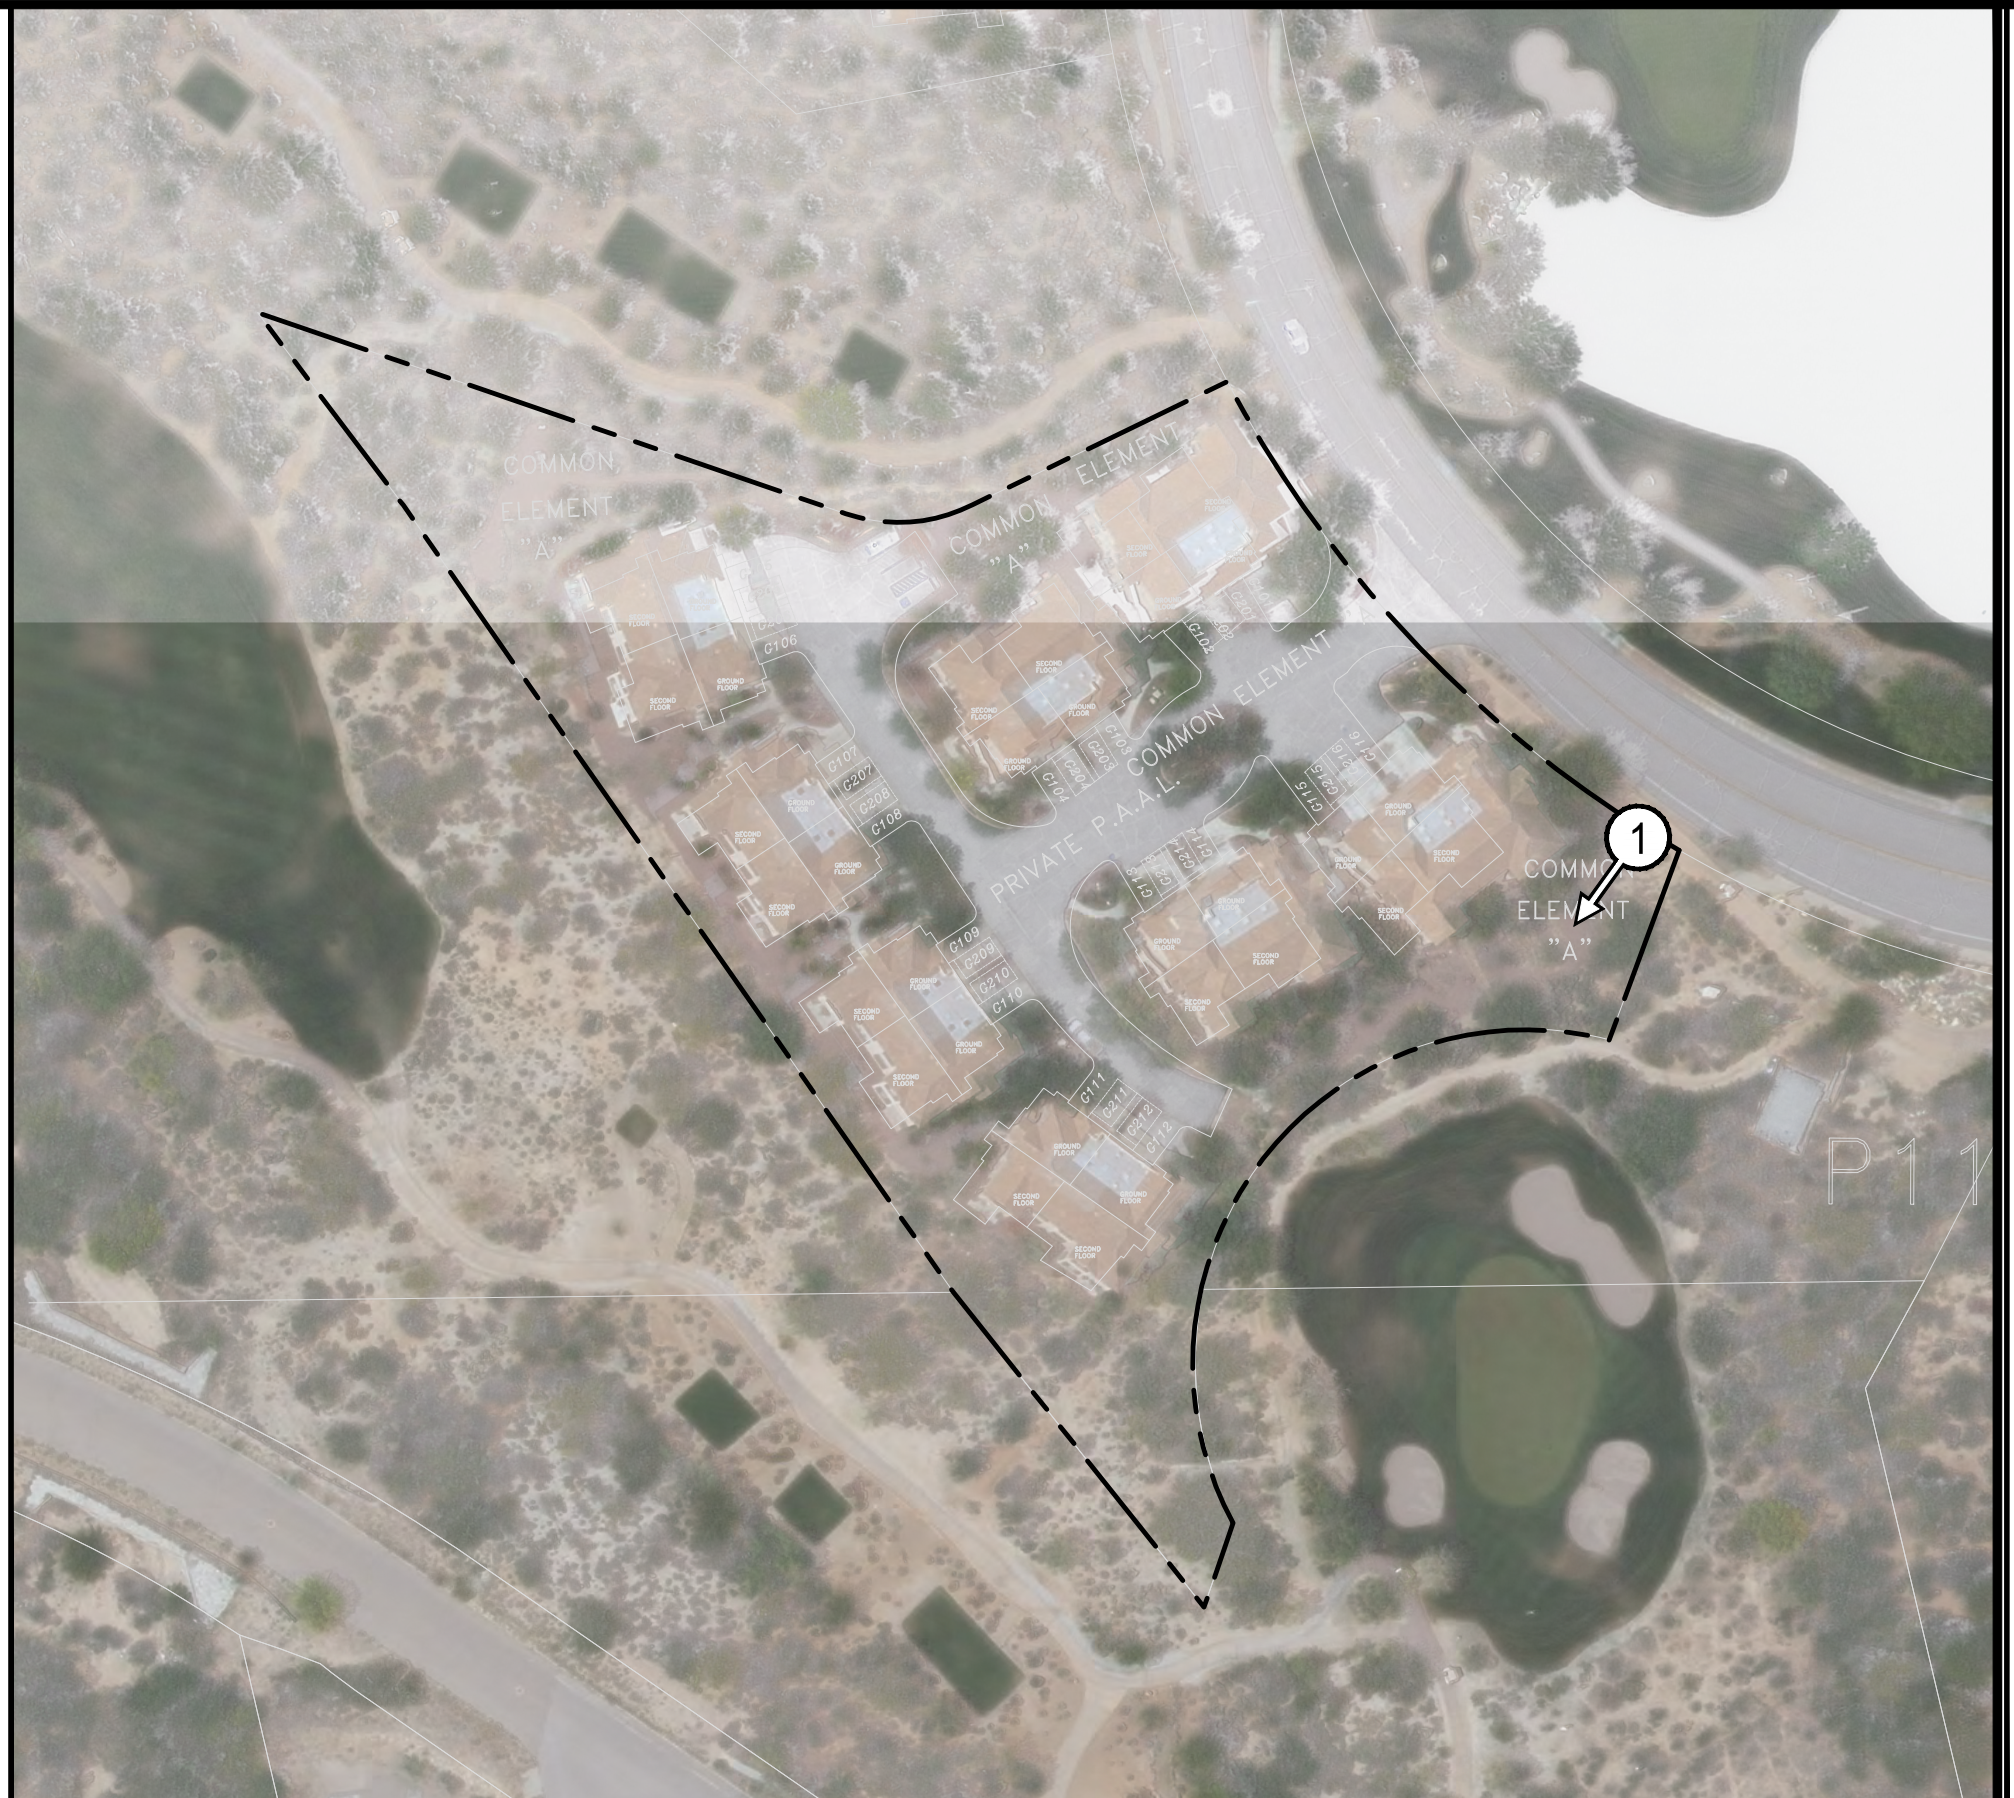
RANCHO VISTOSO MASTER ASSOCIATION				
Subdivision/Facility ID	Date/Description	Field Observations	Priority	Recommendations
Vistoso Golf Casitas II (G2)	March 2020			PRIORITY: Red - Urgent, Blue - 0 to 6 months, Yellow - 6 to 12 months, Clear - Monitor
Site 1	Multiple Offsite Culvert outlets leading to Stormdrain system, Grate inlets, Deperessed culvert and Splash pads	Some sedimentation located at culvert outlets, some debris at grate inlet		Remove sediment at outlets and debris at inlet

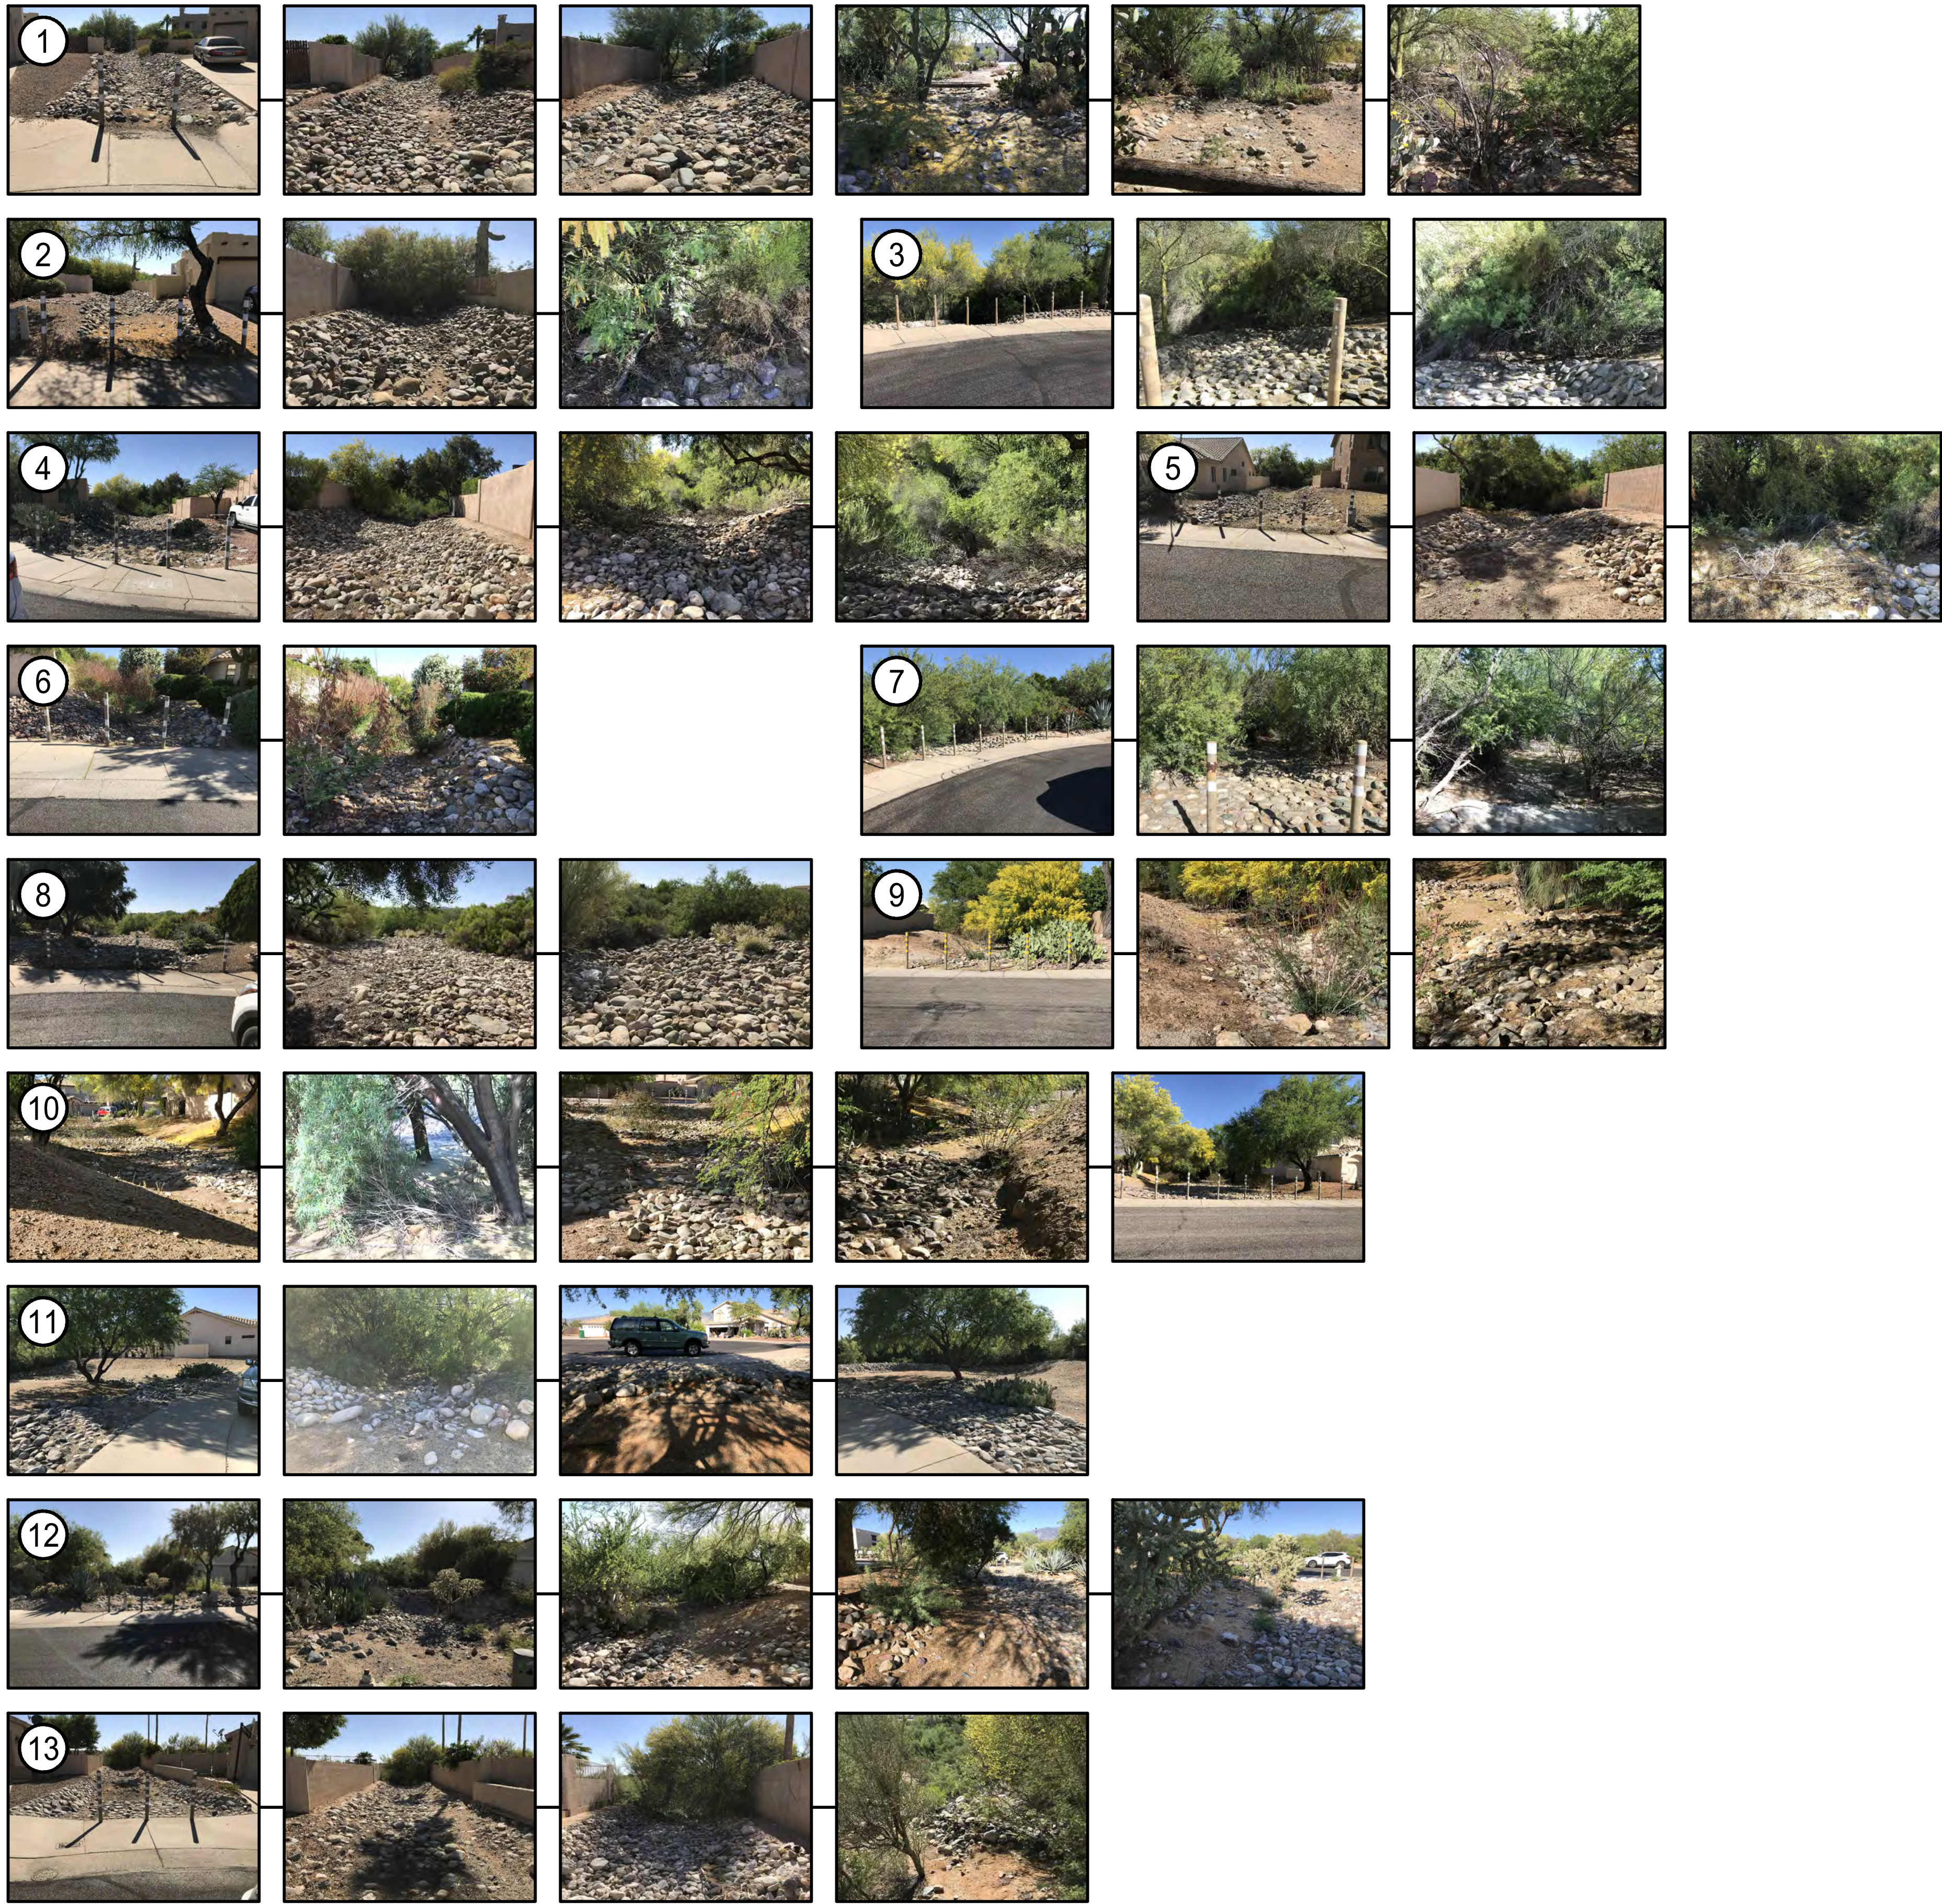
MAP 'LC' - LAS COLINAS

RANCHO VISTOSO MASTER ASSOCIATION - DRAINAGE INVENTORY - NOVEMBER 2020				
Subdivision/Facility ID	Date/Description	Field Observations	Priority	Recommendations
Las Colinas (LC)	May 2020			PRIORITY: Red - Urgent, Blue - 0 to 6 months, Yellow - 6 to 12 months, Clear - Monitor
Site 1	Channel	Sediment build-up and displaced rock rip rap; fallen stumps across channel; overgrown vegetation at downstream end		Remove tree stumps/repair channel and remove excess vegetation
Site 2	Channel	Sediment build-up upstream; large tree at downstream end along with debris and excess vegetation at outlet		Remove tree and debris and excess vegetation
Site 3	Channel/Spillway	Good condition except at outlet (overgrowth of vegetation)		Remove excess vegetation
Site 4	Channel	Minor sediment, rip rap displacement and thick vegetation downstream end		Remove excess vegetation/repair rip rap
Site 5	Channel	Significant sedimentation/ missing or misplaced rip rap; debris and vegetation overgrowth at exit		Repair channel rip rap; remove sediment and overgrowth

Site 6	Channel	Channel in fair condition with heavy vegetation overgrowth at exit		Remove overgrowth
Site 7	Channel	Channel in good condition; dead vegetation at downstream end		Remove dead vegetation
Site 8	Channel	Channel in good condition; dead vegetation at downstream end		Remove dead vegetation
Site 9	Drainageway	Drainageway in good condition		
Site 10	Drainageway	Drainageway in good condition; dead vegetation		Remove dead vegetation
Site 11	Drainageway	Drainageway in good condition		
Site 12	Drainageway	Drainageway in good condition; minor sediment impacting rip rap		
Site 13	Channel	Channel in good condition; large shrub/tree impairs flow		Remove shrub/tree

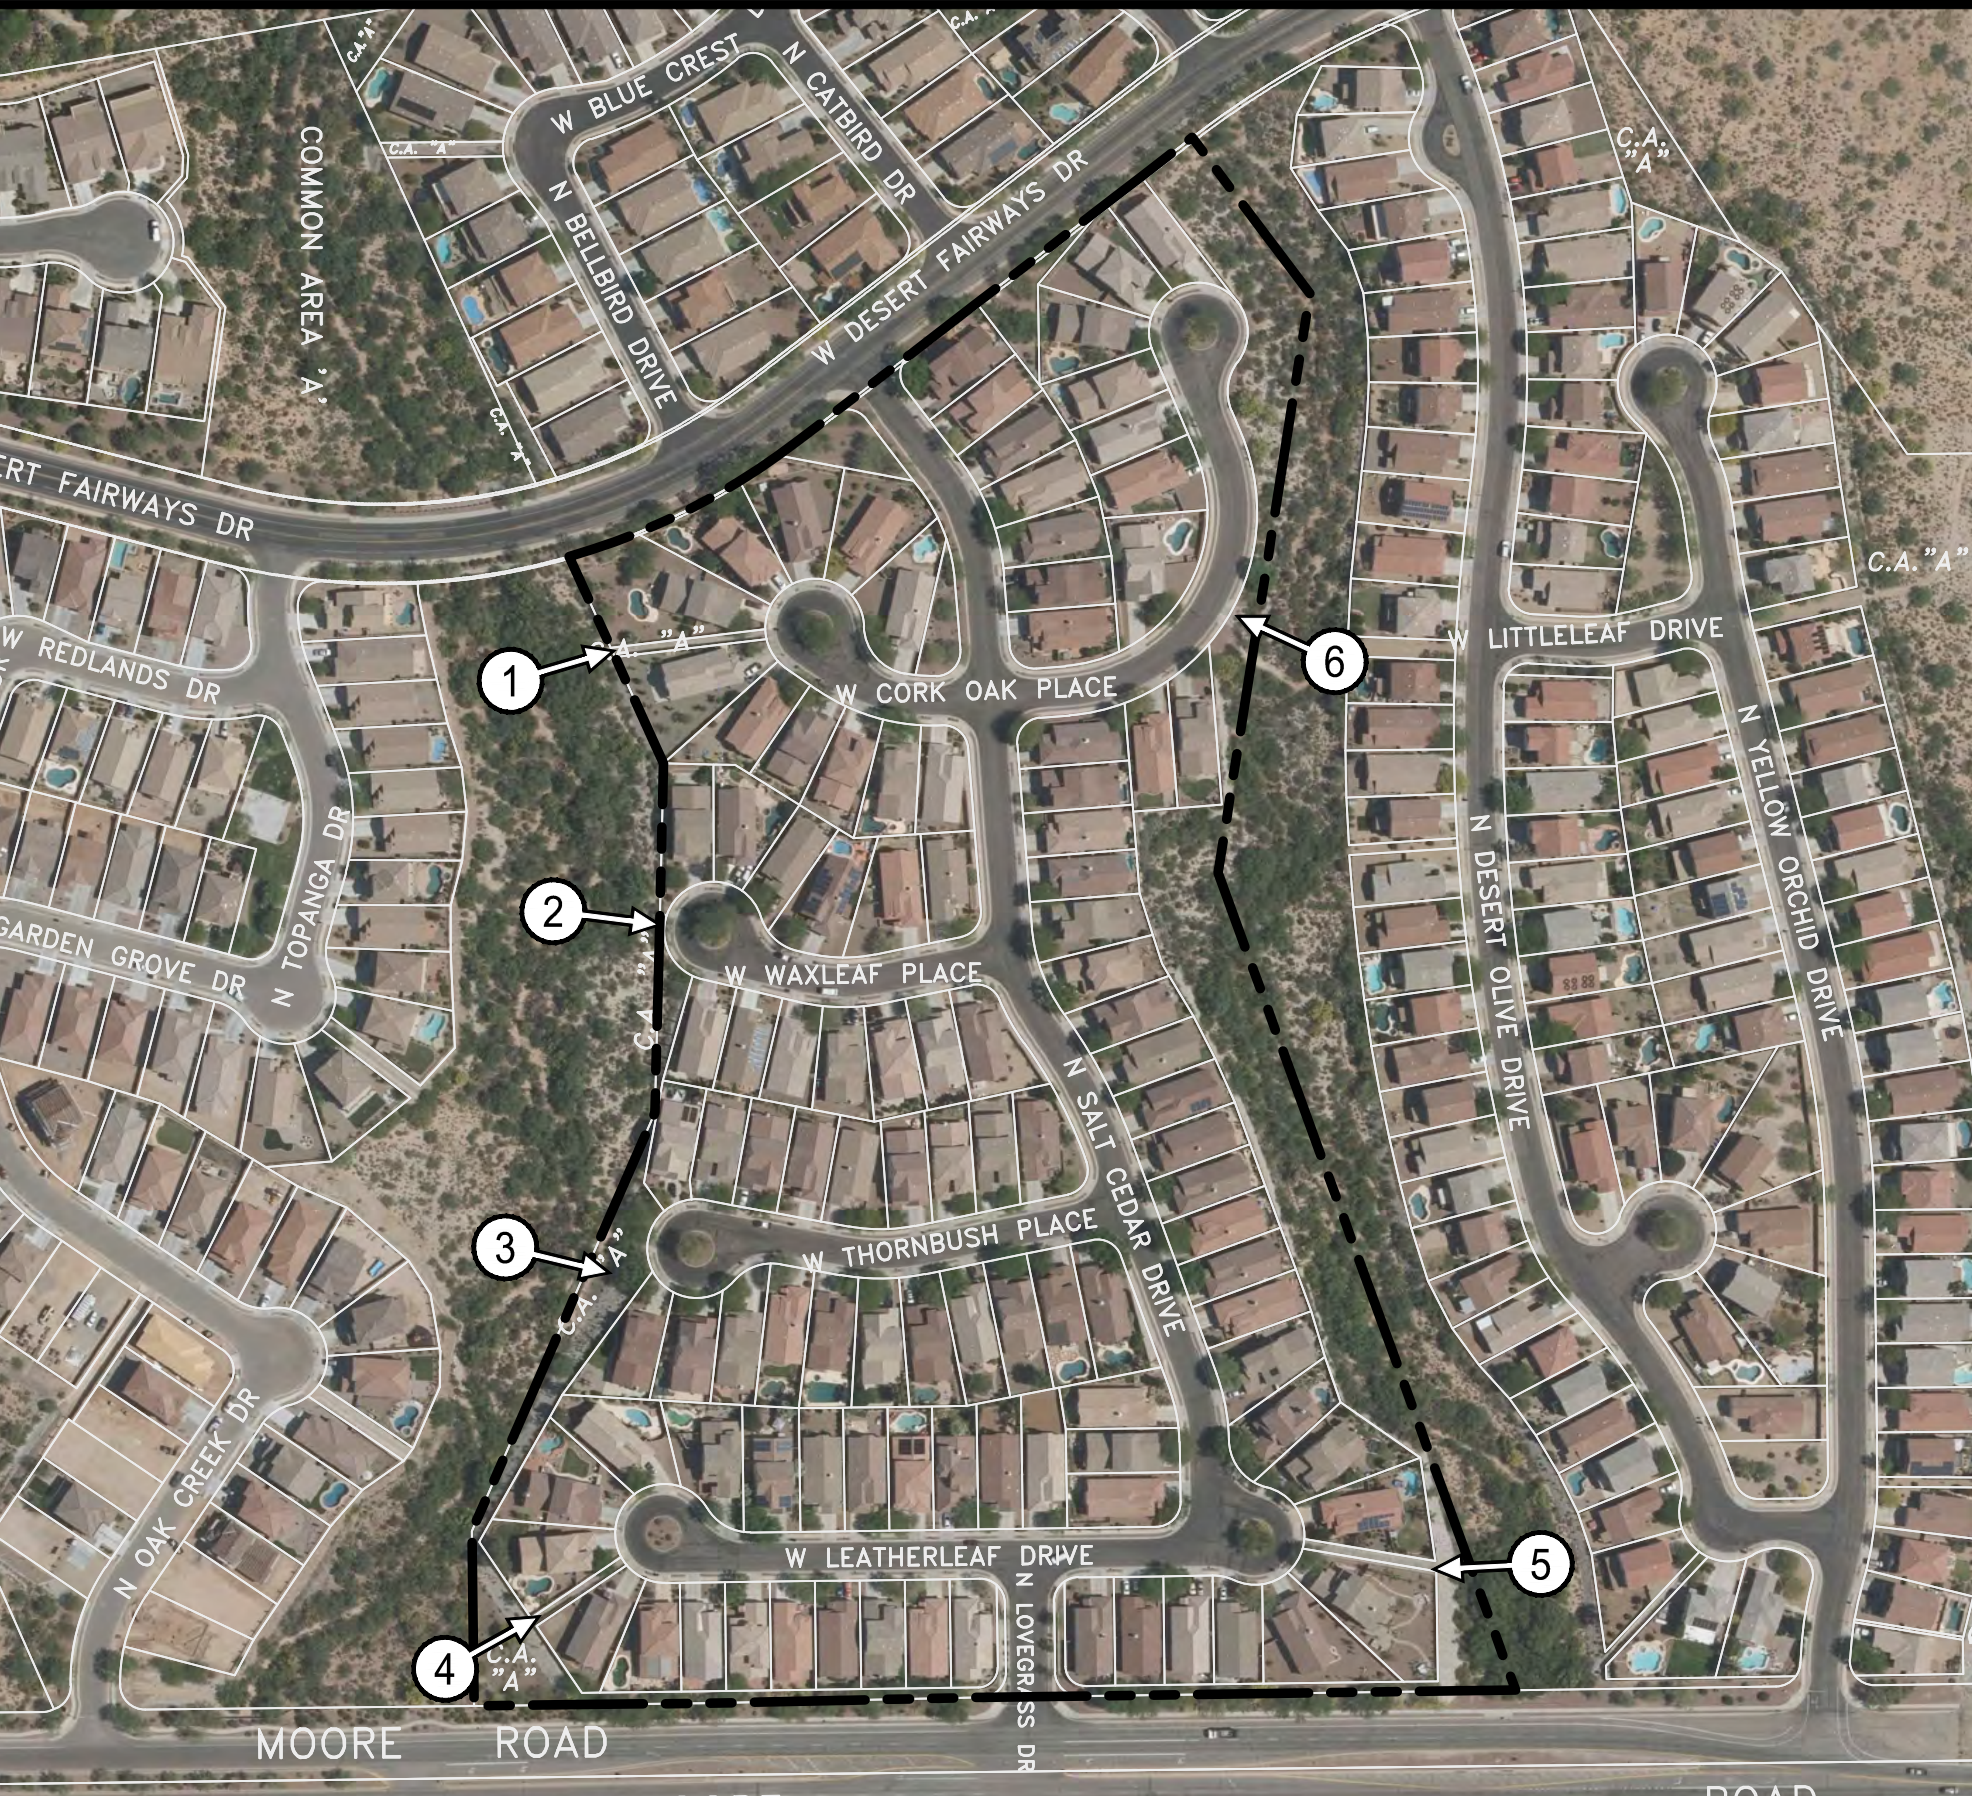
MAP 'LT' - LA TERRAZA

RANCHO VISTOSO MASTER ASSOCIATION				
Subdivision/Facility ID	Date/Description	Field Observations	Priority	Recommendations
Las Terraza (LT)	May 2020			PRIORITY: Red - Urgent, Blue - 0 to 6 months, Yellow - 6 to 12 months, Clear - Monitor
Site 1	Channel	Channel in good condition; outlet has some minor erosion with debris and vegetative overgrowth		Remove debris and overgrowth
Site 2	Rock Spillway	Inlet looks good, erosion occuring at the outlet and within natural area		Repair erosion
Site 3	Detention/Retention Basin	Basin inlet in good condition; overall basin in fair condition; heavy vegetation and debris in basin bottom		Remove debris and overgrowth
Site 4	Channel and Detention/Retention Basin	Channel and basin in good condition		
Site 5	Channel	Rock-lined channel in good condition		
Site 6	Curb cut to Swale	Curb cut in good condition; swale has erosion and some minor head cutting		Repair swale
