FINAL 11-16-20

MAP 'AA' - AREAS WITHIN ASSOCIATION RESPONSIBILITY

RANCHO VISTOSO COMMUNITY ASSOCIATION - DRAINAGE FACILITIES INVENTORY MAP 'ES' - EAGLE SUMMIT

2020.03.xx
WLB No. 185050-V-A06

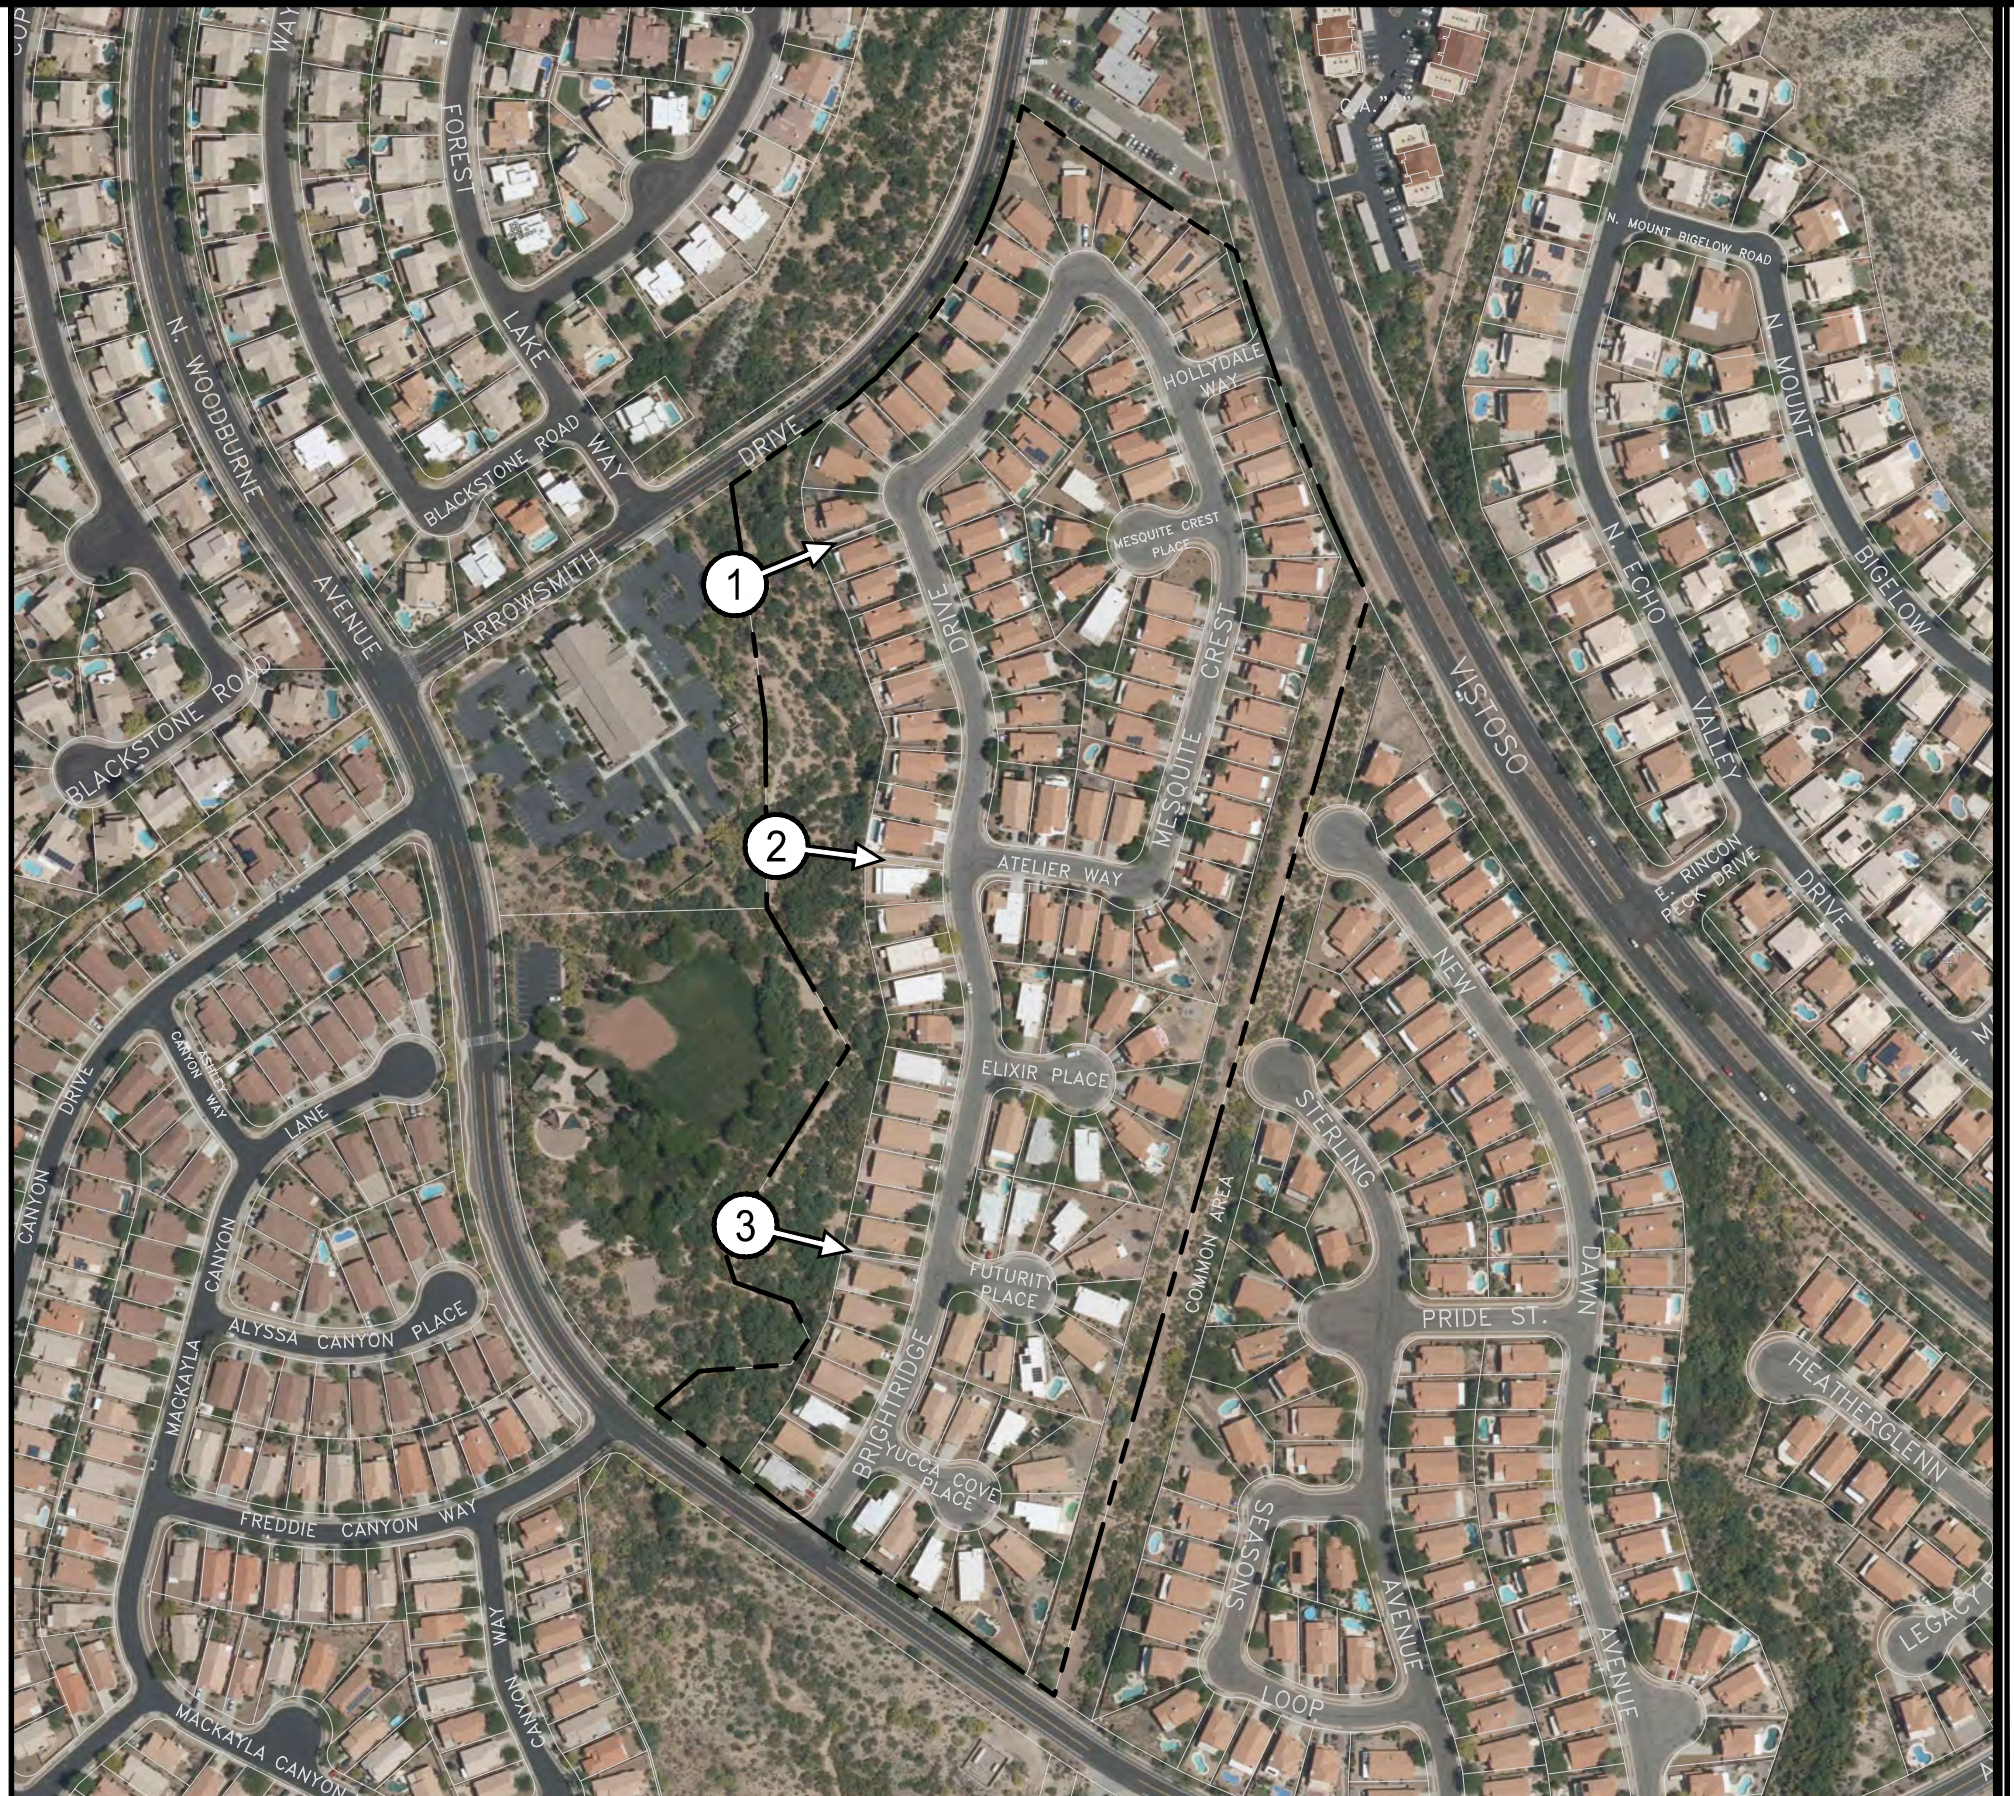
MAP 'MC' - MESQUITE CREST

RANCHO VISTOSO MASTER ASSOCIATION				
Subdivision/Facility ID	Date/Description	Field Observations	Priority	Recommendations
Mesquite Crest (MC)	May 2020			PRIORITY: Red - Urgent, Blue - 0 to 6 months, Yellow - 6 to 12 months, Clear - Monitor
Site 1	Channel	Overall in good condition with small gravel/sediment in channel and nominal erosion downstream		
Site 2	Channel/Culverts	Overall in good condition with small gravel in channel, Minor sediment at downstream culvert outlet		
Site 3	Channel	Good condition; excess of vegetative growth at downstream end (natural channel)		Remove downstream overgrowth

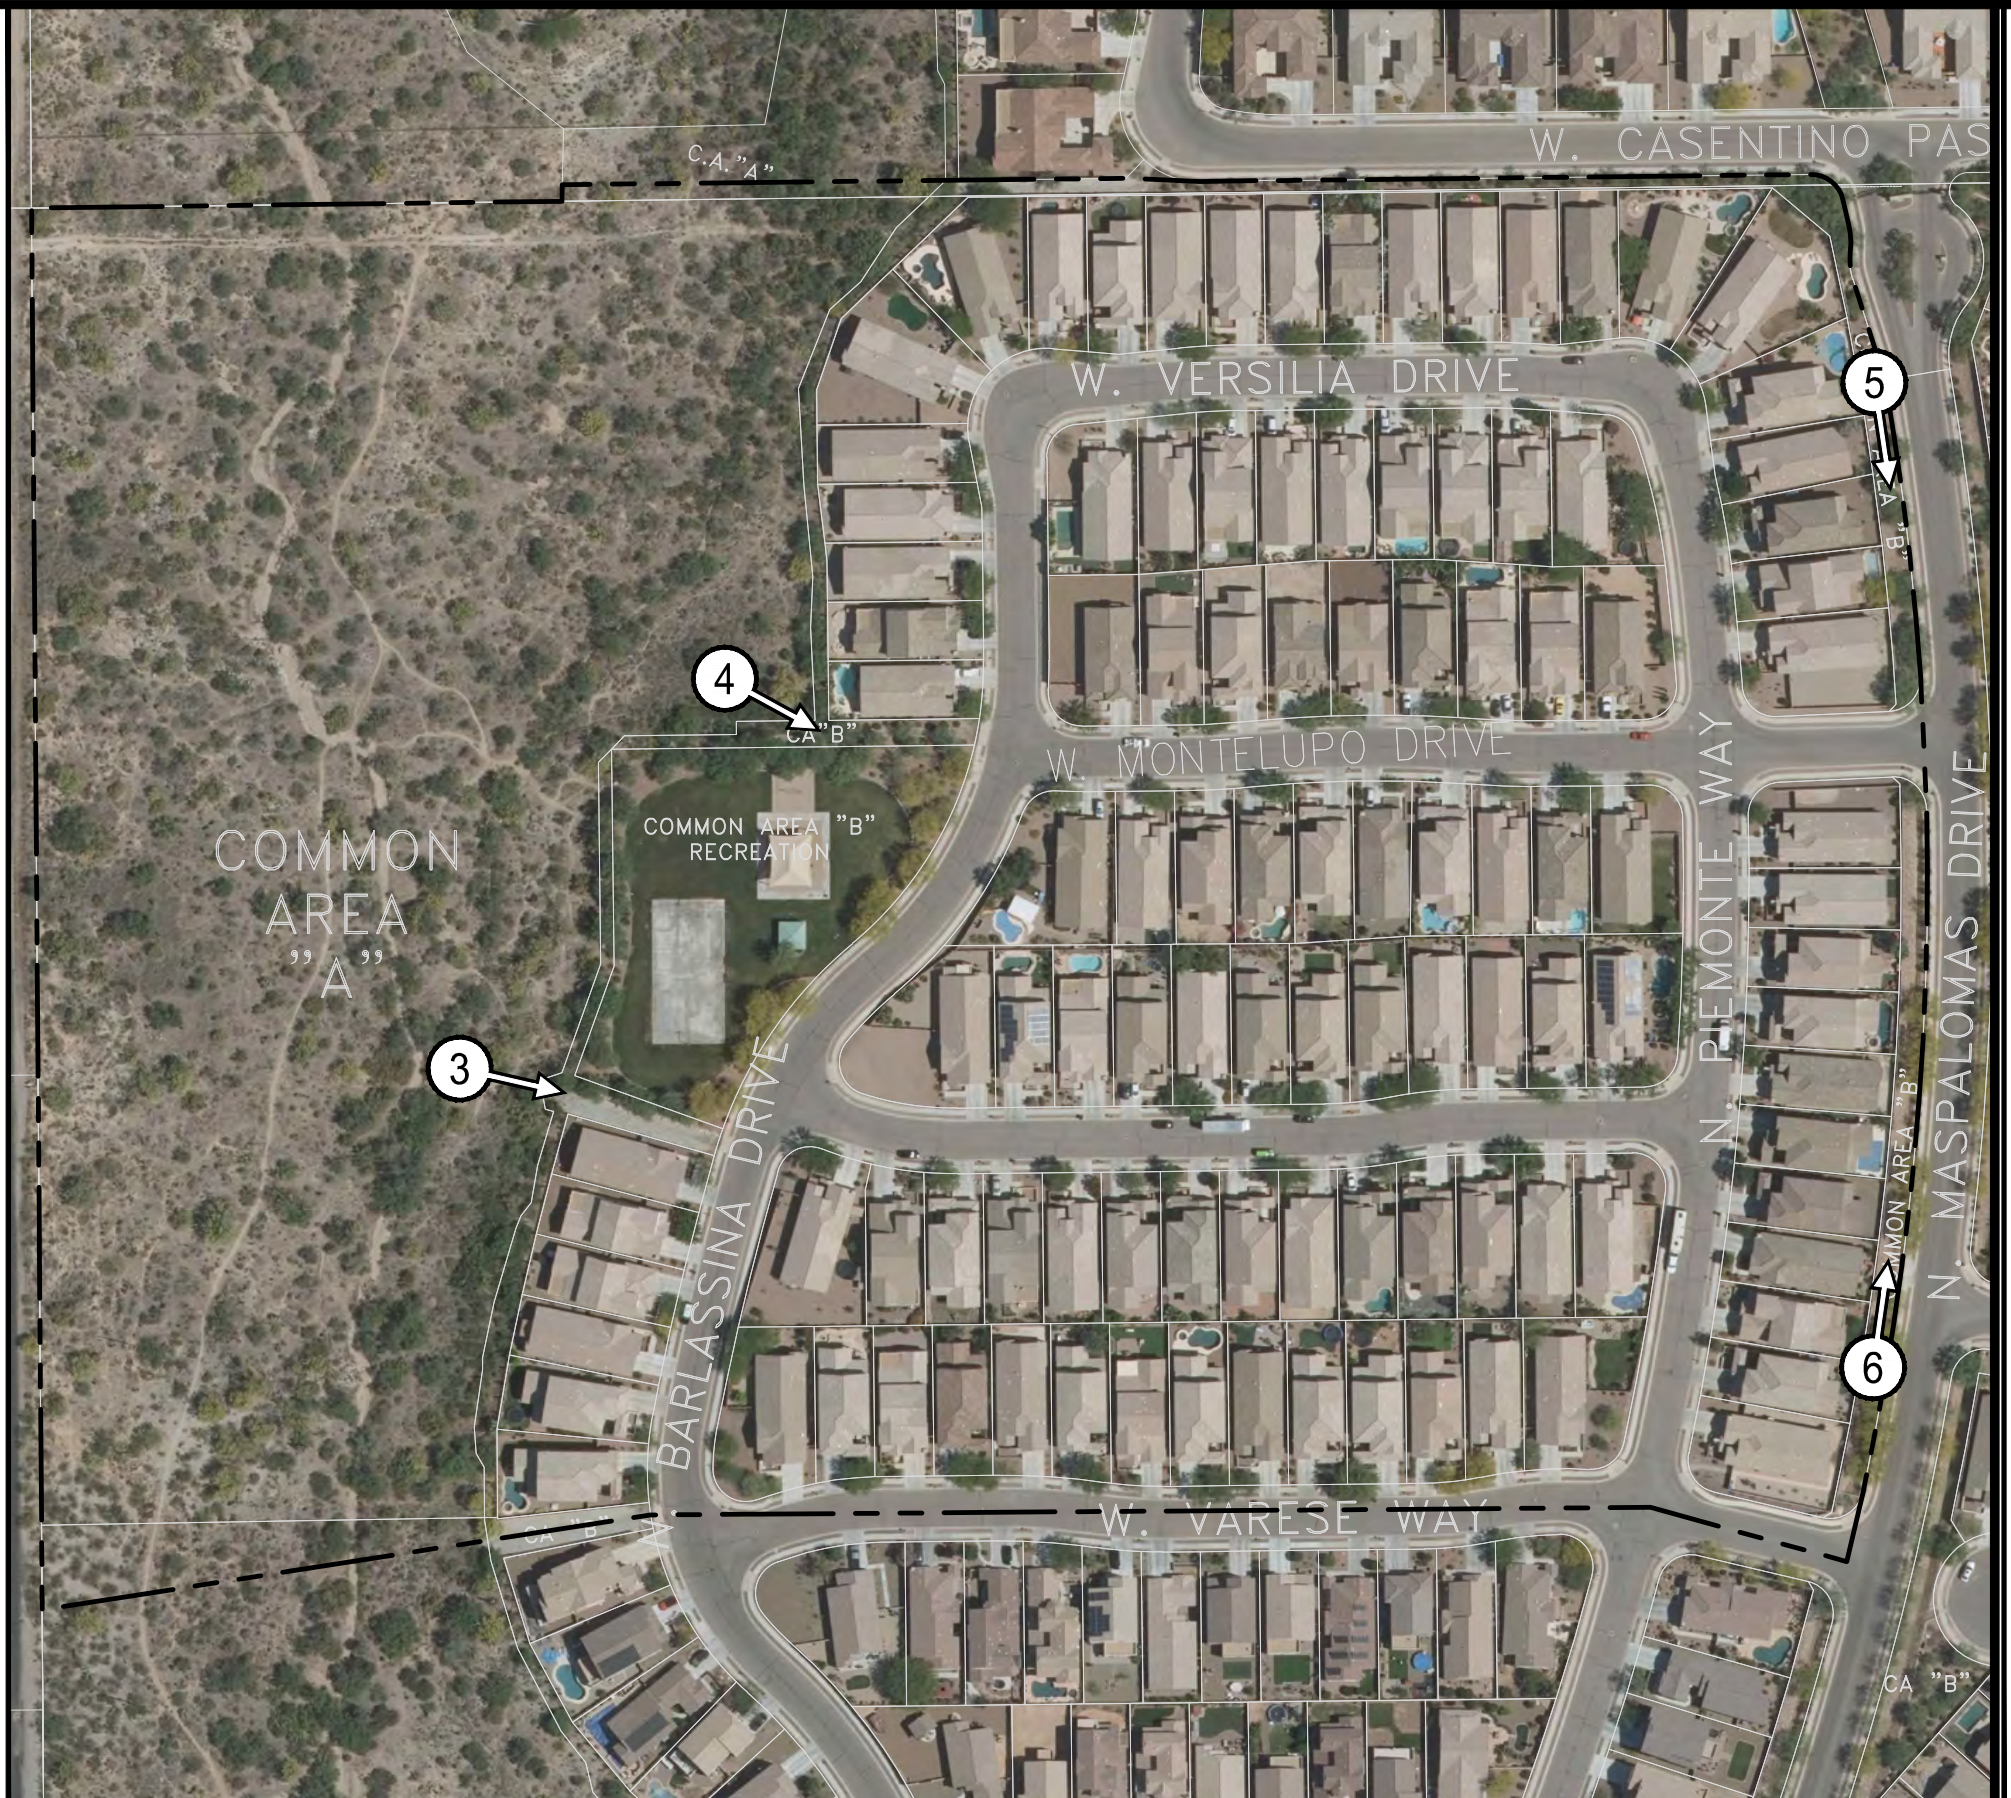
MAP 'MN' - MONTICELLO

RANCHO VISTOSO MASTER ASSOCIATION				
Subdivision/Facility ID	Date/Description	Field Observations	Priority	Recommendations
Monticello (MN)	June 2020			PRIORITY: Red - Urgent, Blue - 0 to 6 months, Yellow - 6 to 12 months, Clear - Monitor
Site 1	Scupper/Channel	Scupper in good condition; channel inlet has minor sediment and outlet has excess of vegetative growth		Remove sediment and excess downstream vegetation
Site 2	Scupper/Channel	Scupper in good condition; channel contains leaves and outlet has vegetative overgrowth		Remove leaves and excess downstream vegetation
Site 5	Channel and Culvert	Channel in good condition; sediment at culvert inlet and outlet with rocks at the upstream end		Clean culvert at inlet and outlet
Site 4	Scupper/Channel/Culvert	All structures in good condition

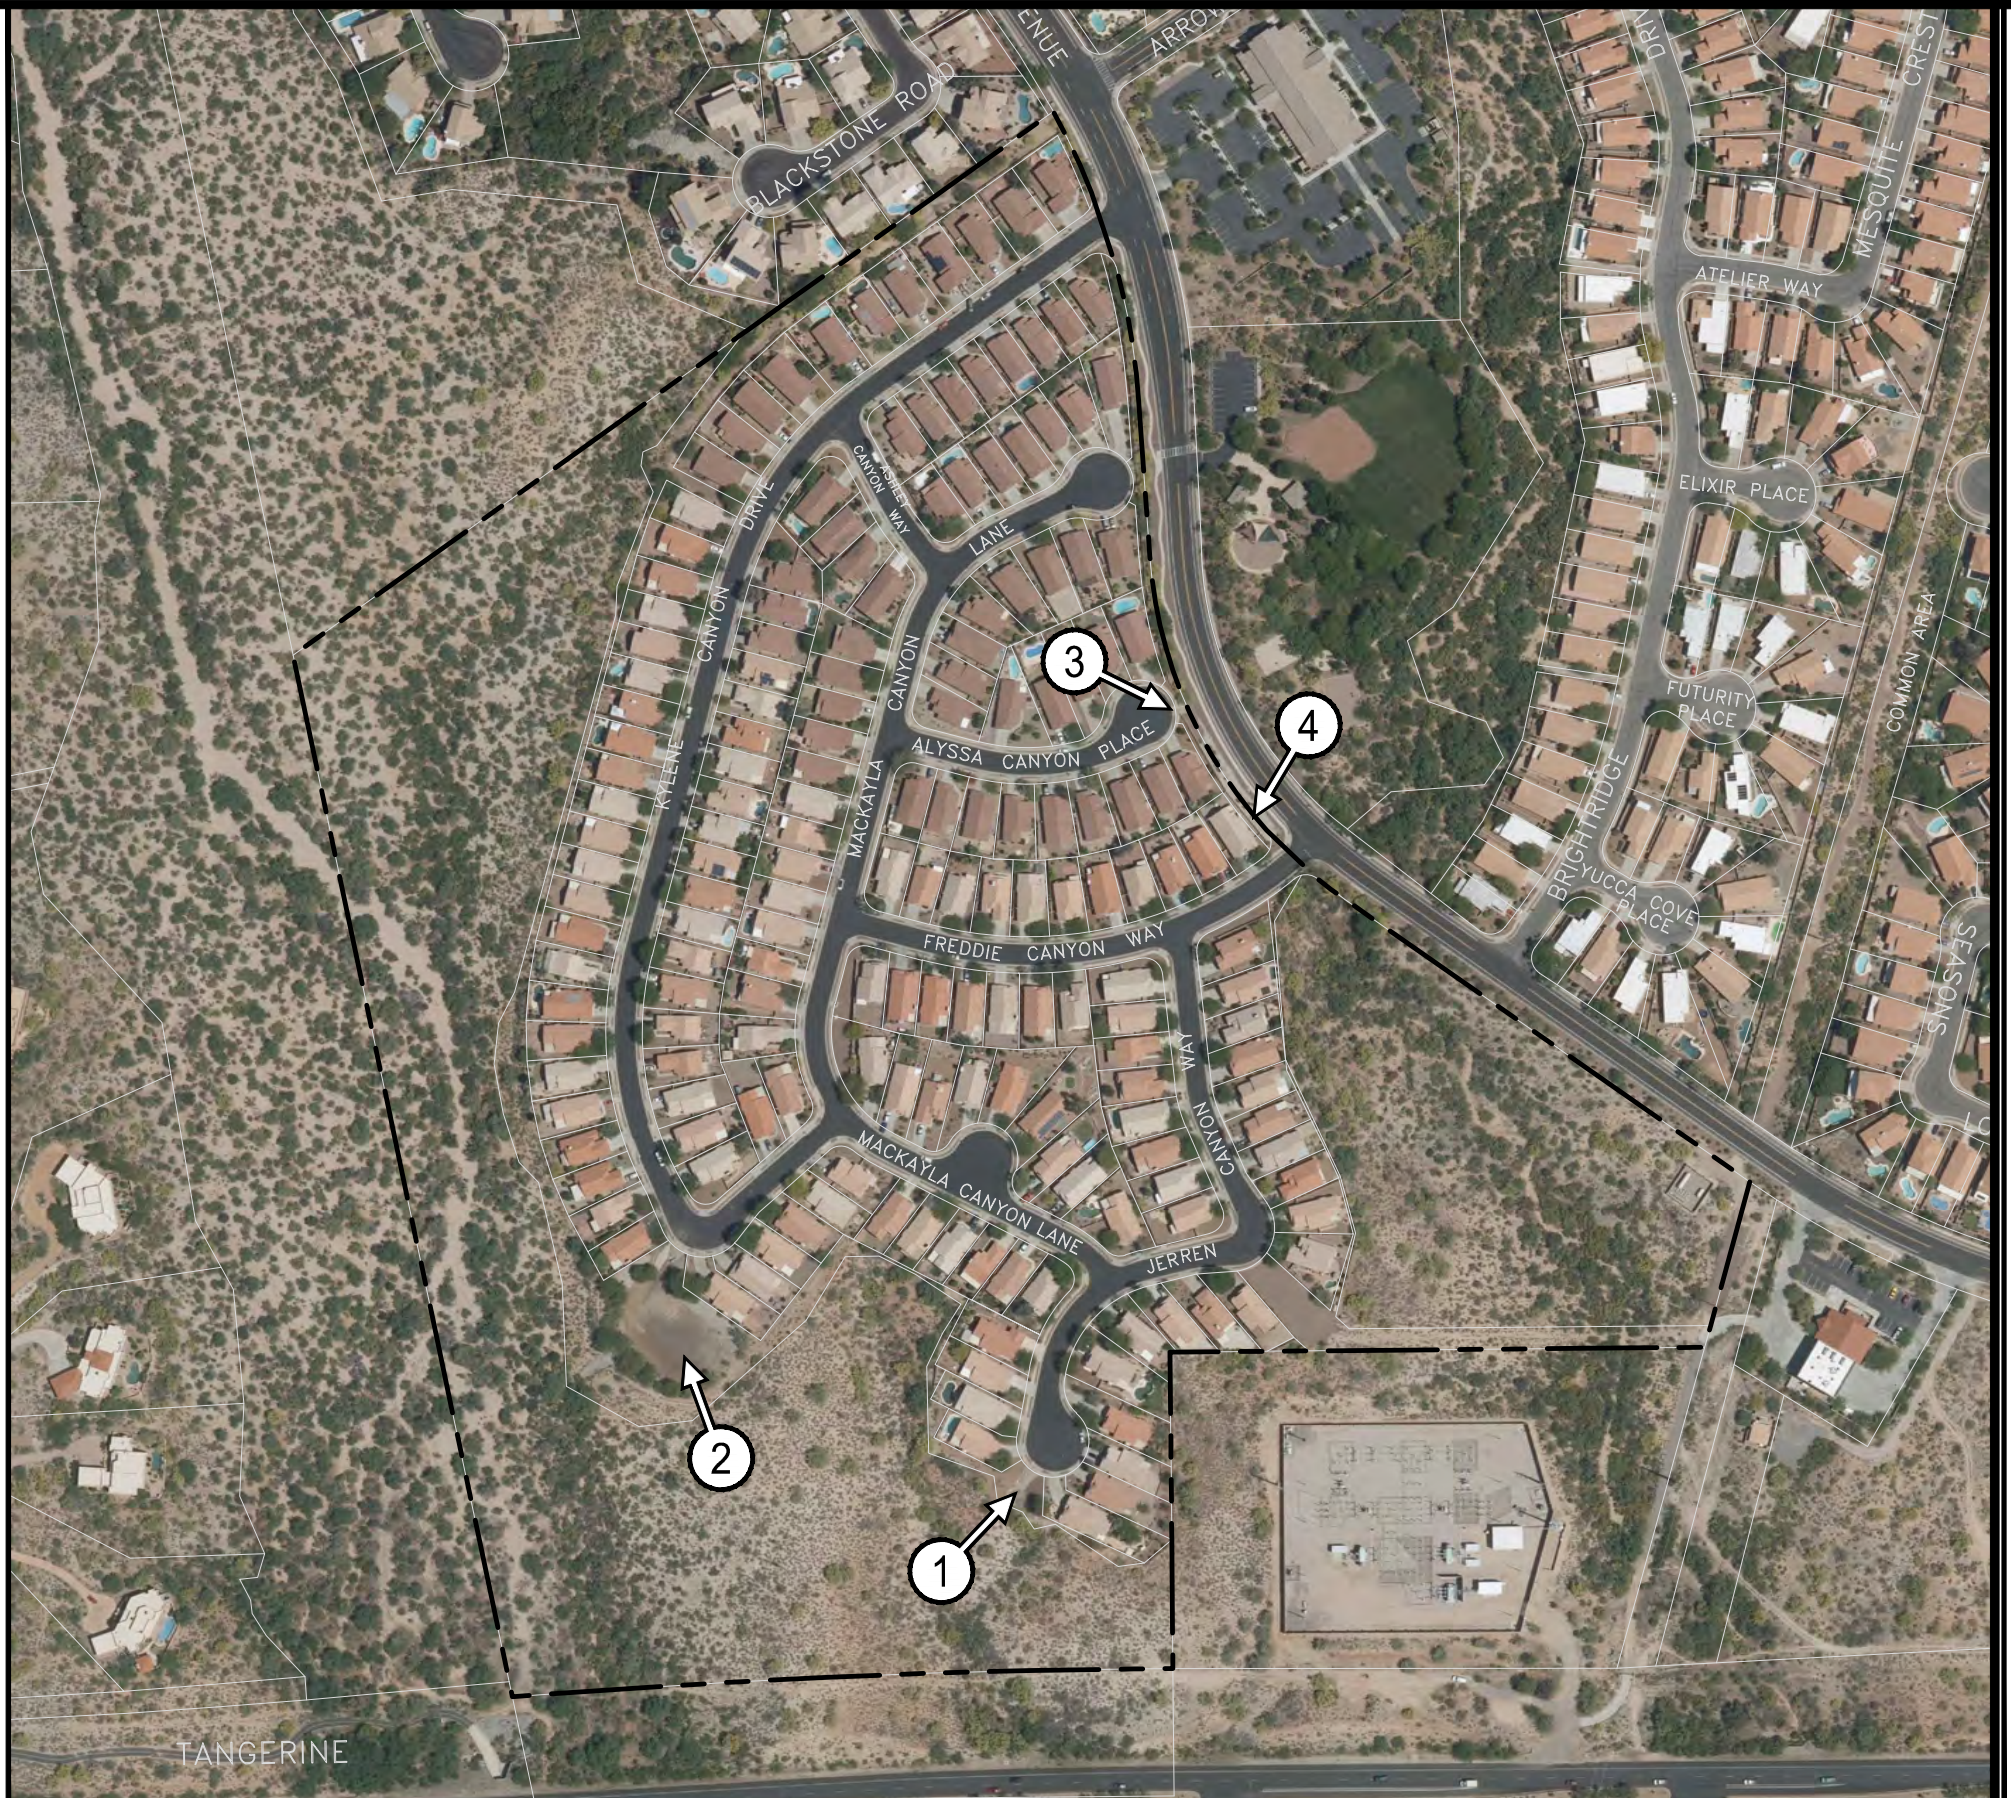
MAP 'OL' - THE OVERLOOK

RANCHO VISTOSO MASTER ASSOCIATION				
Subdivision/Facility ID	Date/Description	Field Observations	Priority	Recommendations
The Overlook (OL)	May 2020			PRIORITY: Red - Urgent, Blue - 0 to 6 months, Yellow - 6 to 12 months, Clear - Monitor
Site 1	Channel	Overall in good condition with thick vegetation at outlet		Remove overgrowth at outlet
Site 2	Detention/Retention Basin	Overall structure in good condition; inlet culvert is 1/3 blocked at grate ; outfall spillway in good condition		Remove grate covering at inlet, clean and reinstall grate
Site 3	Channel	Channel in good condition		
Site 4	Channel	Channel in good condition; heavy vegetative growth at downstream outlet		Remove overgrowth at outlet

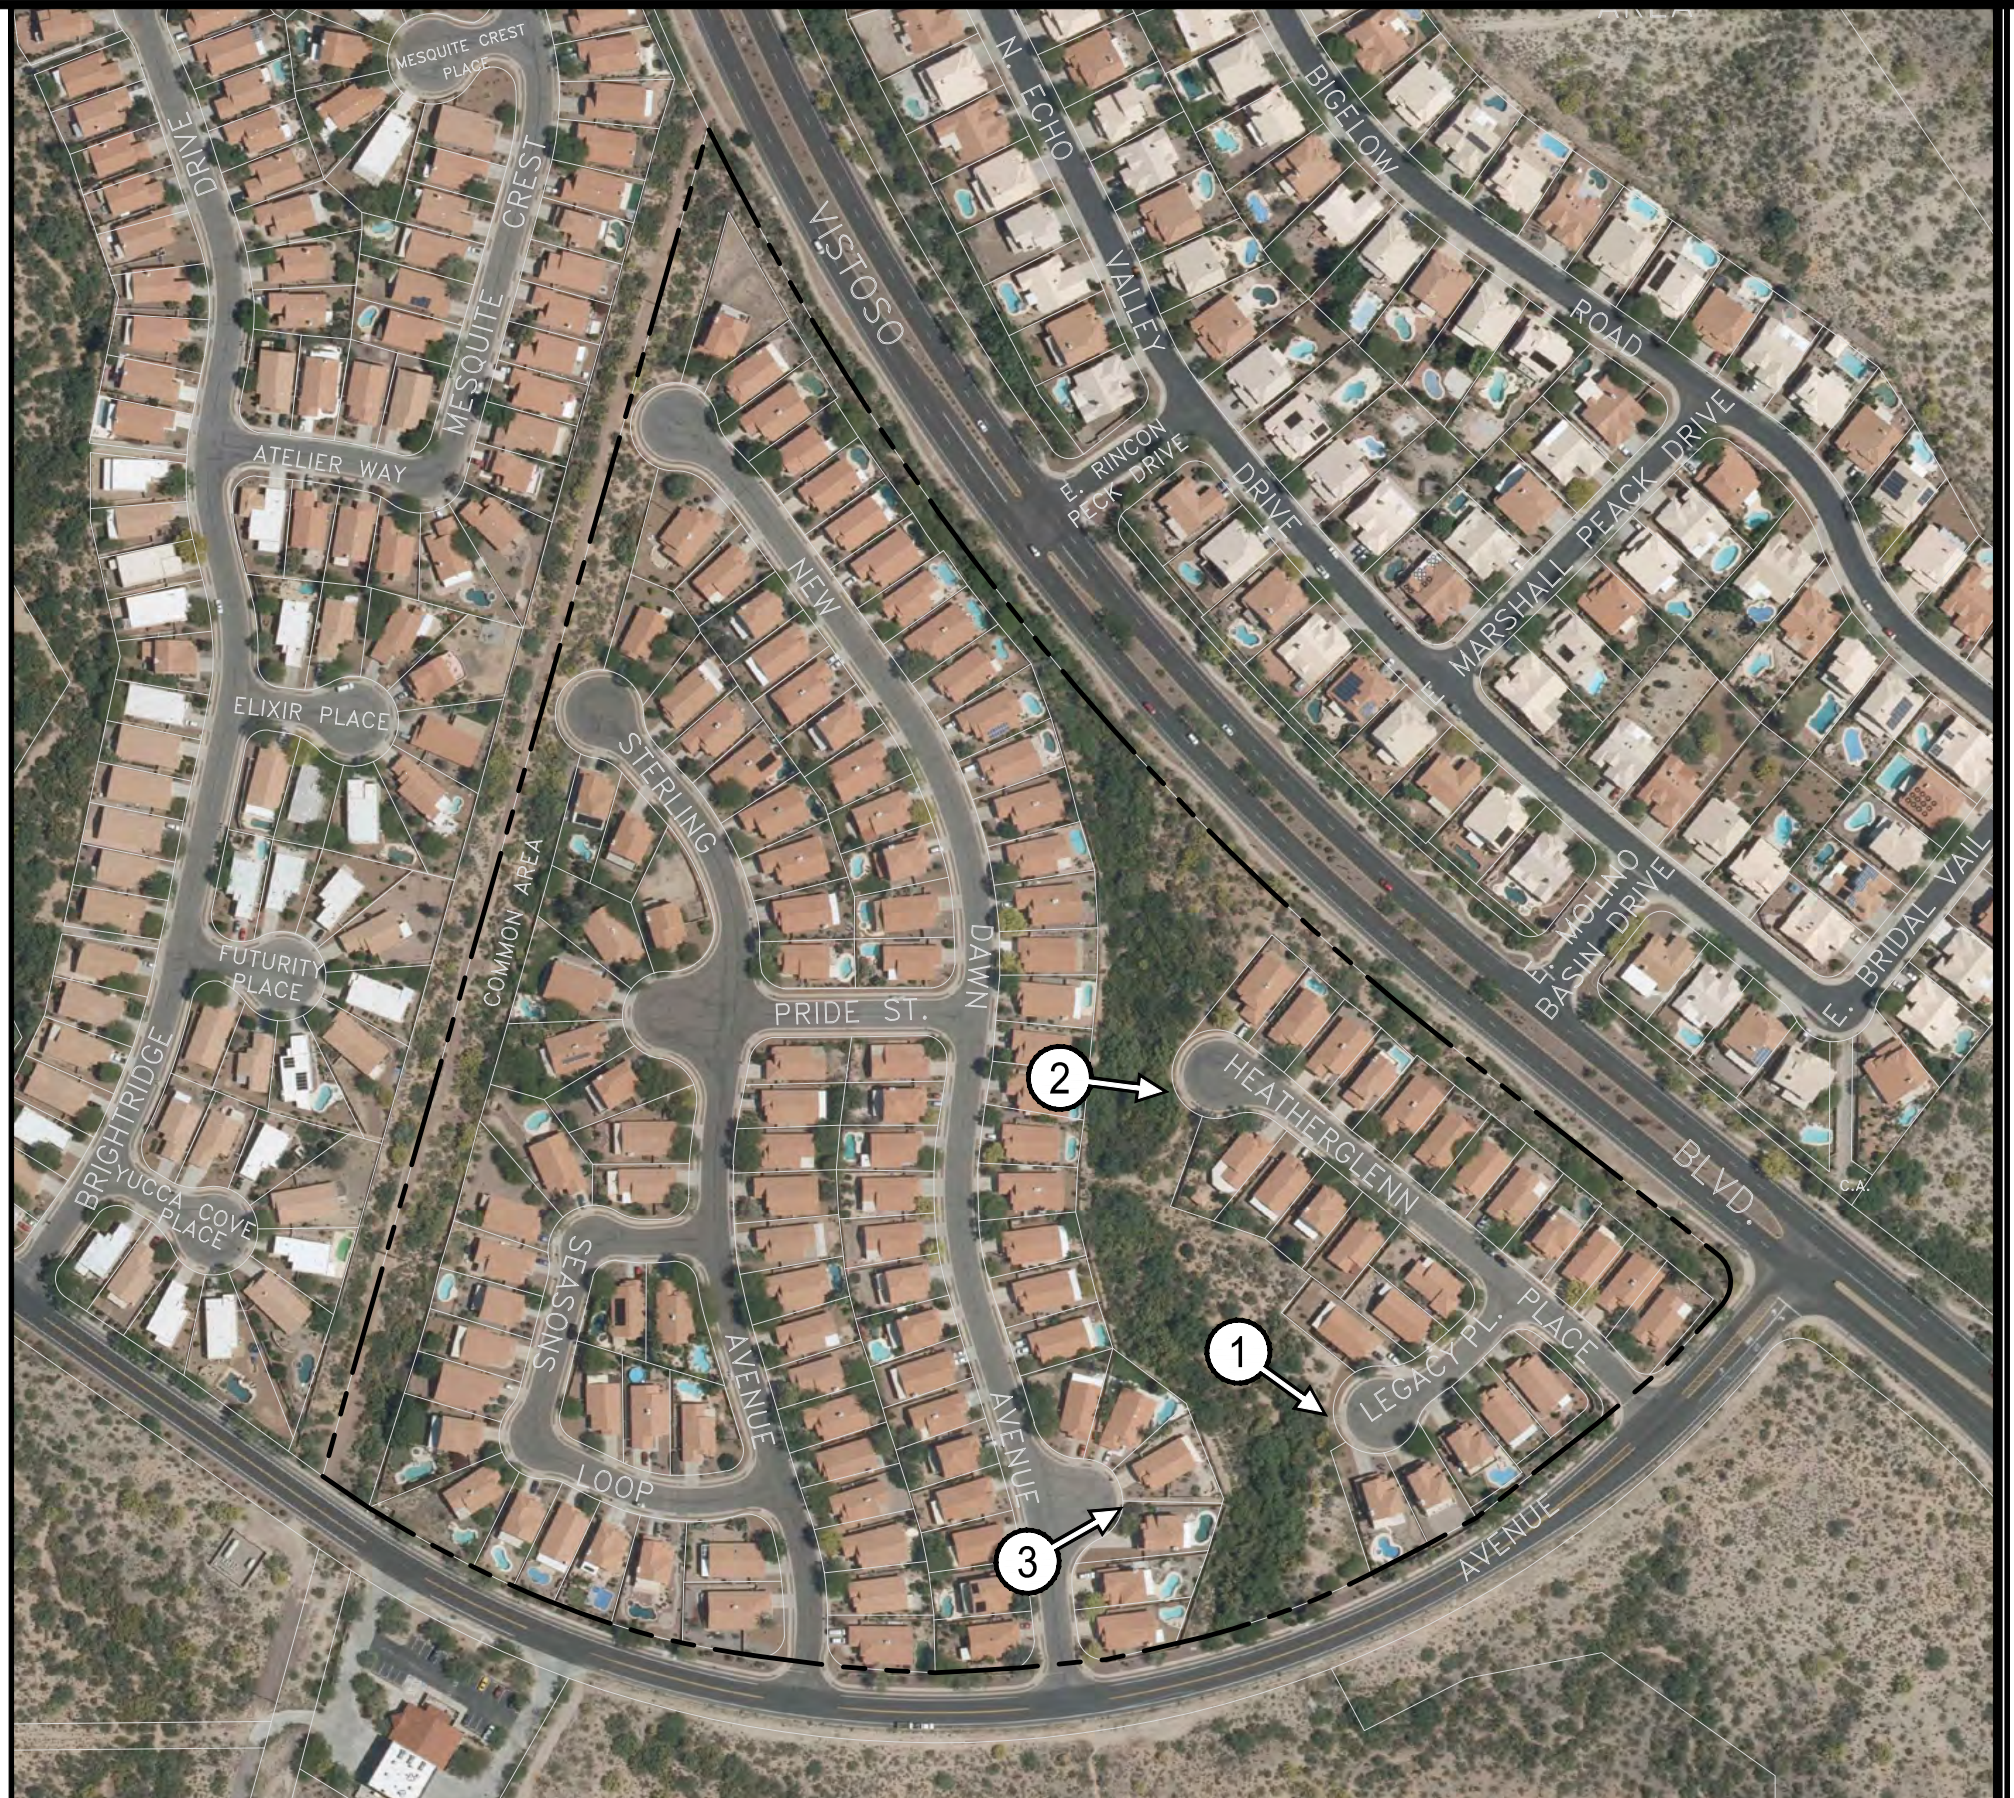
MAP 'RF' - REFLECTIONS

RANCHO VISTOSO MASTER ASSOCIATION - DRAINAGE INVENTORY - NOVEMBER 2020				
Subdivision/Facility ID	Date/Description	Field Observations	Priority	Recommendations
Reflections (RF)				PRIORITY: Red - Urgent, Blue - 0 to 6 months, Yellow - 6 to 12 months, Clear - Monitor
Site 1	May 2020/Spillway	Spillway in good condition with excess vegetative growth		Remove vegetation overgrowth
Site 2	May 2020/Spillway and Earthen Berm in Channel with Culvert (June 2020)	Spillway in good condition with excess vegetative growth/ In-line earthen berm in channel with culvert at bottom - very heavy vegetation and overgrown trees		Remove vegetation overgrowth in and around spillway; clean out culvert under berm as necessary, trim trees and remove excess vegetation around and on berm
Site 3	May 2020/Channel	Channel in good condition

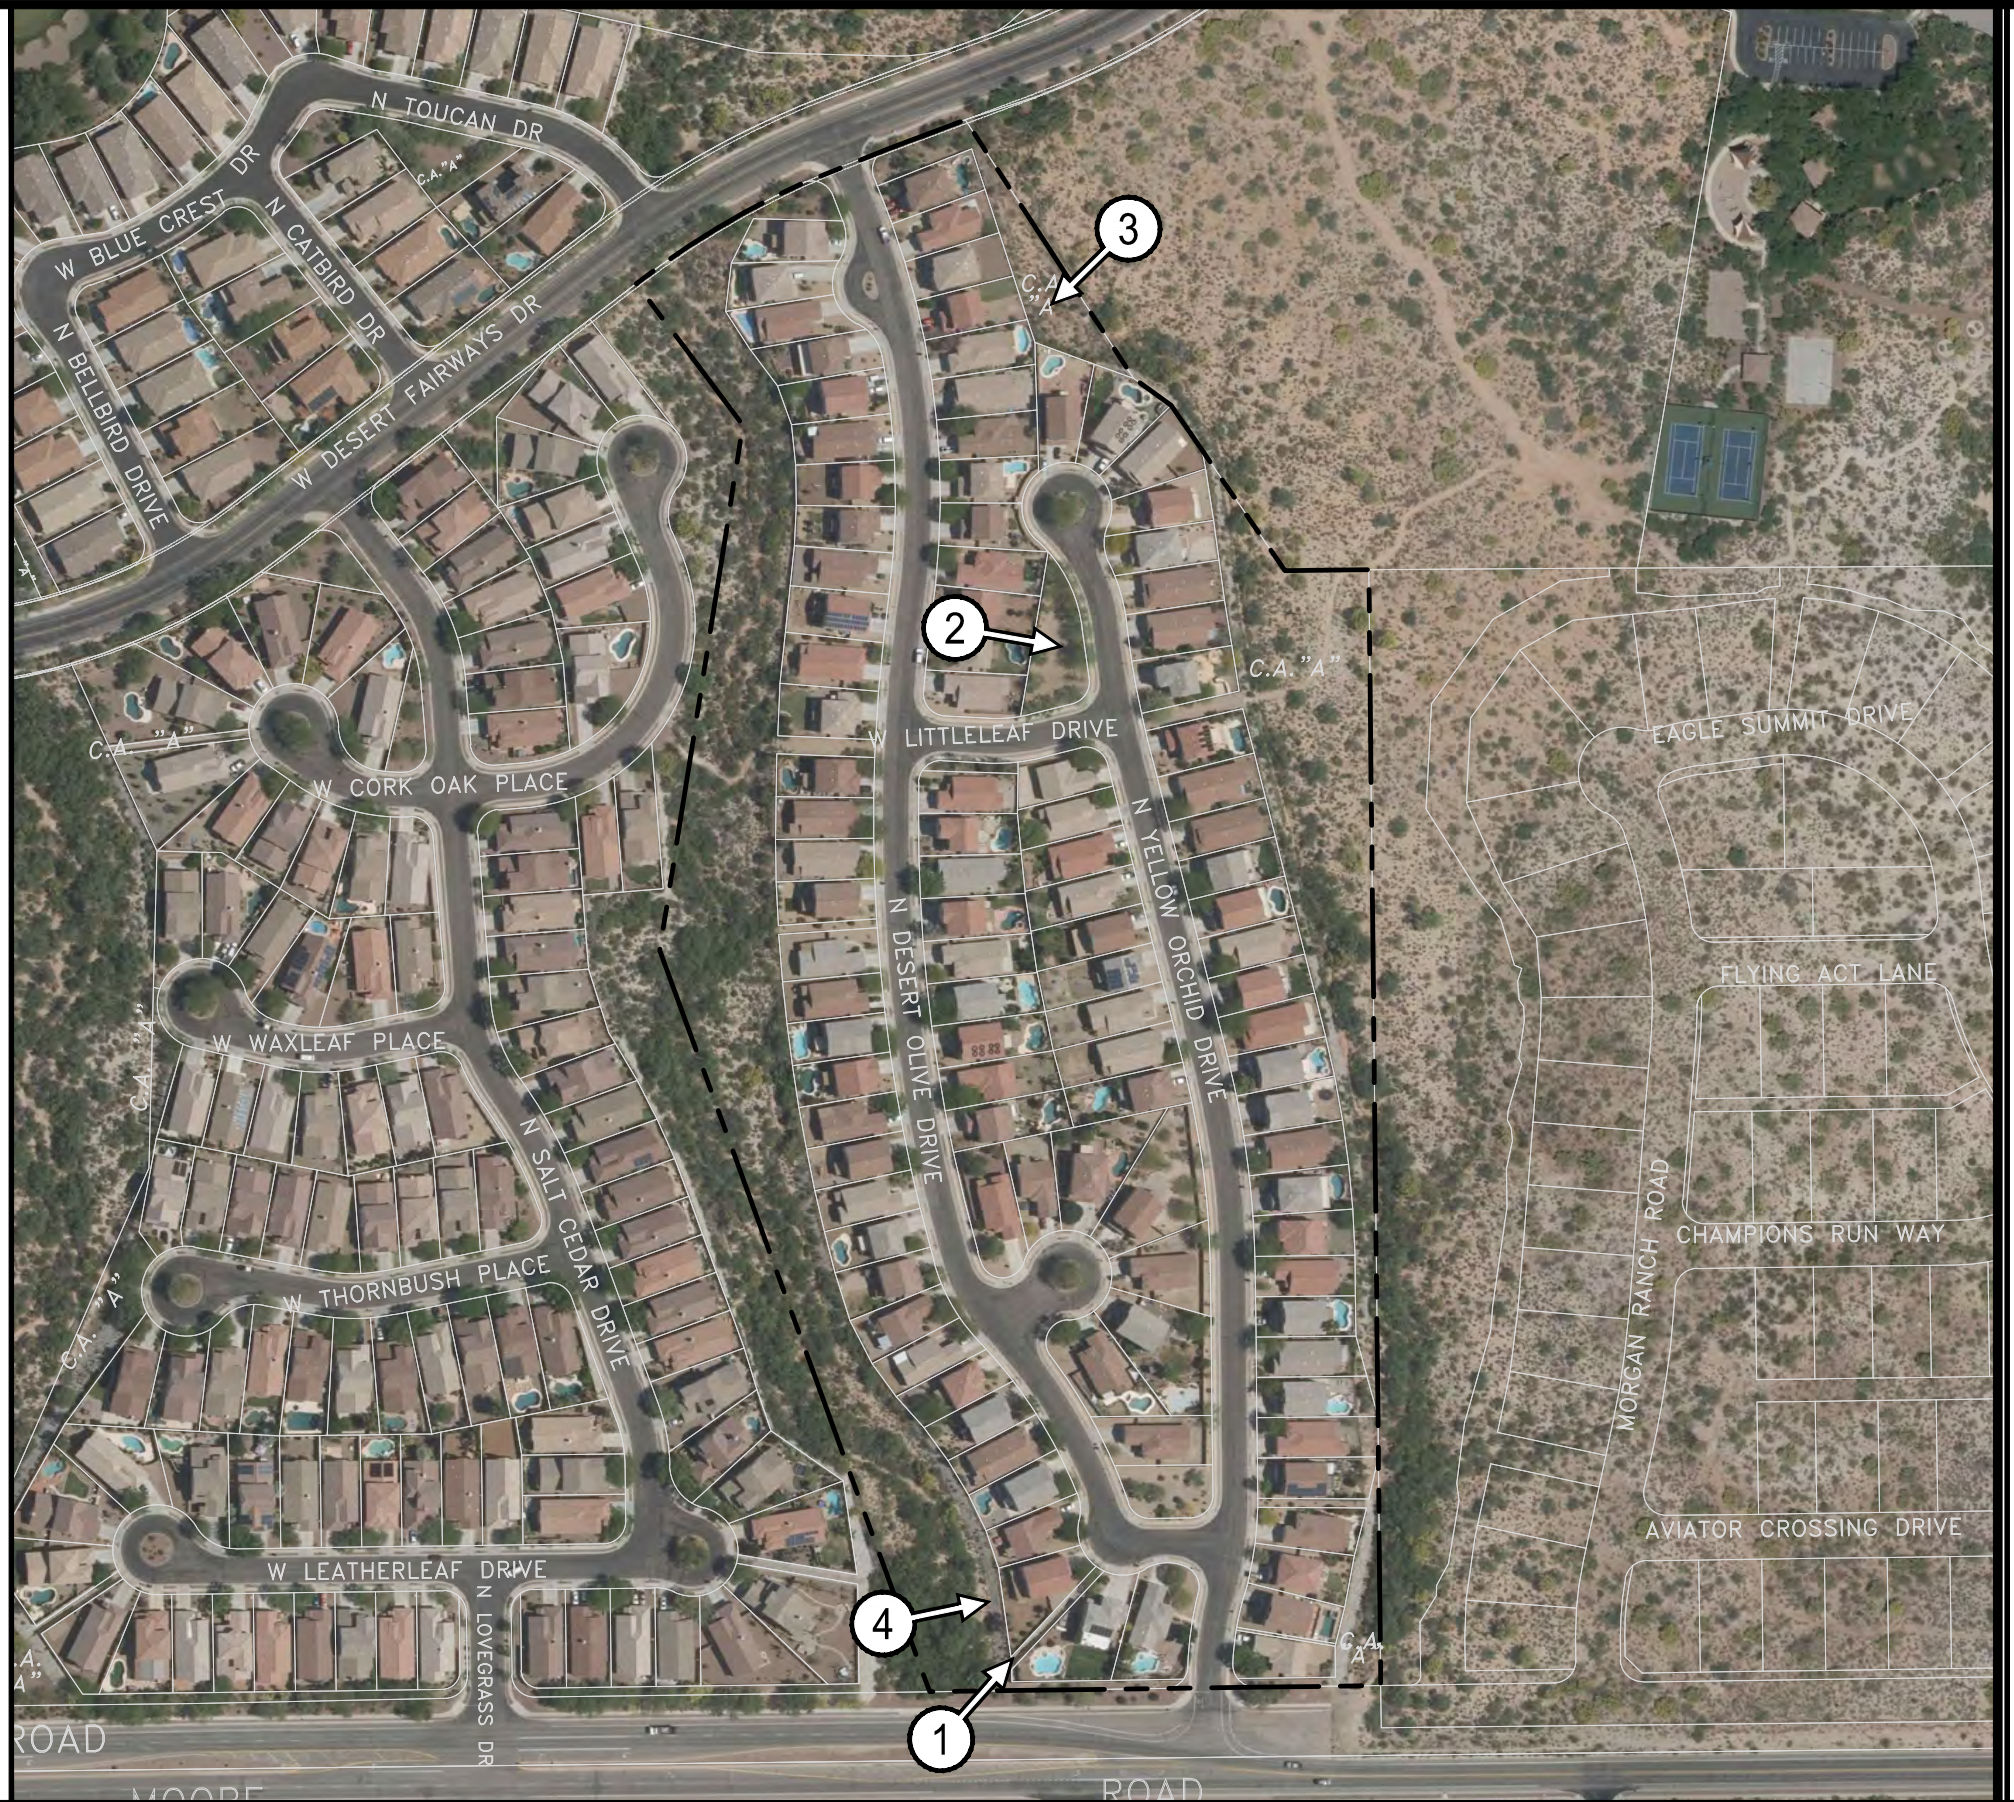
RANCHO VISTOSO MASTER ASSOCIATION - DRAINAGE INVENTORY - NOVEMBER 2020				
Subdivision/Facility ID	Date/Description	Field Observations	Priority	Recommendations
St. Andrews II (S2)	May 2020			PRIORITY: Red - Urgent, Blue - 0 to 6 months, Yellow - 6 to 12 months, Clear - Monitor
Site 1	Channel	Channel in fair condition with some rock out of place and additional sediment/debris; outlet in fair condition with some rip rap failure and erosion		Repair channel; remove sediment and debris
Site 2	Detention/Retention Basin	Basin and outlet structure in good condition		
Site 3	Common Area (Basin)	Heavy vegetation		Thin out the excess vegetation
Site 4	August 2020/Channel with Rip-Rap Slope Protection	Channel in good condition with thick vegetation along rip-rap slope		Thin out the excess vegetation

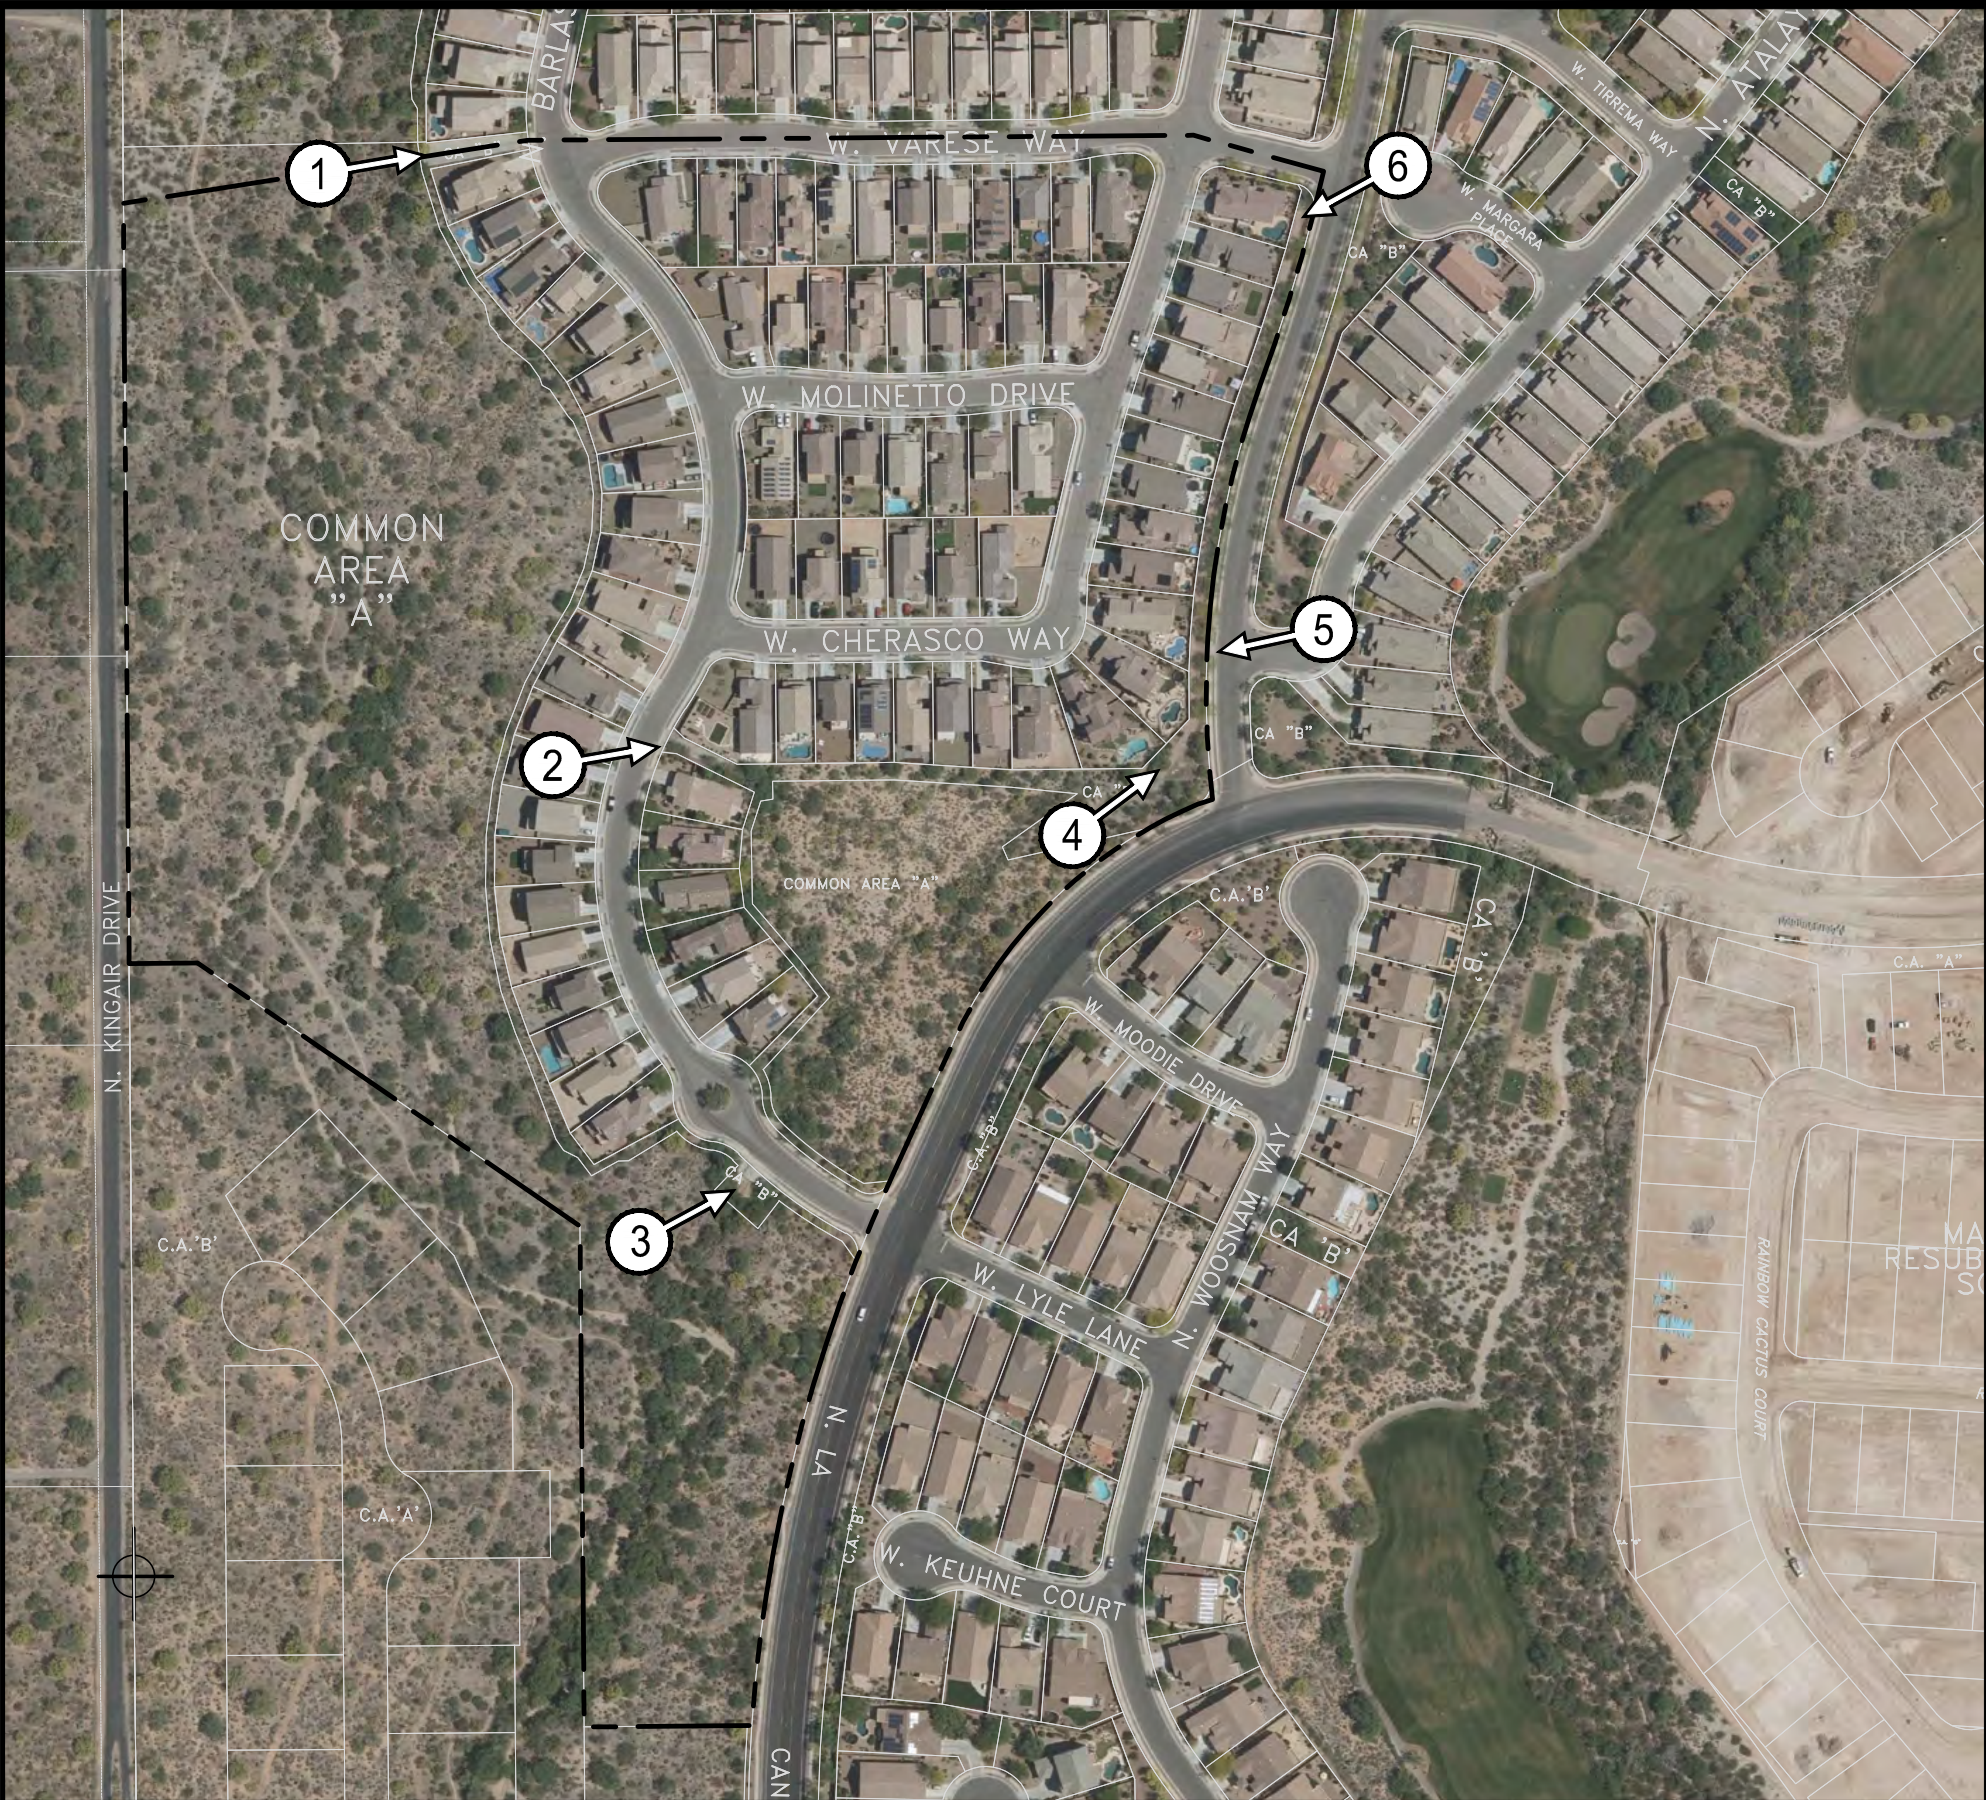
MAP 'SF' - STONEFIELD

RANCHO VISTOSO MASTER ASSOCIATION				
Subdivision/Facility ID	Date/Description	Field Observations	Priority	Recommendations
Stonefield (SF)	June 2020			PRIORITY: Red - Urgent, Blue - 0 to 6 months, Yellow - 6 to 12 months, Clear - Monitor
Site 1	Scupper/Channel	Upstream scupper good, downstream scupper has sediment build-up; channel in good condition with vegetative overgrowth at outlet		Clean out sediment and remove excess overgrowth
Site 2	Scupper/Channel	Upstream scupper good, downstream scupper has sediment build-up; channel contains sediment and debris and vegetative overgrowth at outlet		Clean out sediment/debris and remove excess overgrowth
Site 3	Scupper/Channel	Scupper and slope in good condition; channel has vegetative overgrowth at both upstream and downstream ends		Remove excess overgrowth
Site 4	Channel	Channel in good condition; minor debris		
Site 5	Culvert	Culvert - broken at downstream end		Repair or replace culvert

Site 6	Channel/Culvert	Both structures in good condition
