FINAL 11-16-20

MAP 'AA' - AREAS WITHIN ASSOCIATION RESPONSIBILITY

RANCHO VISTOSO COMMUNITY ASSOCIATION - DRAINAGE FACILITIES INVENTORY MAP 'ES' - EAGLE SUMMIT

2020.03.xx
WLB No. 185050-V-A06

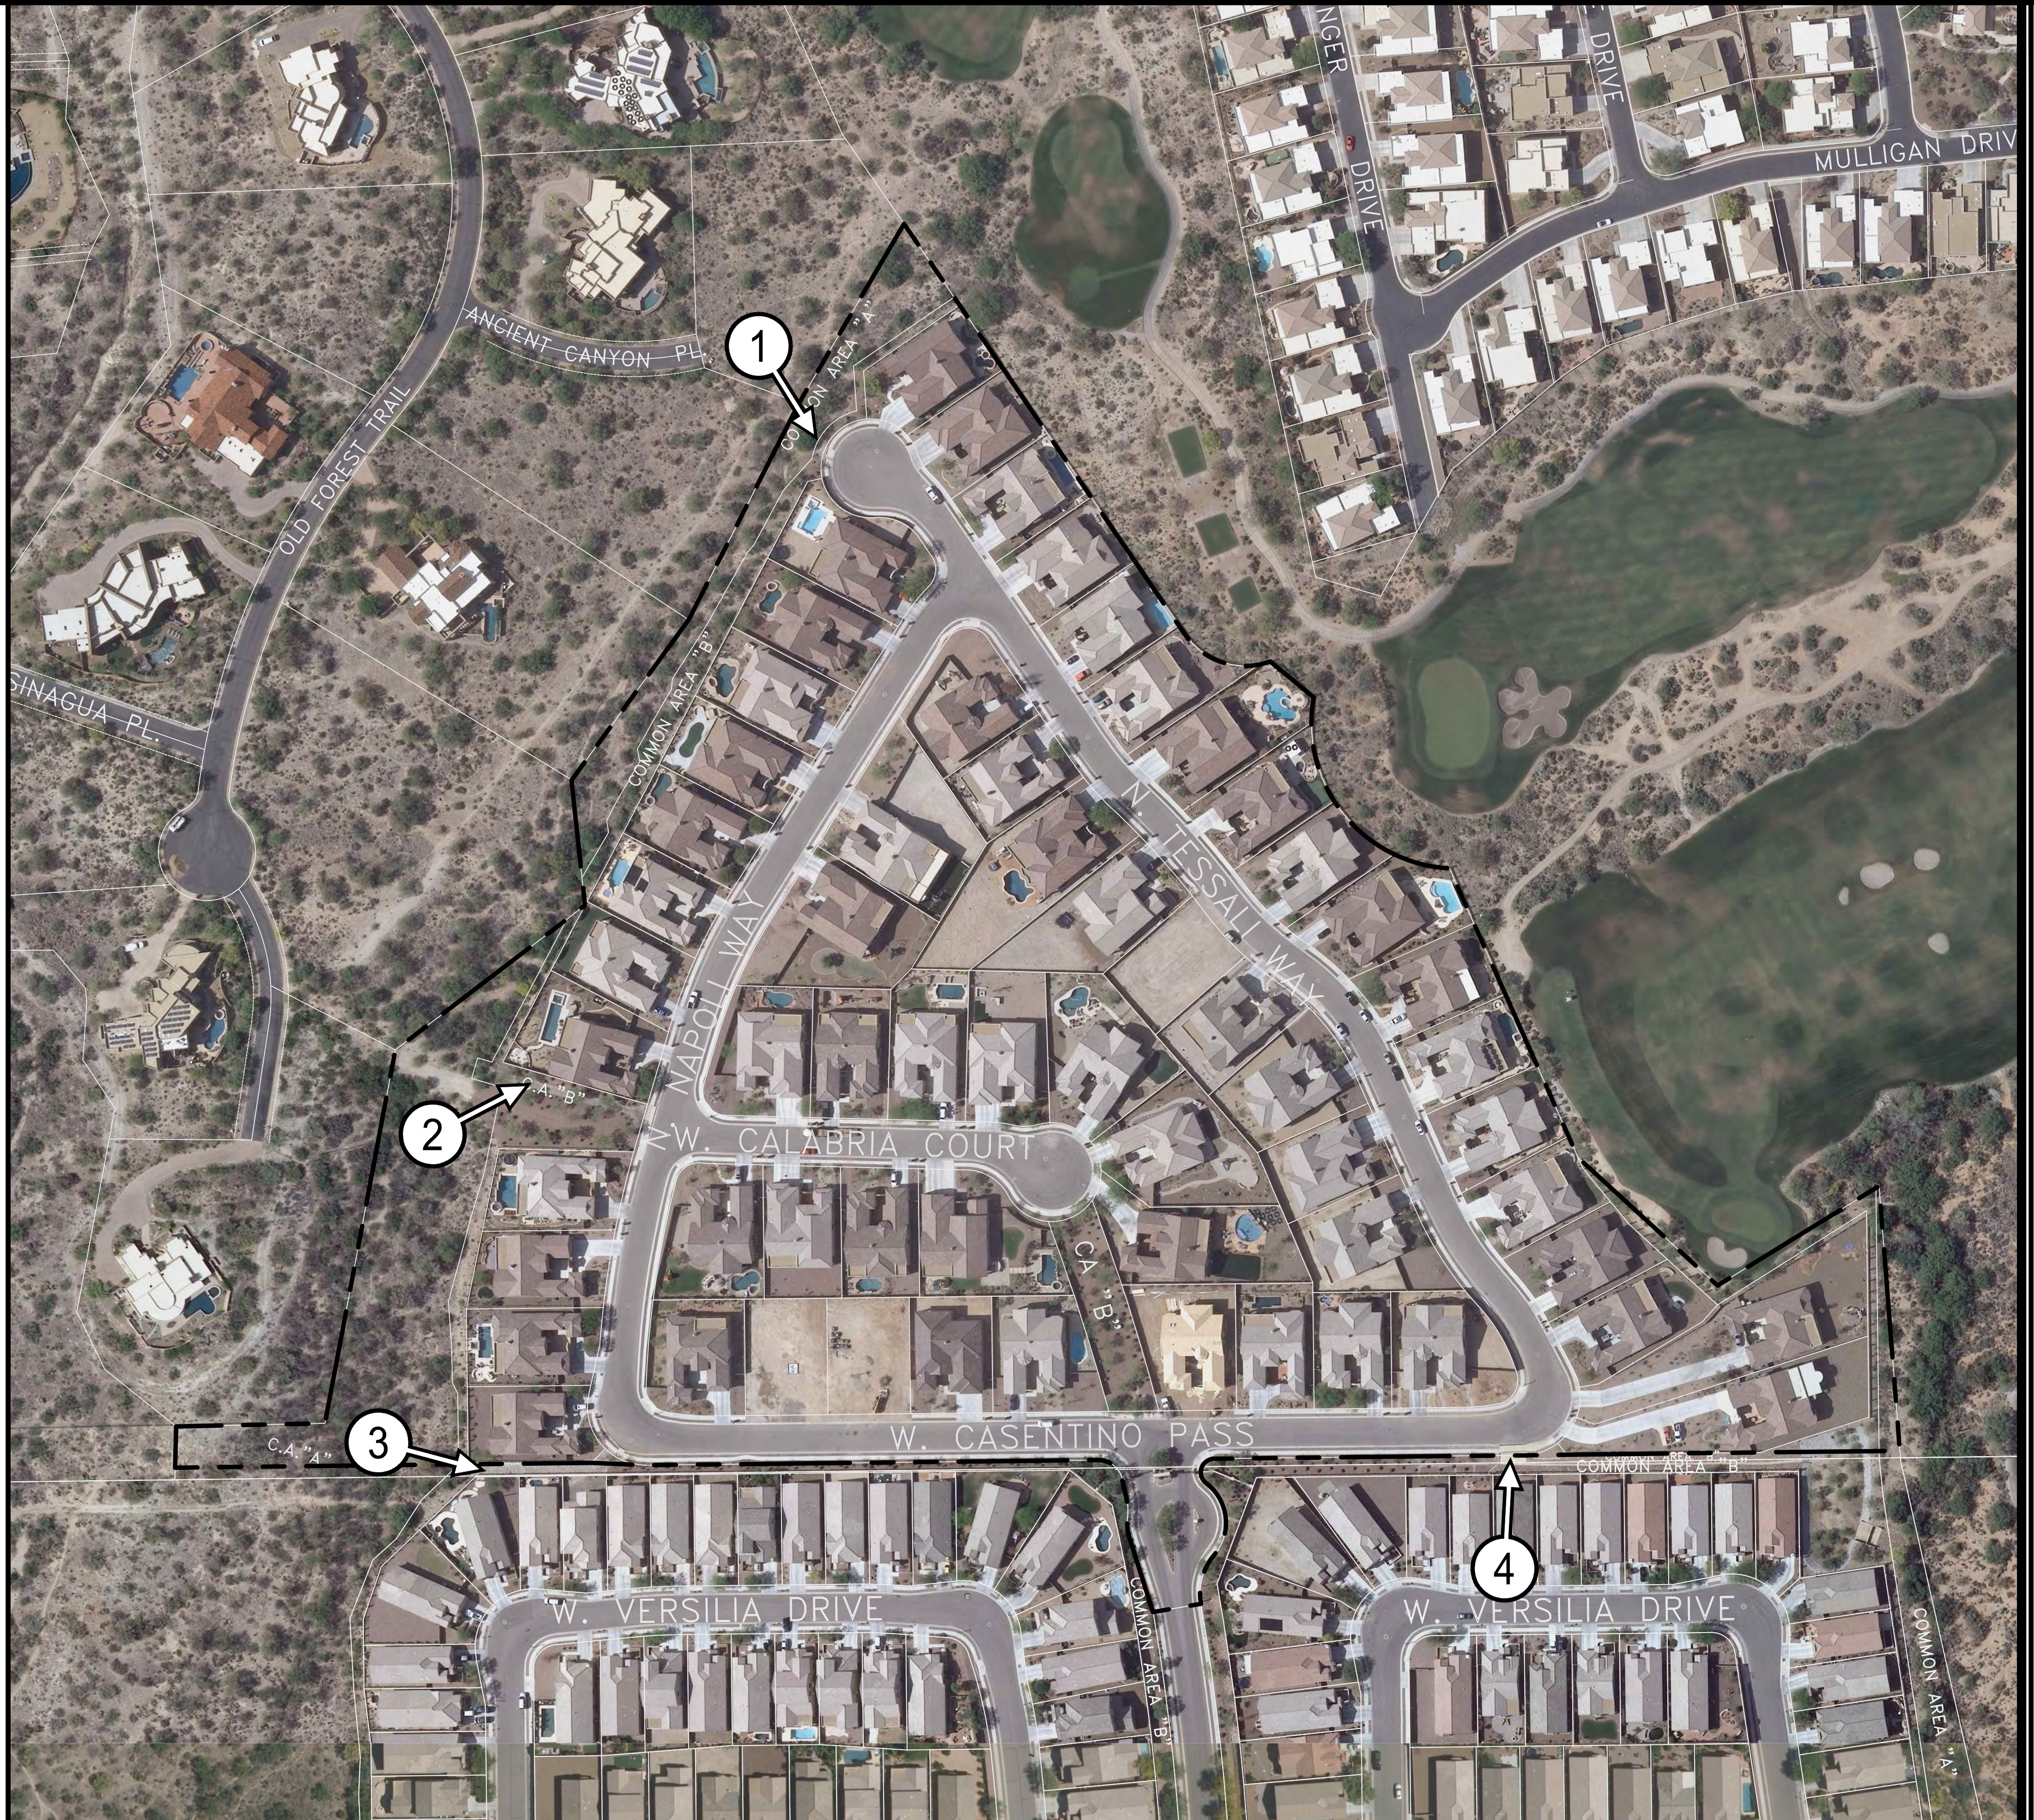
RANCHO VISTOSO MASTER ASSOCIATION - DRAINAGE INVENTORY - NOVEMBER 2020				
Subdivision/Facility ID	Date/Description	Field Observations	Priority	Recommendations
Siena (SN)	June 2020			PRIORITY: Red - Urgent, Blue - 0 to 6 months, Yellow - 6 to 12 months, Clear - Monitor
Site 1	Spillway	Upstream rock in good condition; downstream outlet heavy with vegetative overgrowth		Thin out the excess vegetation
Site 2	Scupper/Channel	Both structures in good condition; outlet has some vegetative overgrowth		Thin out the excess vegetation
Site 3	Scupper/Channel	Both strucures in good condition with sediment build-up at outlet along with thick vegetative overgrowth		Clean sediment from outlet and remove excess vegetation
Site 4	Sept 20/Scupper, Channel, Basin (CT#9)	Scupper and channel in good condition - drains to Basin (CT #9), outlet from channel obstructed with heavy vegetation		Clear vegetation at channel outlet into Basin CT #9

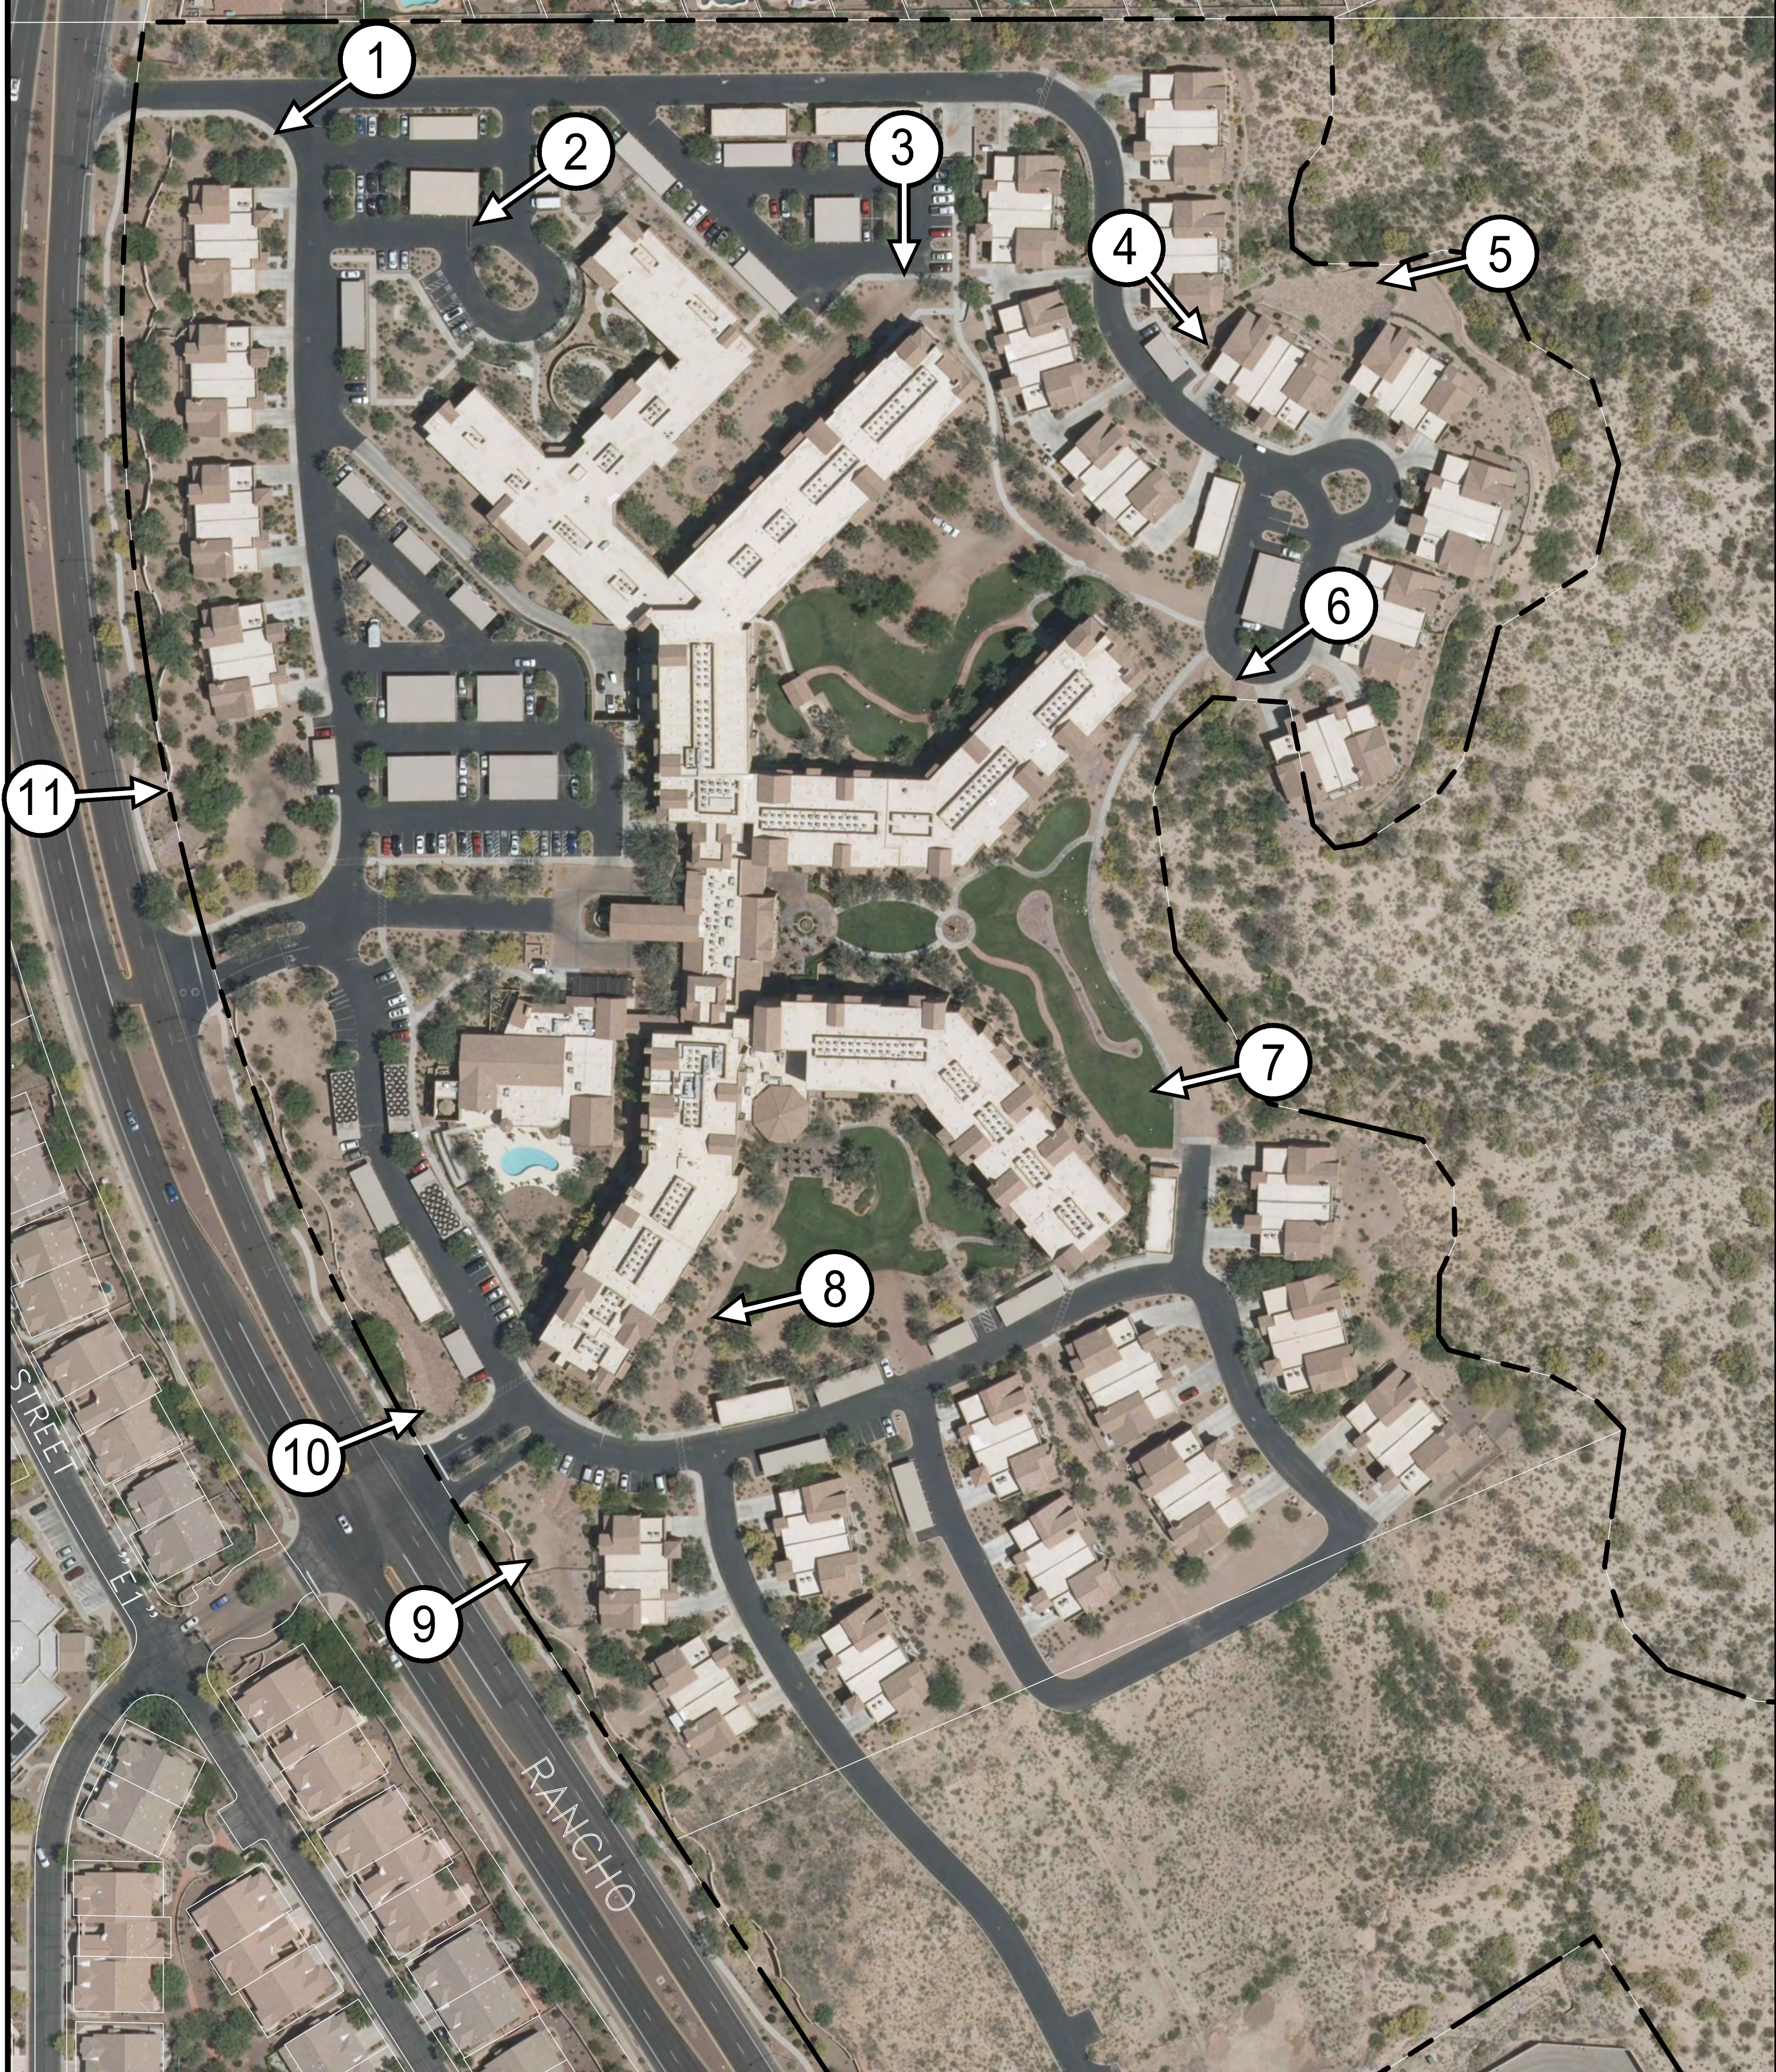
RANCHO VISTOSO MASTER ASSOCIATION - DRAINAGE INVENTORY - NOVEMBER 2020				
Subdivision/Facility ID	Date/Description	Field Observations	Priority	Recommendations
Splendido (SP)	June 2020			PRIORITY: Red - Urgent, Blue - 0 to 6 months, Yellow - 6 to 12 months, Clear - Monitor
Site 1	Detention/Retention Basin	Facility in good condition		
Site 2	Inlet grate	Grate in good condition		
Site 3	Sidewalk opening	Structure in good condition		
Site 4	August 2020/ Channel	Drains to Basin (#5) - good condition		
Site 5	Detention/Retention Basin	Facility in good condition		
Site 6	Inlets (3 locations)	All in good condition with minor debris and excess vegetation at outlets		Remove excess vegetation
Site 7	Detention/Retention Basin/Swale	Strucures in good condition		
Site 8	Detention/Retention Basin Inlets	All inlets in good condition		
SP-09	Detention/Retention Basin	Facility in good condition		
Site 10	Detention/Retention Basin	Facility in good condition

Site 11	Detention/Retention Basin and Inlets	Facility in good condition

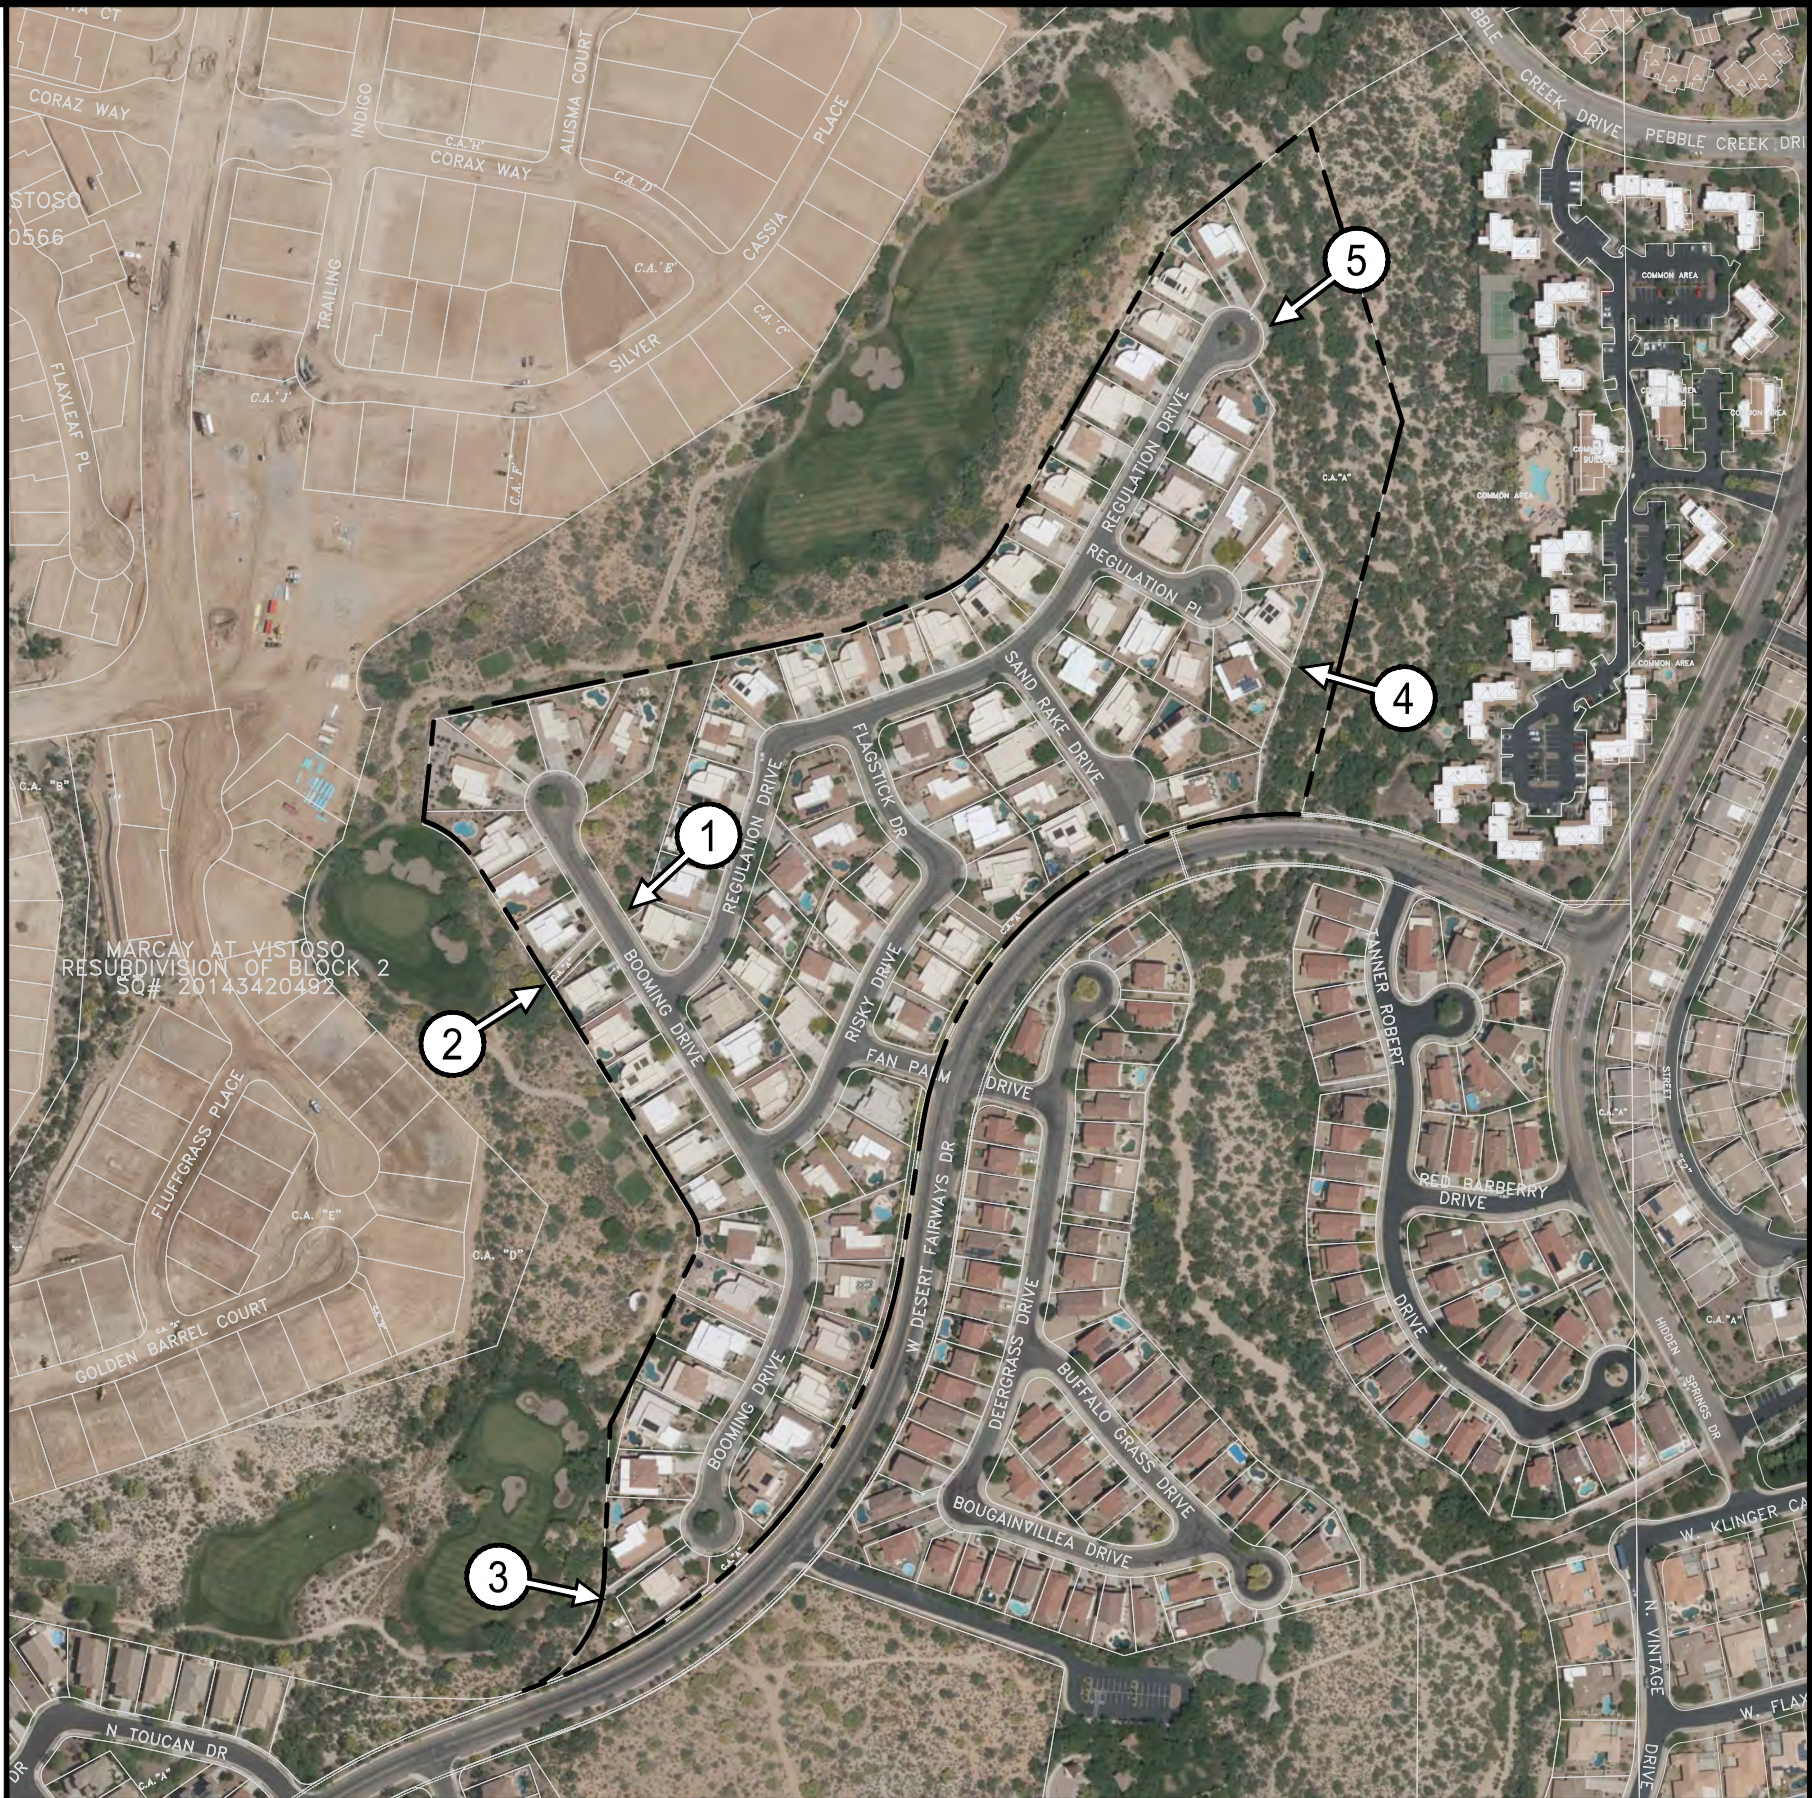
RANCHO VISTOSO MASTER ASSOCIATION				
Subdivision/Facility ID	Date/Description	Field Observations	Priority	Recommendations
Stone Terrace (ST)	March 2020			PRIORITY: Red - Urgent, Blue - 0 to 6 months, Yellow - 6 to 12 months, Clear - Monitor
Site 1	Culvert Inlet	Culvert inlet contains vegetative overgrowth; headwalls have some damage		Repair damage and remove excess overgrowth
Site 2	Culvert Outlet/Channel	Culvert outlet clear, minor sediment within channel		
Site 3	Grate Inlet/ Channel/Culvert	Minor sediment within channel; culvert inlets clear		
Site 4	Depressed Curb/Channel	Curb opening clear; minor sediment in channel		
Site 5	Depressed Curb	Curb opening clear; minor sediment within splash pad

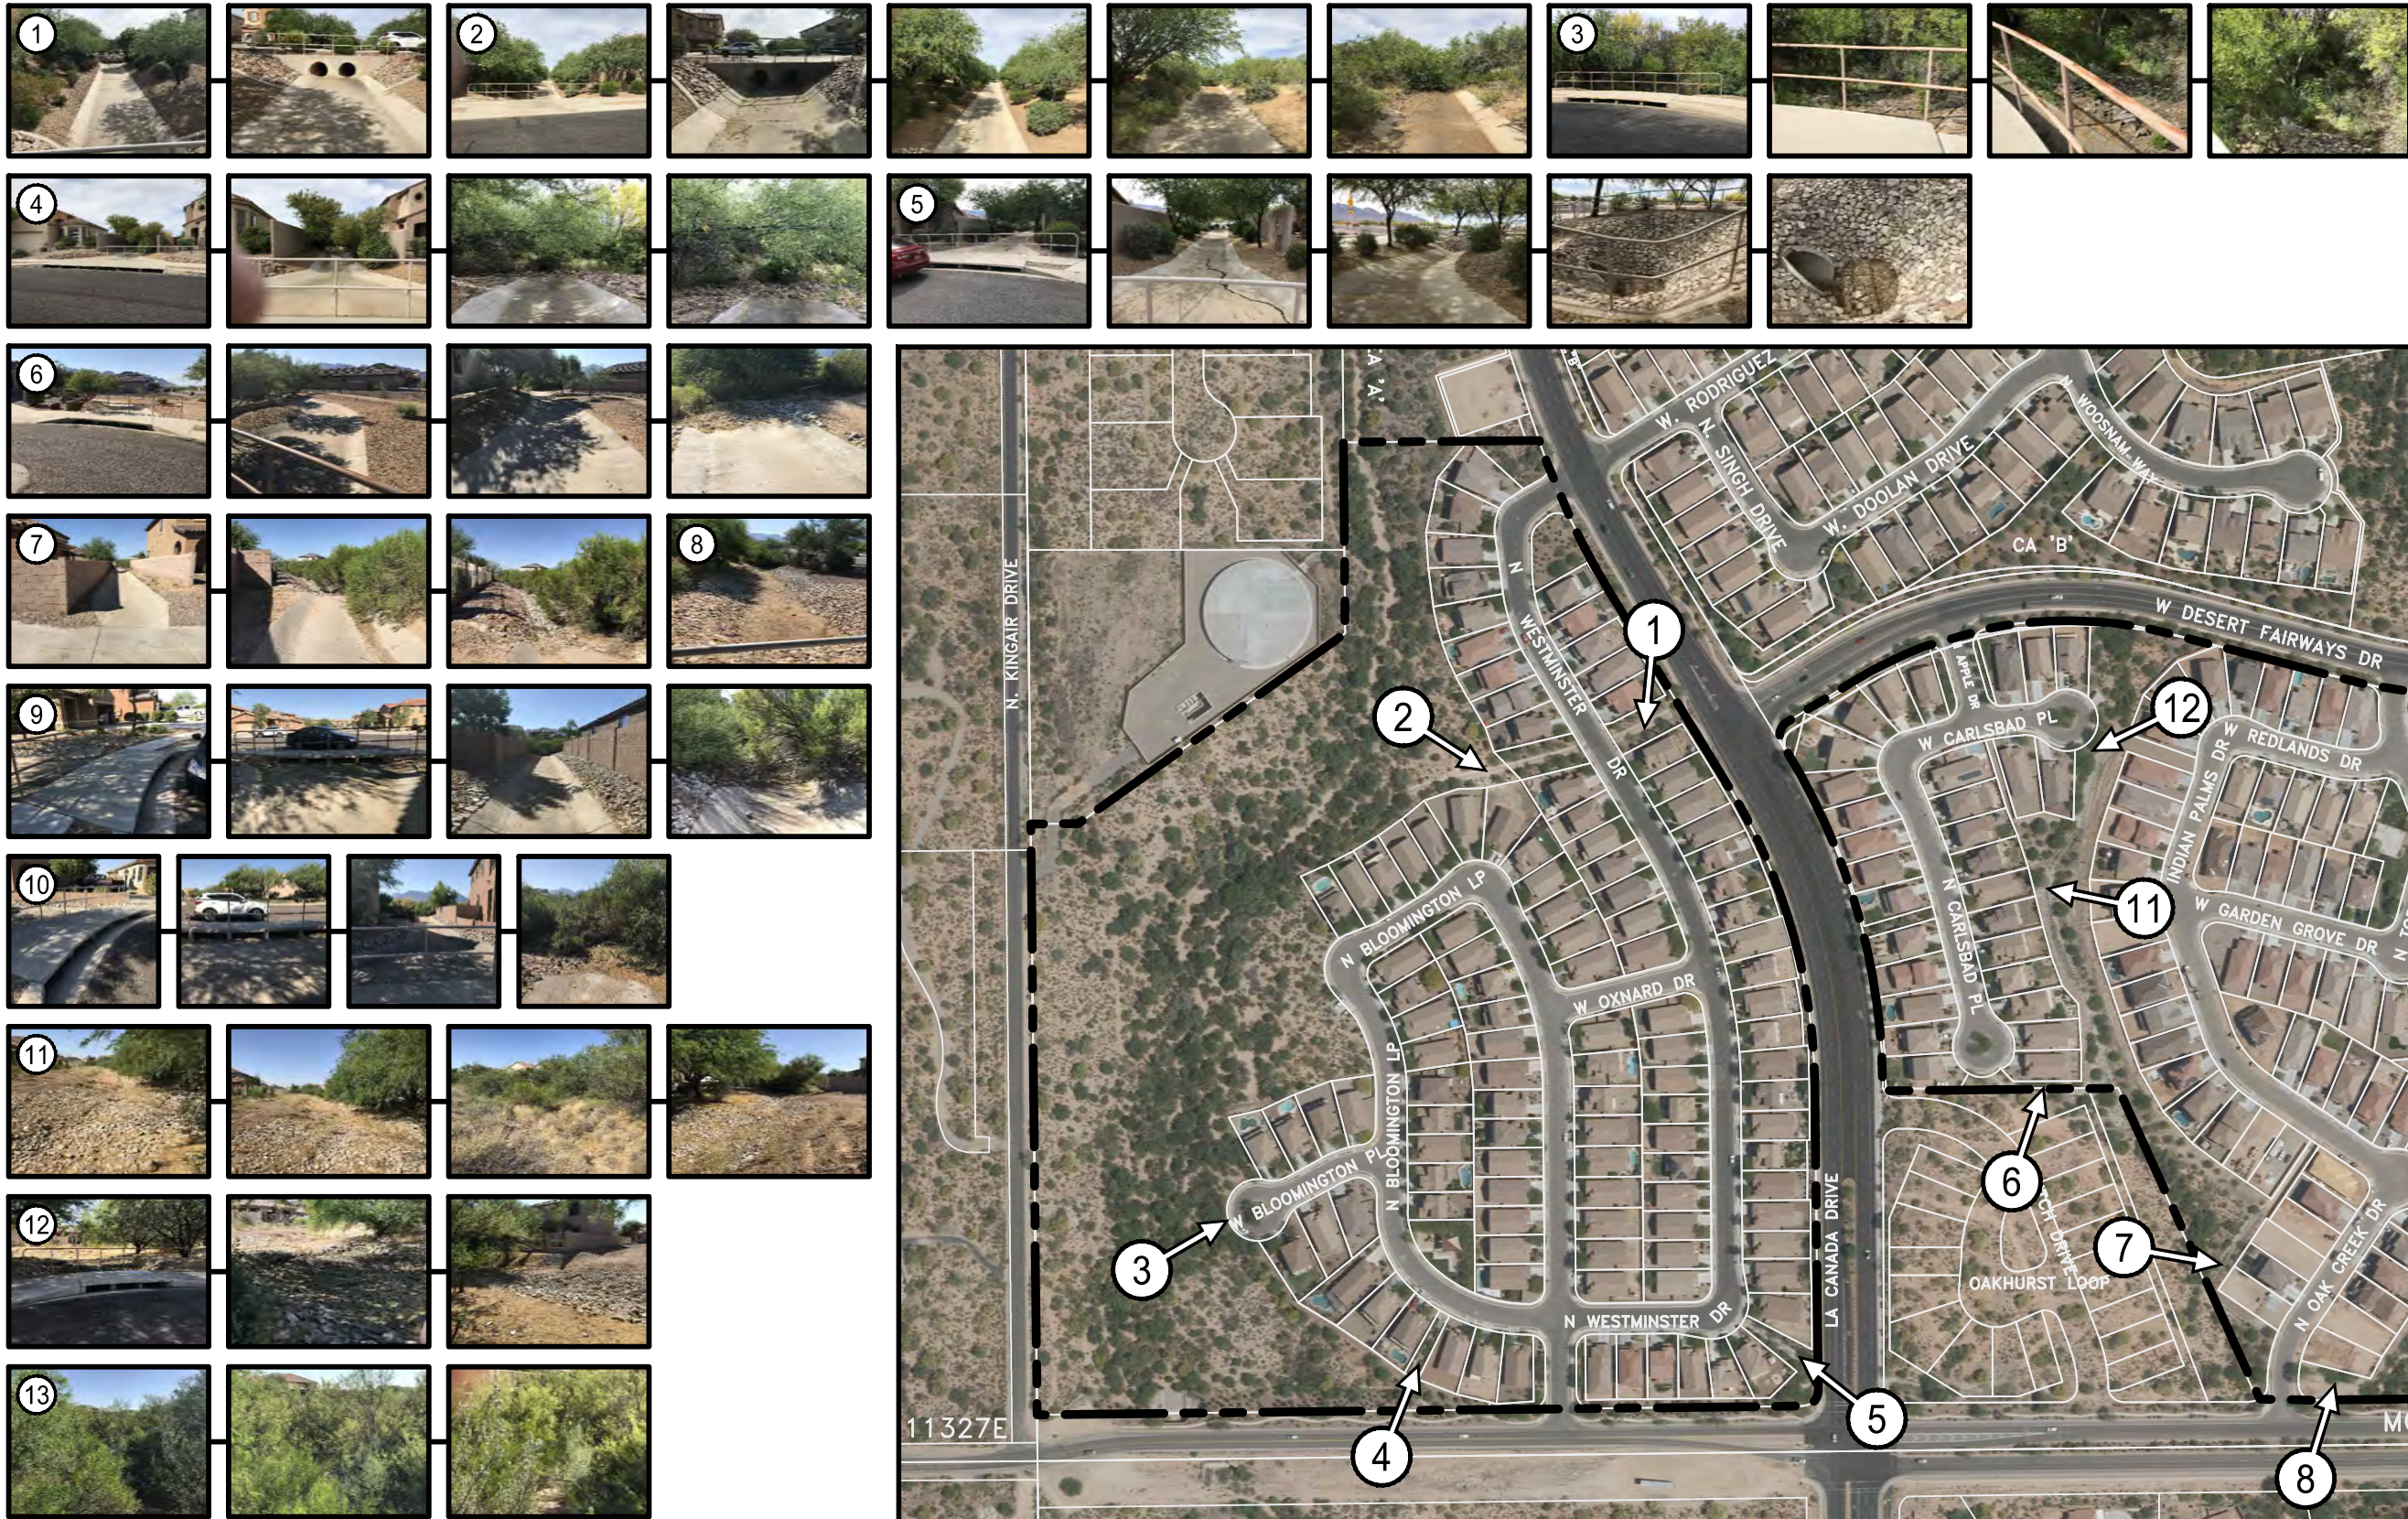
RANCHO VISTOSO MASTER ASSOCIATION - DRAINAGE INVENTORY - NOVEMBER 2020				
Subdivision/Facility ID	Date/Description	Field Observations	Priority	Recommendations
Sonoran Vistas (SV)	May 2020			PRIORITY: Red - Urgent, Blue - 0 to 6 months, Yellow - 6 to 12 months, Clear - Monitor
Site 1	Channel	Entrance in good condition; downstream has erosion and vegetative overgrowth		Repair erosion issues and remove excess overgrowth
Site 2	Spillway	Spillway in good condition; downstream exit point has thick vegetation overgrowth		Remove excess overgrowth
Site 3	Channel	Entrance in fair condition; downstream channel has erosion/head cutting (right bank has erosion and head cutting also), exit point has thick vegetative overgrowth		Repair channel and right bank; remove excess vegetation at exit
Site 4	August 2020/Culvert Outlets, Scour Basin	Culvert outlets and scour basin have recently been cleared of heavy vegetation; culverts to be cleared of sediment build-up in near future		Scour basin and immediate downstream channel to be re-designed and re-established/constructed (WLB and AAA)

Site 5	Channel to Wash	Minor sediment in manmade channel; at the outlet to natural wash, rip rap collapse with erosion and excess vegetation overgrowth		Repair rip rap and remove excess vegetation
SV-06	Channel to Wash	Minor sediment in manmade channel; at the outlet to natural wash, erosion at headwall, rip rap failing, channel eroding and heavy vegetation in the natural wash		Repair erosion issues and rip rap; remove excess vegetation

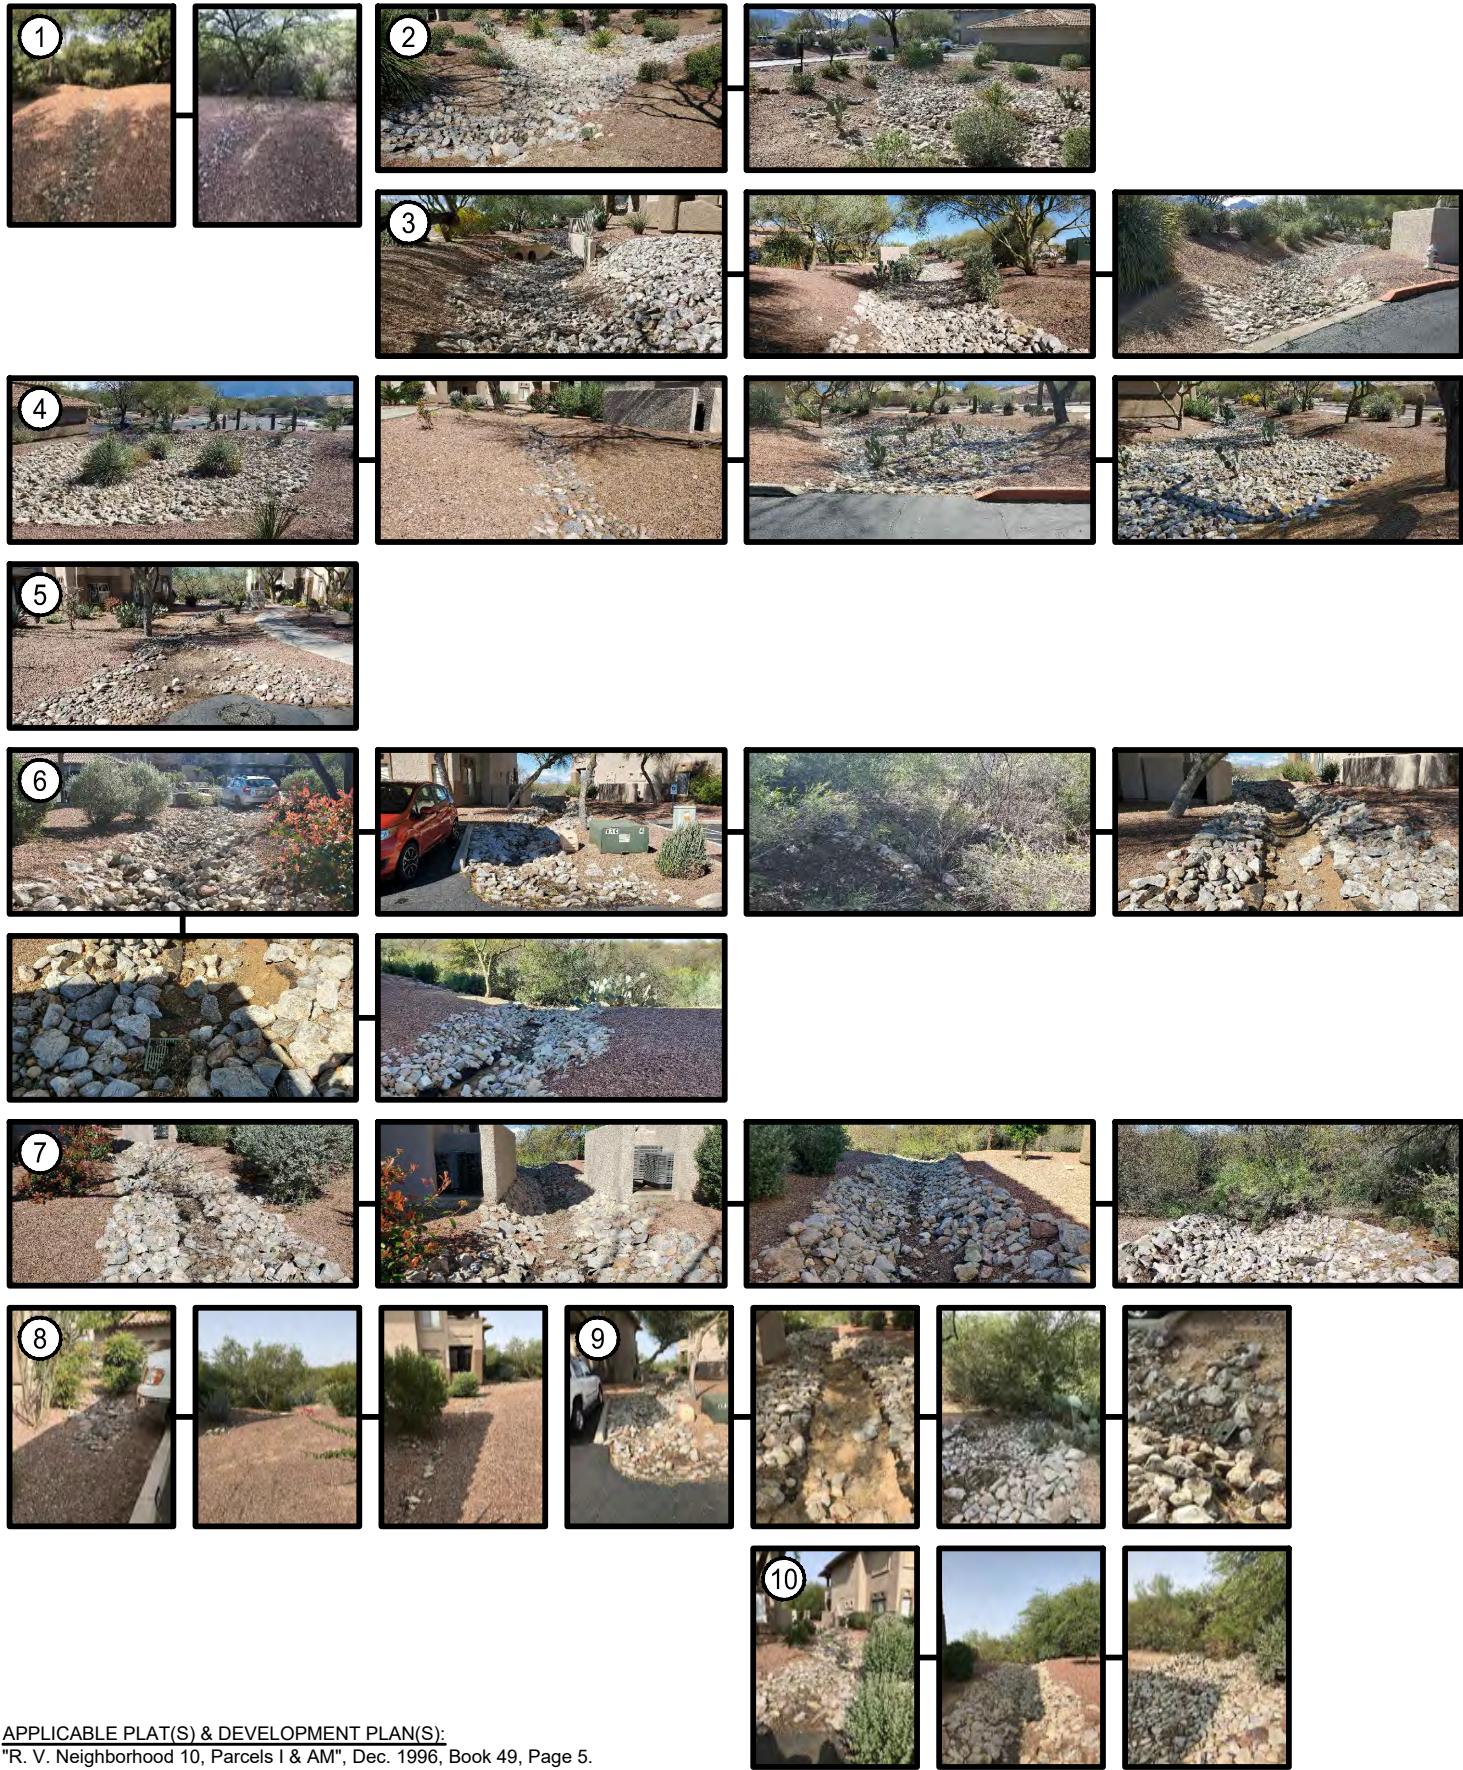
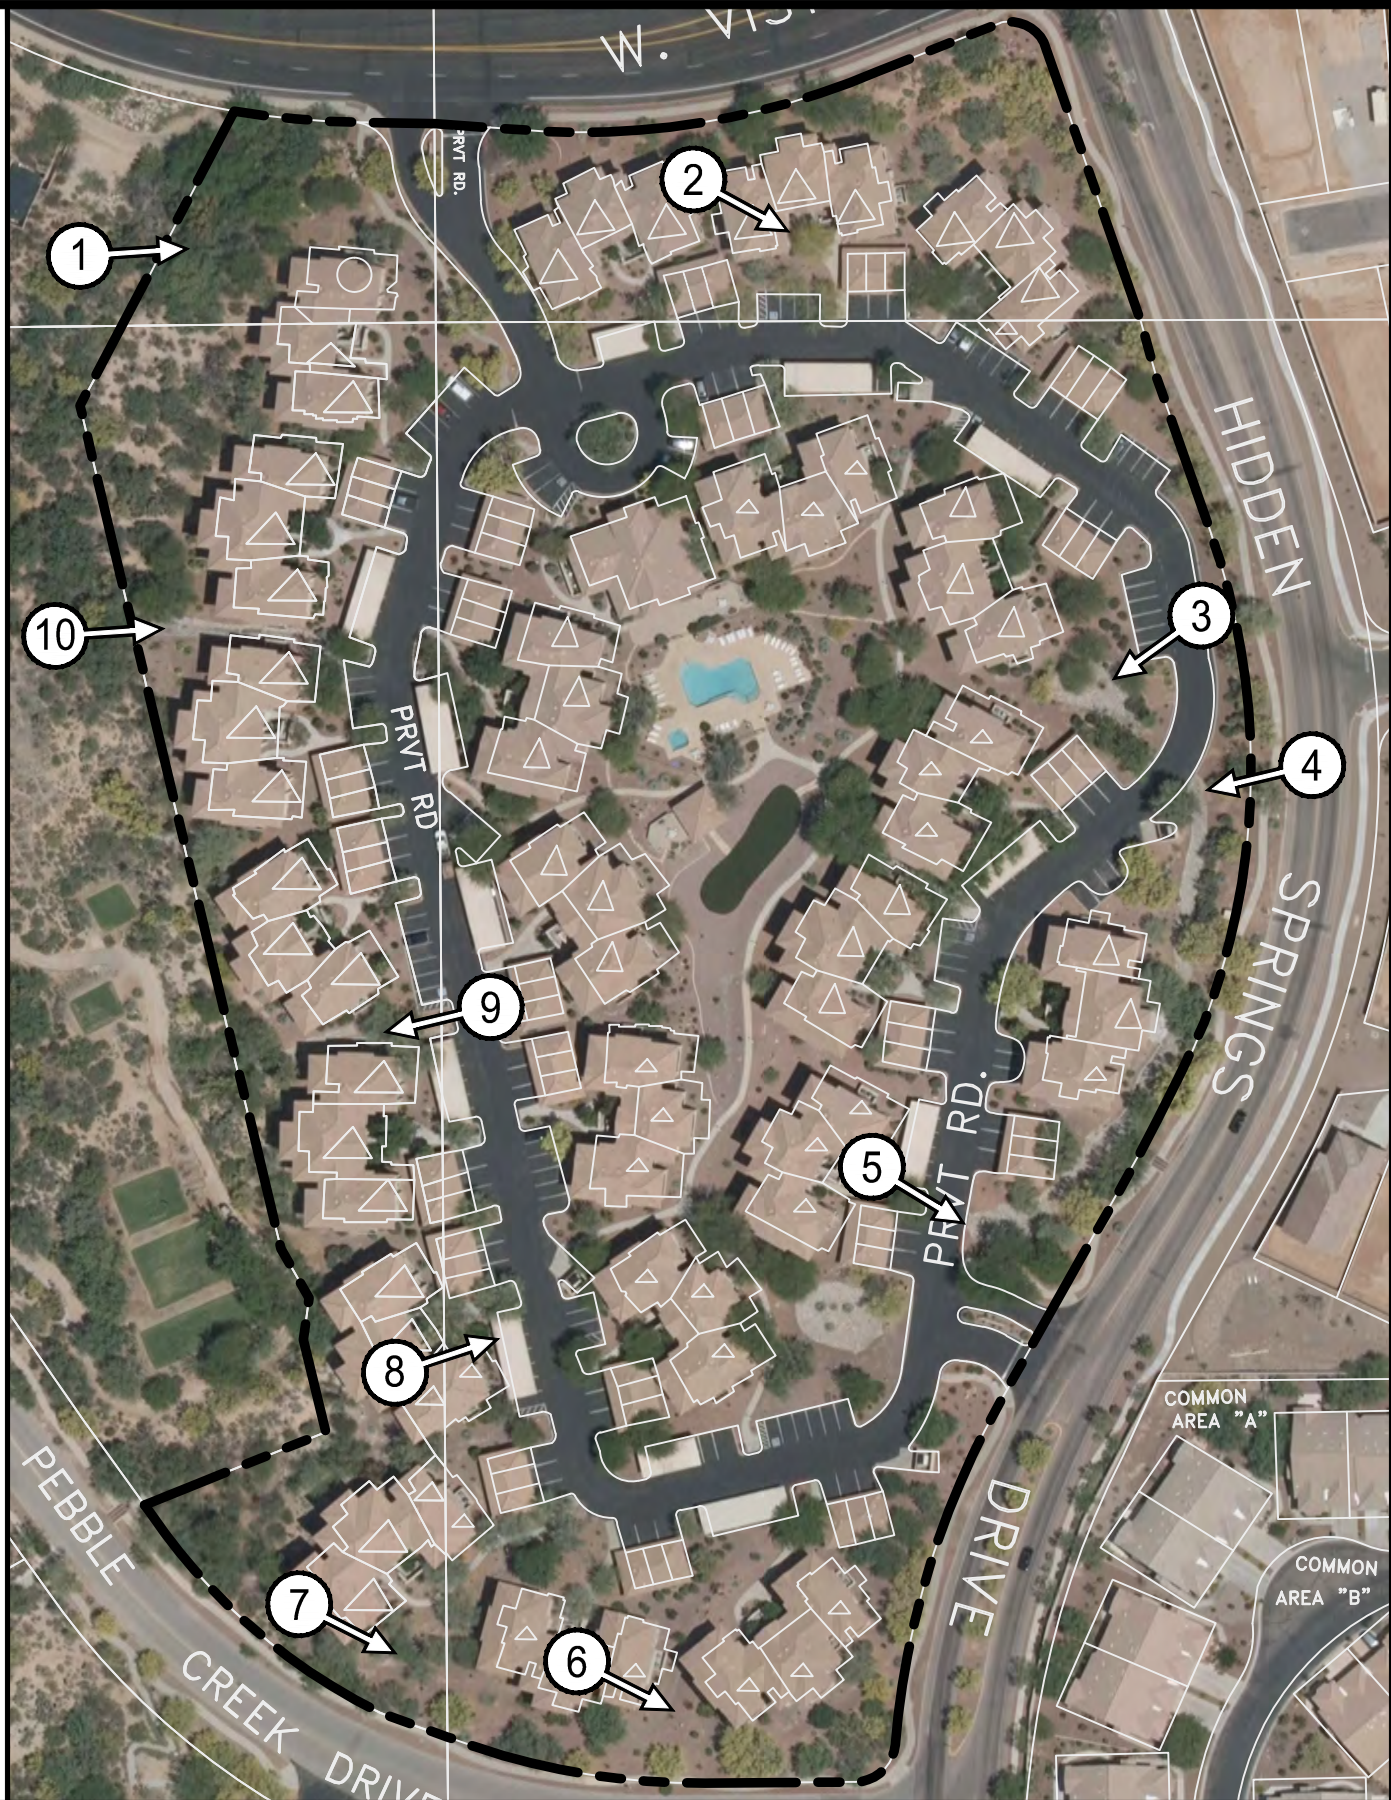
MAP 'VC' - VISTOSO RESORT CASITAS

RANCHO VISTOSO MASTER ASSOCIATION - DRAINAGE INVENTORY - NOVEMBER 2020				
Subdivision/Facility ID	Date/Description	Field Observations	Priority	Recommendations
Vistoso Resort Casitas (VC)	March 2020			PRIORITY: Red - Urgent, Blue - 0 to 6 months, Yellow - 6 to 12 months, Clear - Monitor
Site 1	Sept 20/Rip-rap Swales to Natural Open Area	Swales in good condition		
Site 2	Swale to Detention/Retention Basin	Minor sedimentation within basin		
Site 3	Curb Opening to Channel to Culvert	Minor seditmentation within channel		
Site 4	Detention/Retention Basins/Channels and Swales	Minor sedimentation within second basin		
Site 5	Curb opening to Channel/Swale	Rock rip rap within swale appears washed away.		Replace rock rip rap
Site 6	Grate / Channel to Grate Inlet / Channel	Sedimentation present within channel and grate inlet, channel failure and filter fabric exposure throughout		Repair failures within channel and remove sediment in the structures

Site 7	Channel to Splash Pad to Natural Open Area	Some sedimentation within channel bottom, some failure in channel sidewalls		Repair channel and remove sediment
Site 8	Sept20/ Drainage Swales	Drainage swales in good condition		
Site 9	Sept 20/ Rip-Rap Drainage Swale	Swale - displaced rip-rap, grate covered with rock/sediment, vegetation at outlet		Repair swale - replace rip-rap and filter fabric, clean grate area and replace, clear vegetation at outlet
Site 10	Sept 20/ Rip-rap Drainage Swale	Swale - displaced rip-rap, sediment at entrance, filter fabric exposed		Repair swale - replace rip-rap and filter fabric, remove sediment, clear vegetation at outlet
