FINAL 11-16-20

MAP 'AA' - AREAS WITHIN ASSOCIATION RESPONSIBILITY

RANCHO VISTOSO COMMUNITY ASSOCIATION - DRAINAGE FACILITIES INVENTORY MAP 'ES' - EAGLE SUMMIT

2020.03.xx
WLB No. 185050-V-A06

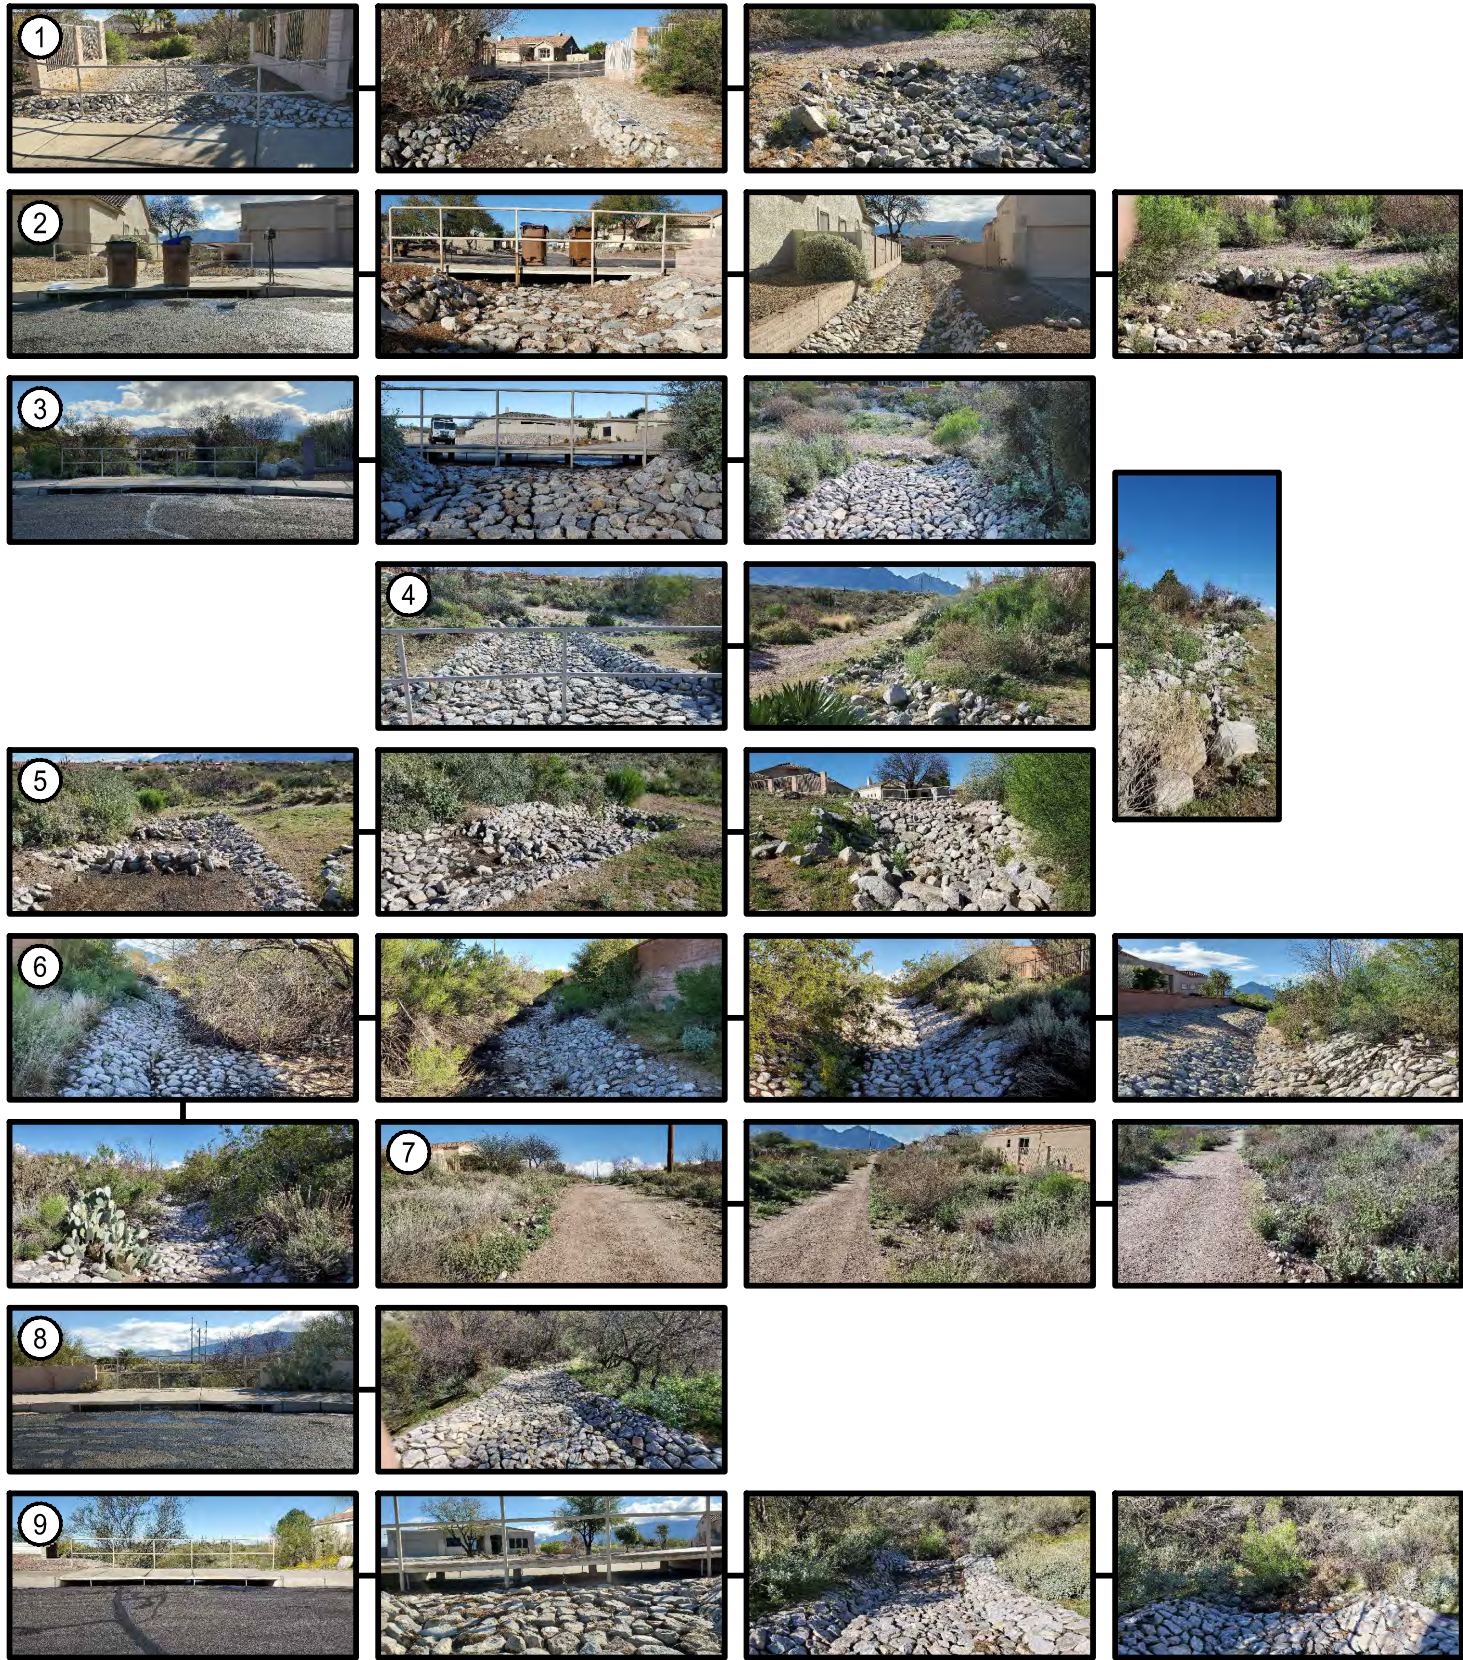
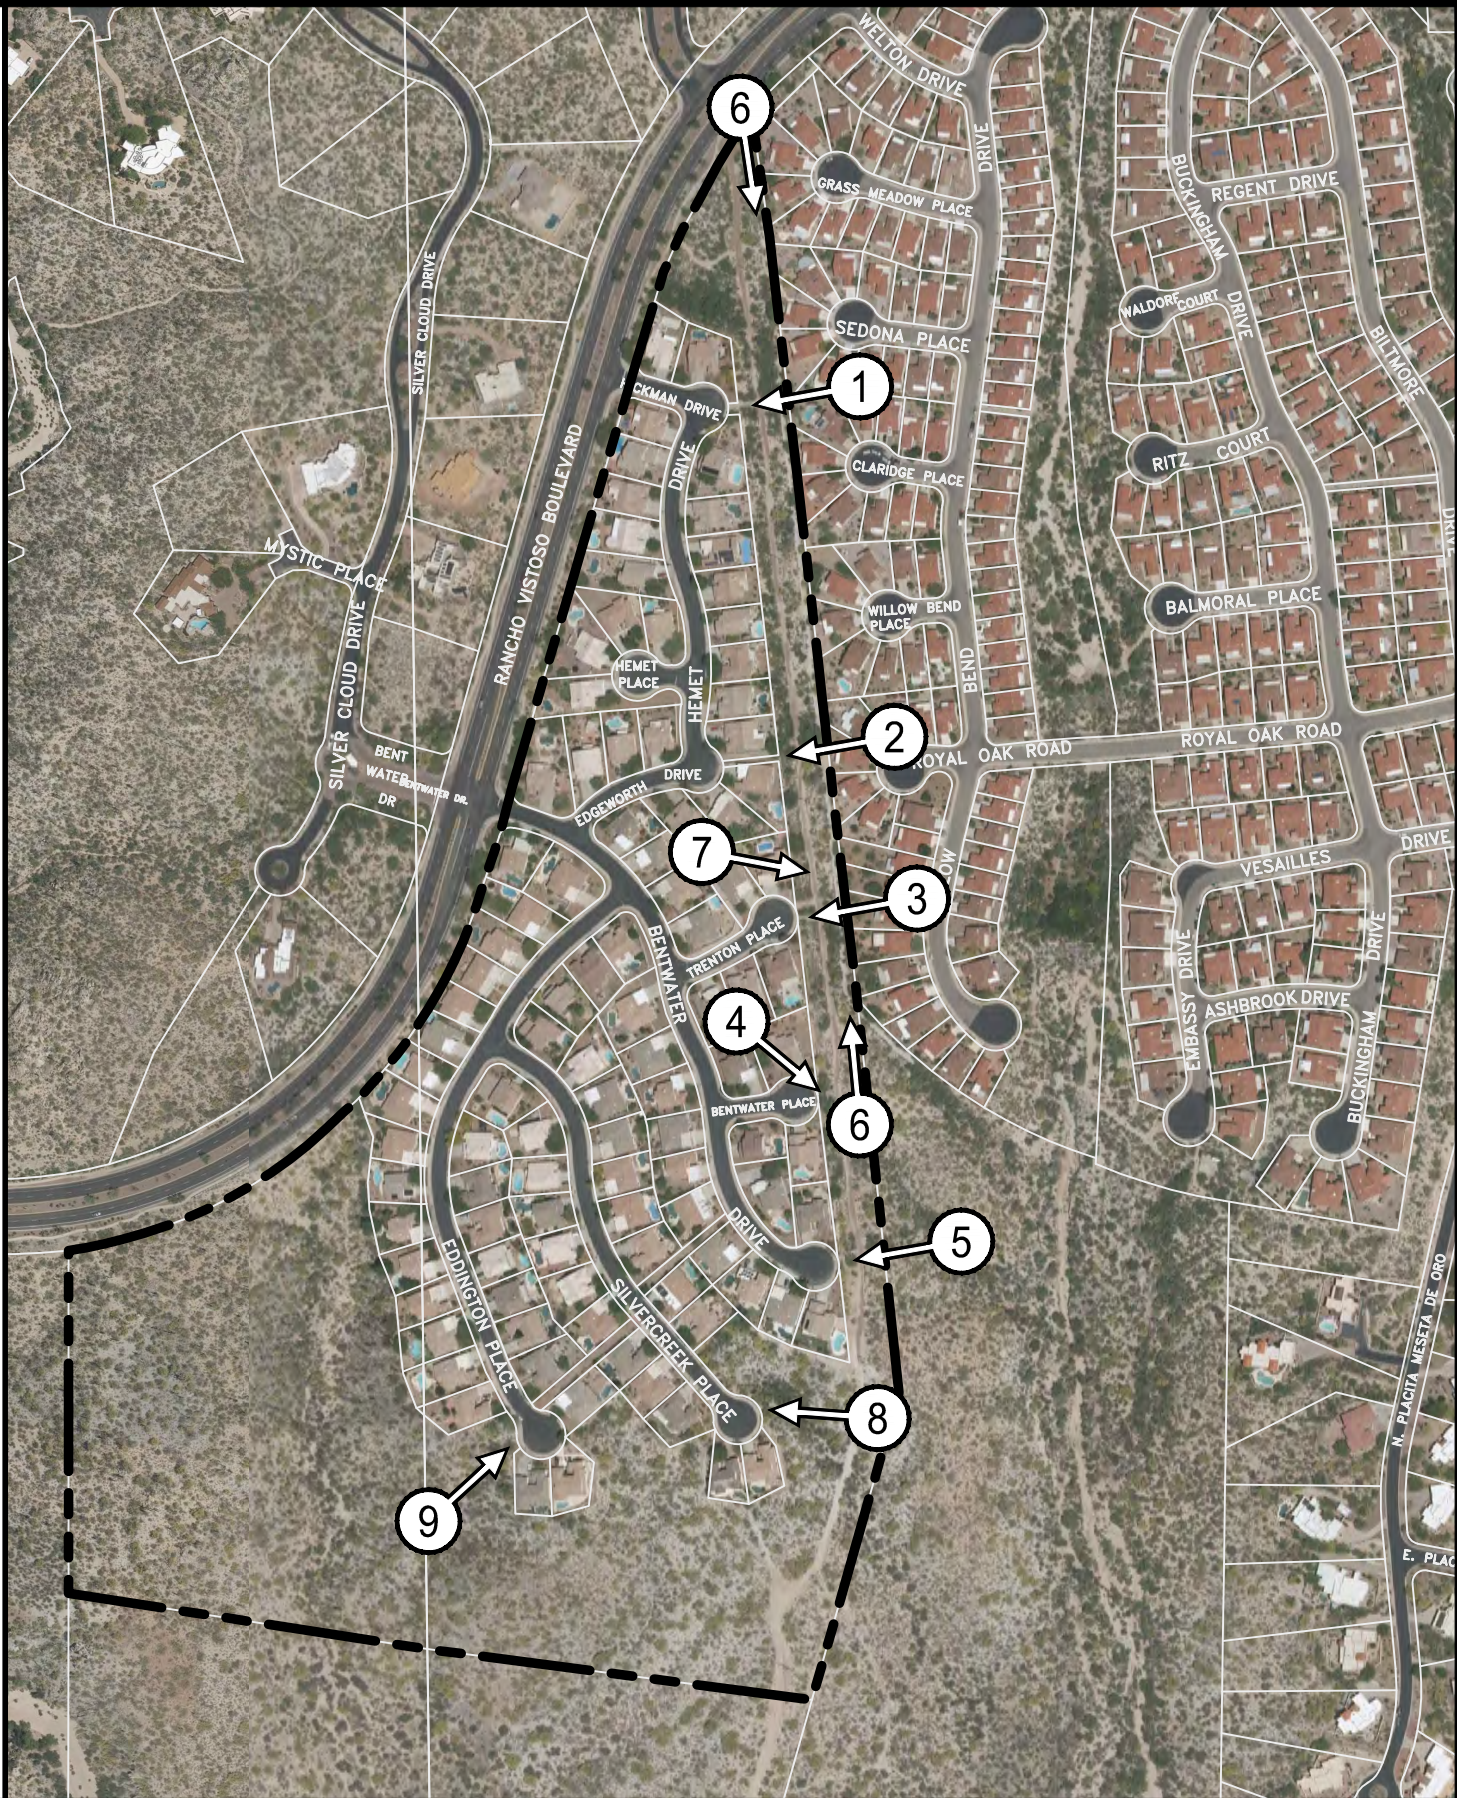
MAP 'VH' - VISTOSO HEIGHTS

RANCHO VISTOSO MASTER ASSOCIATION				
Subdivision/Facility ID	Date/Description	Field Observations	Priority	Recommendations
Vistoso Heights (VH)	March 2020			PRIORITY: Red - Urgent, Blue - 0 to 6 months, Yellow - 6 to 12 months, Clear - Monitor
Site 1	Depressed Curb to Channel	Minor sedimentation, channel intact		Bleeder pipes at end of channel may need maintenance
Site 2	Sidewalk Scupper to Channel	Minor sedimentation within channel, some small stones within channel		
Site 3	Sidewalk Scupper to Channel	Minimal sedimentation, channel intact		
Site 4	Depressed Curb to Channel and Swale	Rip rap splash pad intact, some failure within swale		Repair swale
Site 5	Depressed Curb to Channel	Minimal degradation/aggradation; missing rock		Replace rock
Site 6	Channel	Overgrowth within channel, sedimentation present		Renove excess overgrowth and sediment
Site 7	Channel	Vegetation within channel, some channel failure		Remove vegetation and repair channel

Site 8	Sidewalk Scupper to Channel	Clear of sedimentation, channel intact		
Site 9	Sidewalk Scupper to Channel	Scupper clear of sedimentation and debris, minimal sedimentation within channel bottom, minor headcut at outlet

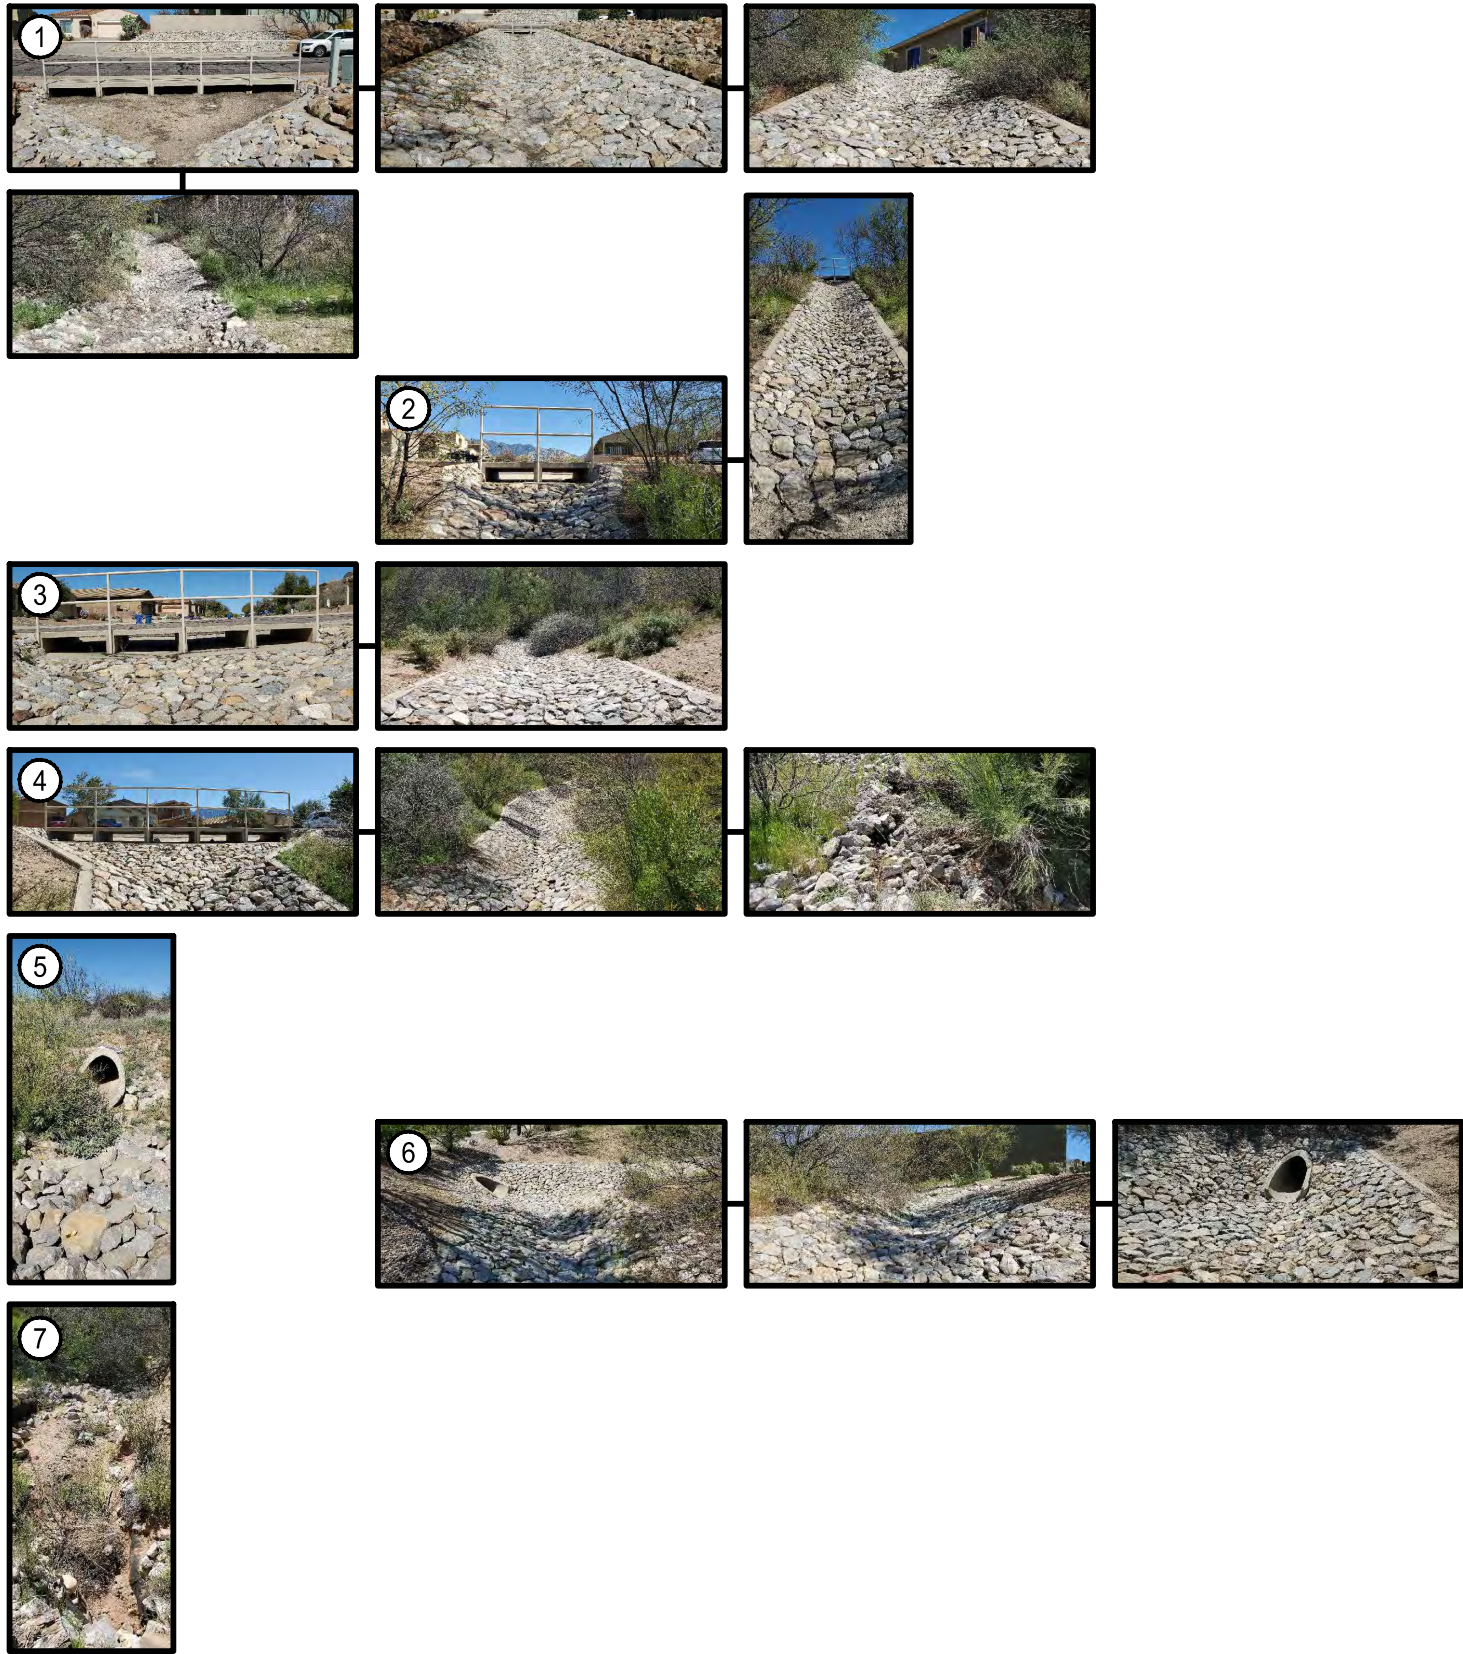
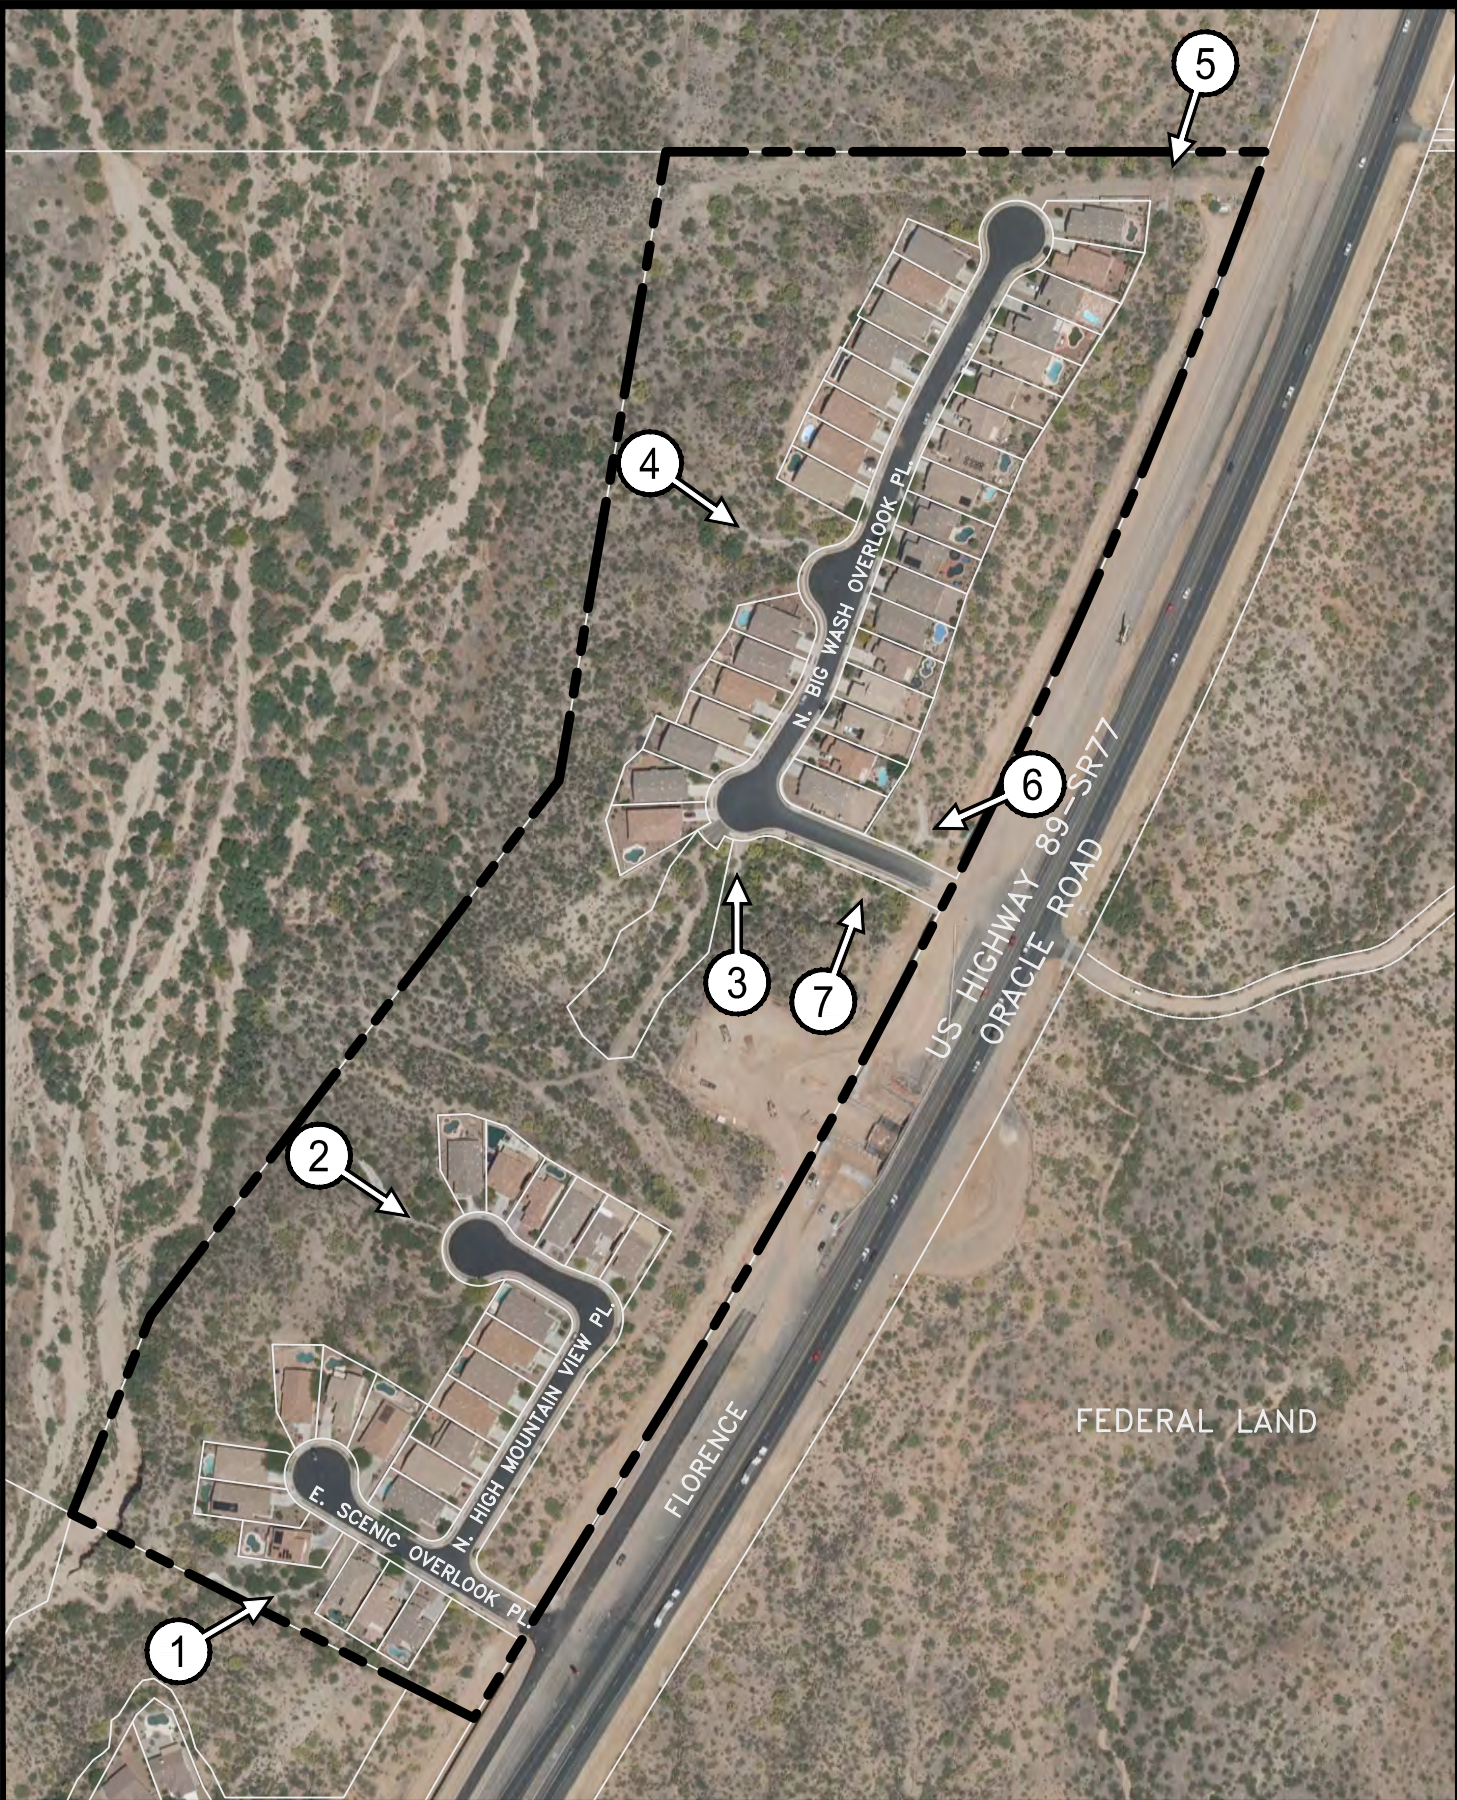
MAP 'VM' - VISTA MIRABELLA

RANCHO VISTOSO MASTER ASSOCIATION				
Subdivision/Facility ID	Date/Description	Field Observations	Priority	Recommendations
Vistoso Mirabella (VM)	March 2020			PRIORITY: Red - Urgent, Blue - 0 to 6 months, Yellow - 6 to 12 months, Clear - Monitor
Site 1	Sidewalk Scupper to Channel	Minor sedimentation within scupper and channel		
Site 2	Sidewalk Scupper to Channel	Structure and channel clear of sediment		
Site 3	Sidewalk Scupper to Channel	Rip rap splash pad somewhat obstructed		Remove vegetated overgrowth in and adjacent to structure
Site 4	Sidewalk Scupper to Channel	Structure clear of sediment and debris, channel/splash pad failure at the end		Repair channel/splash pad failure
Site 5	Offsite Culvert	Culvert clear, some obstruction within splash pad		Remove vegetated overgrowth
Site 6	Channels to Culverts	Channels and culvert clear of sedimentation and debris		
Site 7	Culvert Outlet	Some deterioration of splash pad, filter fabric exposed		Repair splash pad (culvert outlet)

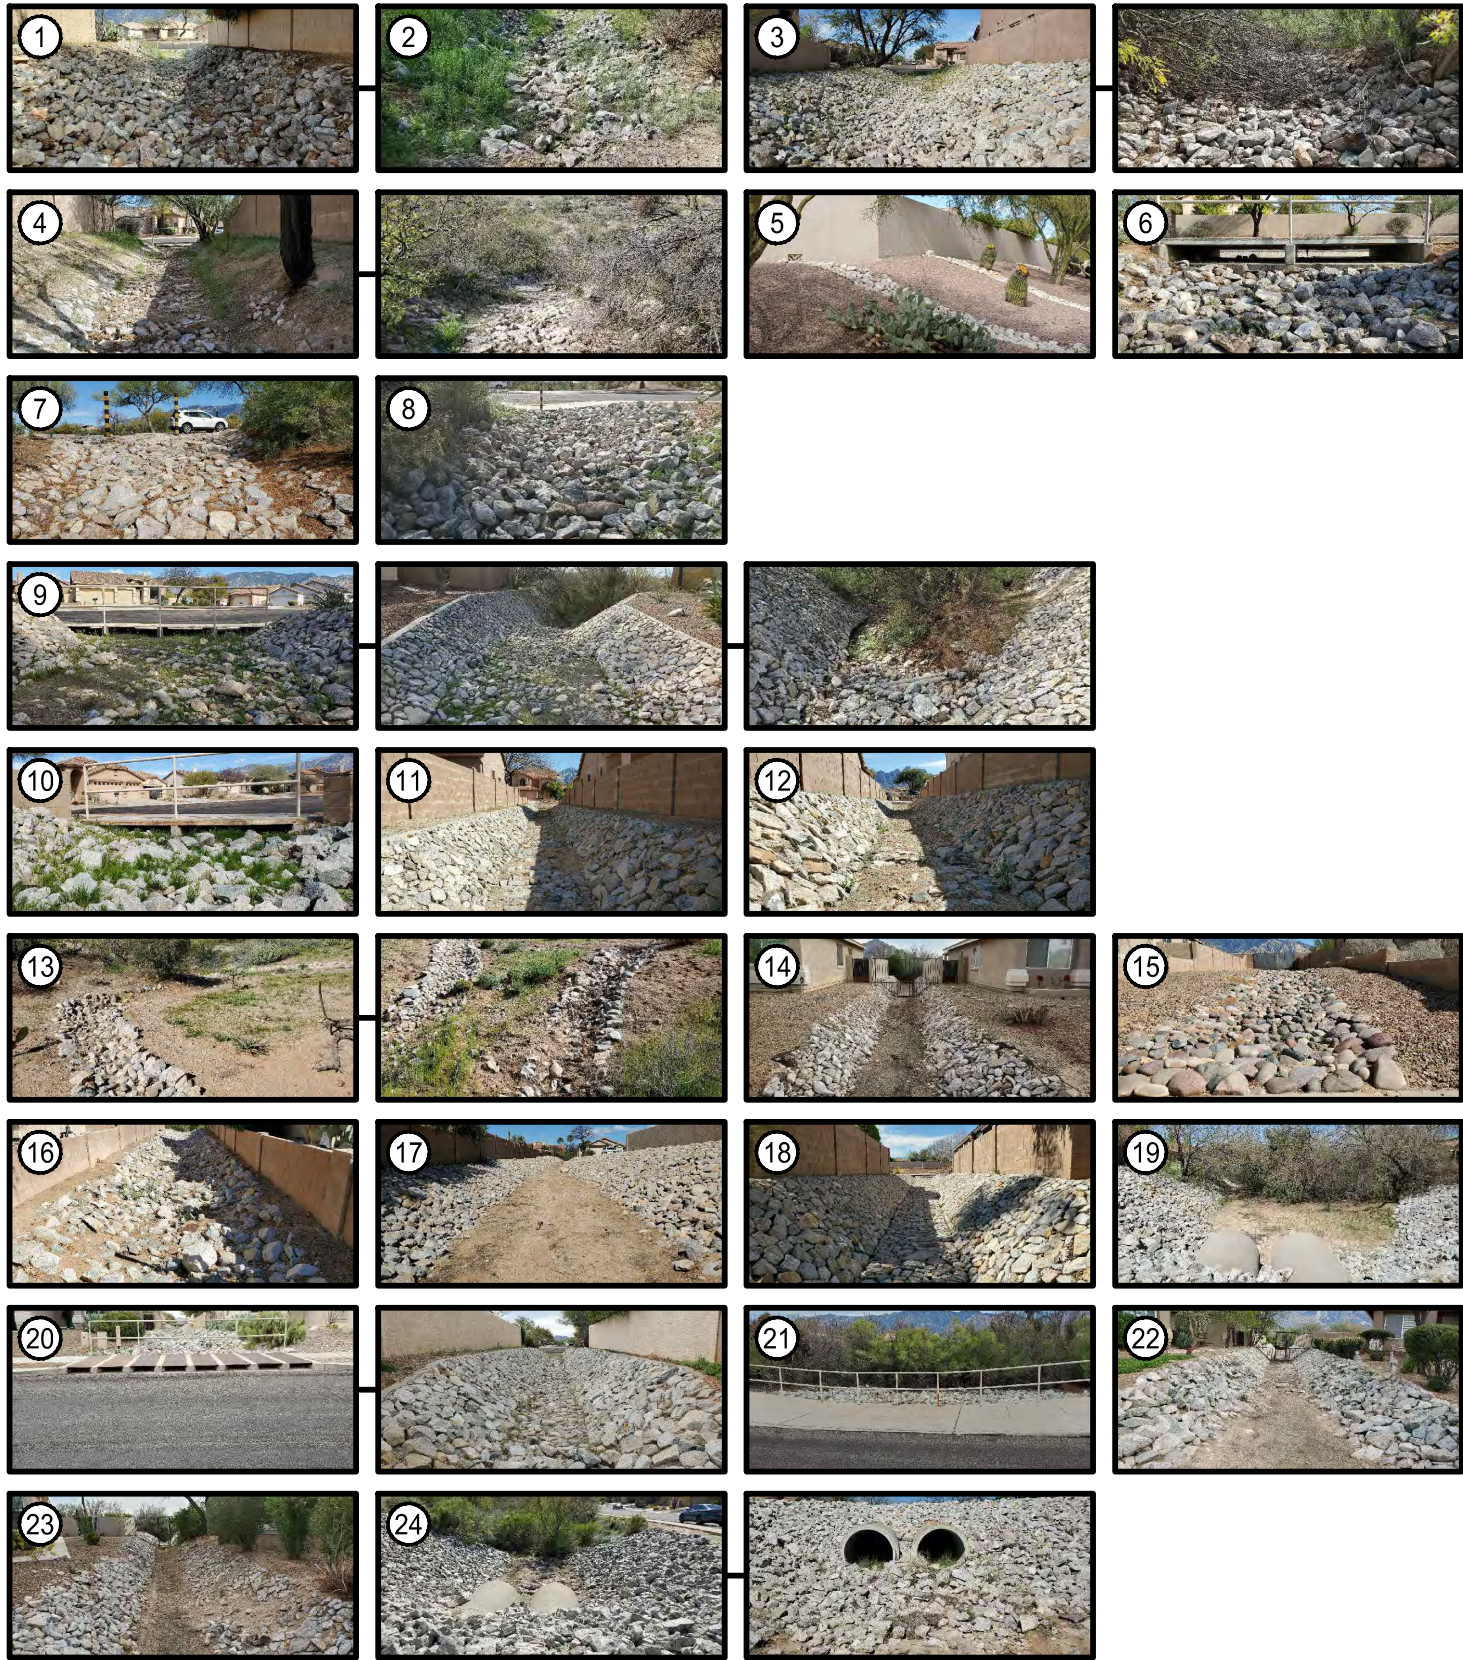
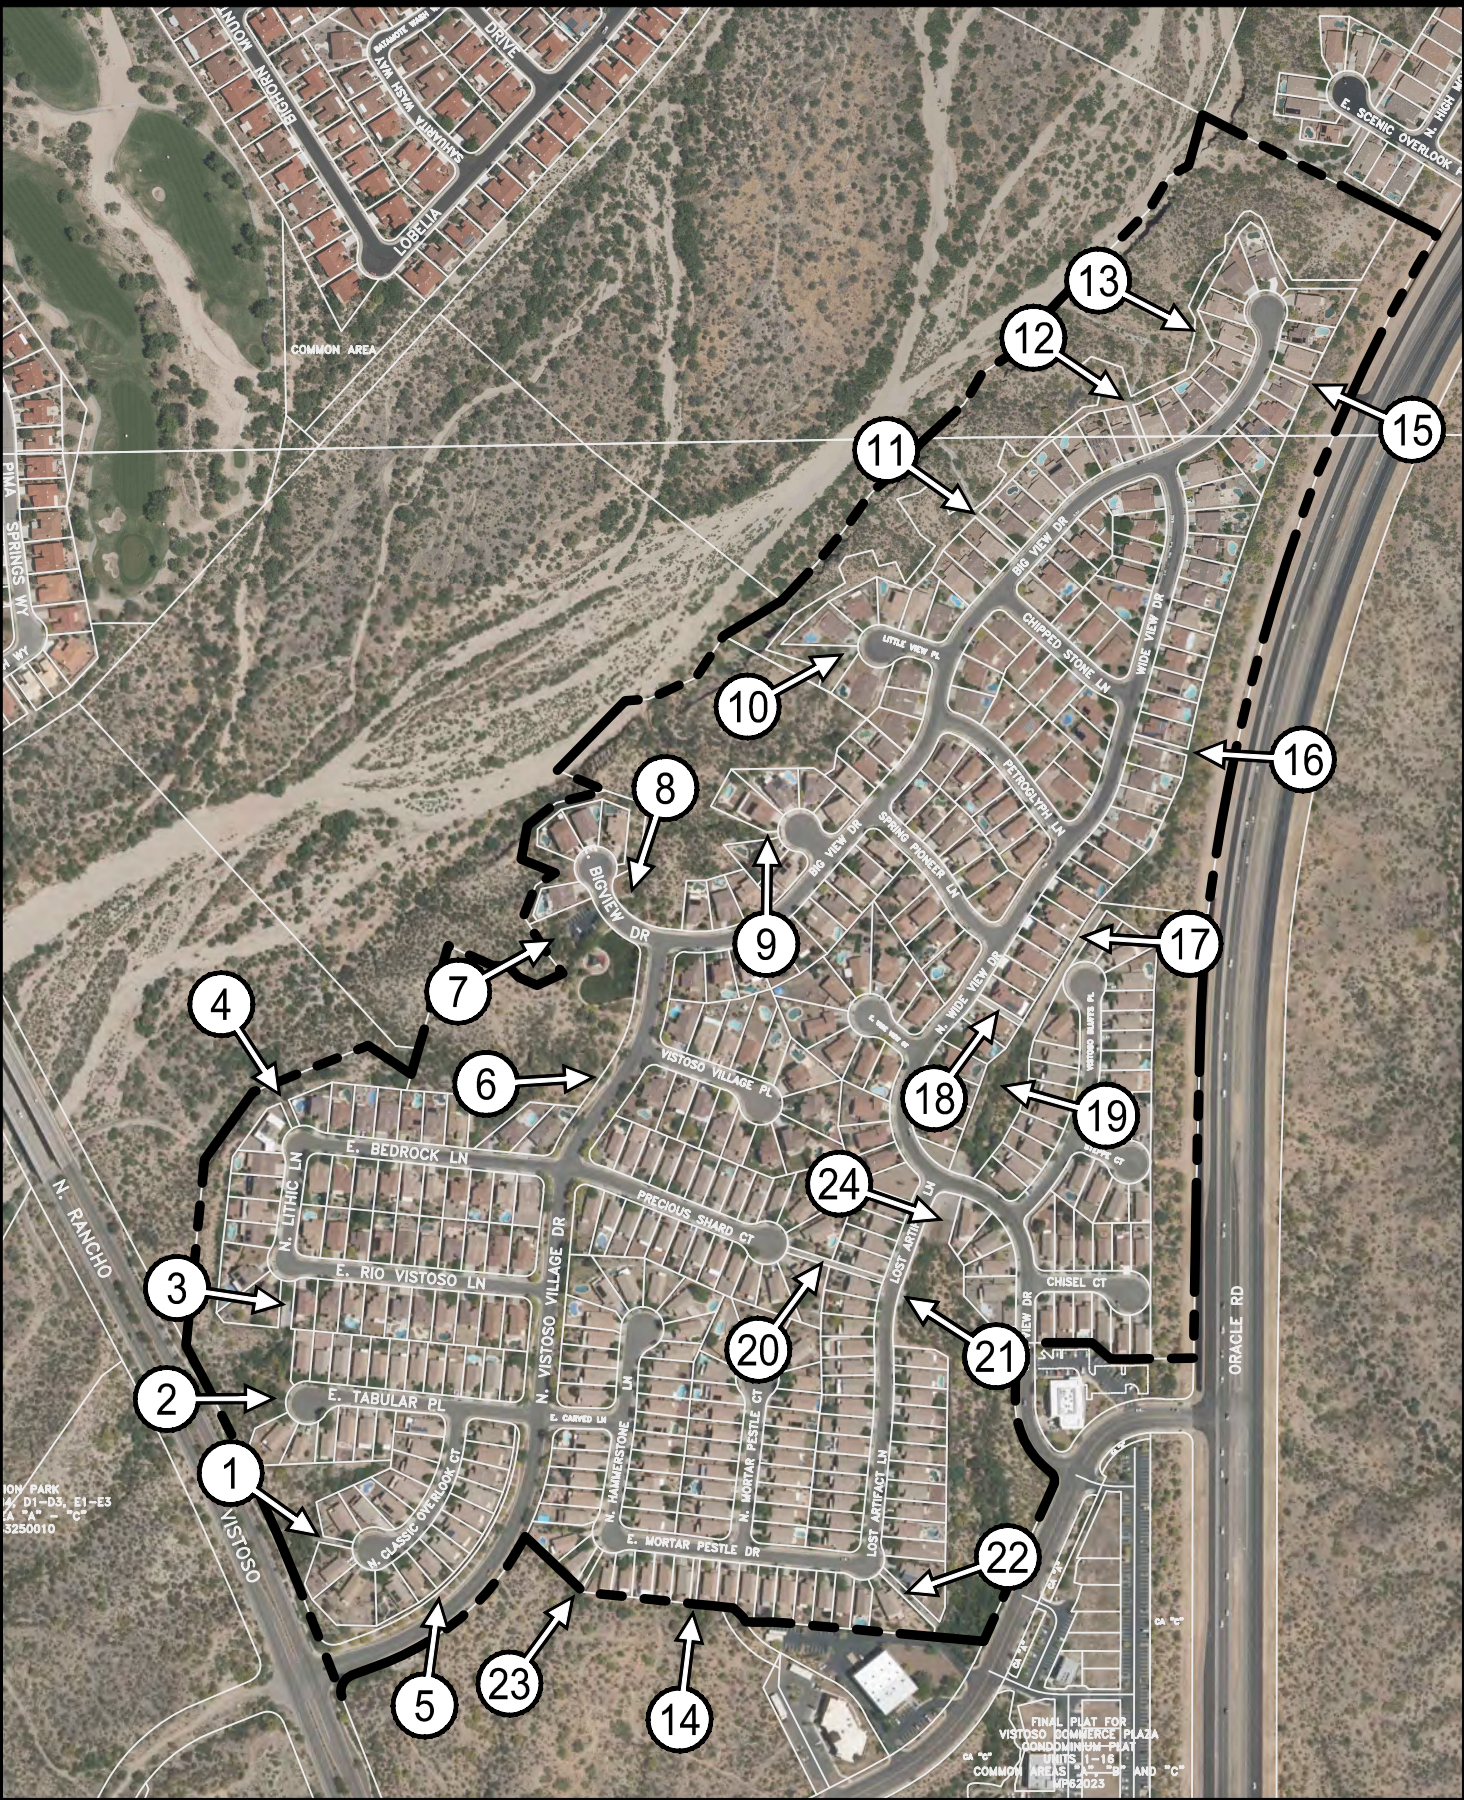
MAP 'VV' - VISTOSO VISTAS

RANCHO VISTOSO MASTER ASSOCIATION				
Subdivision/Facility ID	Date/Description	Field Observations	Priority	Recommendations
Vistoso Vistas (VV)	March 2020			PRIORITY: Red - Urgent, Blue - 0 to 6 months, Yellow - 6 to 12 months, Clear - Monitor
Site 1	Channel	Channel and hand placed rip rap in good condition		
Site 2	Swale	Rip rap swale, some overgrowth, minor sedimentation		Remove vegetative overgrowth
Site 3	Sidewalk Scupper to Channel	Some vegetation overgrowth and obstruction		Remove vegetative overgrowth
Site 4	Sidewalk Scupper to Channel	Sedimentation within channel		Clean sediment from channel
Site 5	Weep Hole/Swales	Weepholes and swales clear of sediment/debris		
Site 6	Sidewalk Scupper	Scupper clear of sediment/debris		
Site 7	Depressed Curb/Splash pad	Minor sedimentation		
Site 8	Depressed Curb/Splash pad	Structure in good condition		
Site 9	Sidewalk Scupper/Channel	Minor sedimentation within channel, grade control structure shows some failure		Repair grade control structure; remove sediment

Site 10	Sidewalk Scupper	Minor vegetation overgrowth		
Site 11	Sidewalk Scupper to Channel	Minor sedimentation within channel		
Site 12	Sidewalk Scupper to Channel	Minor sedimentation within channel		
Site 13	Weep Hole/Swales	Minor sedimention		
Site 14	Channel	Minor sedimentation		
Site 15	Swale	Minor sedimentation		
Site 16	Channel	Some failure within channel sidewalk, minor sedimentation		Repair sidewalk; remove sediment
Site 17	Channel	Some sidewall failure, boulders within channel; recommend clearing		Repair sidewalk; remove boulders from channel
Site 18	Channel	Channel in good condition		
Site 19	Detention/Retention Basin/Culvert	Vegetative overgrowth within basin		Remove overgrowth
Site 20	Channel/Scupper	Structures in good condition		
Site 21	Depressed Curb	Structure in good condition		
Site 22	Channel	Sedimentation within channel bottom		Remove sediment
Site 23	Channel	Sedimentation within channel, minor sidewall failure		Repair wall; remove sediment

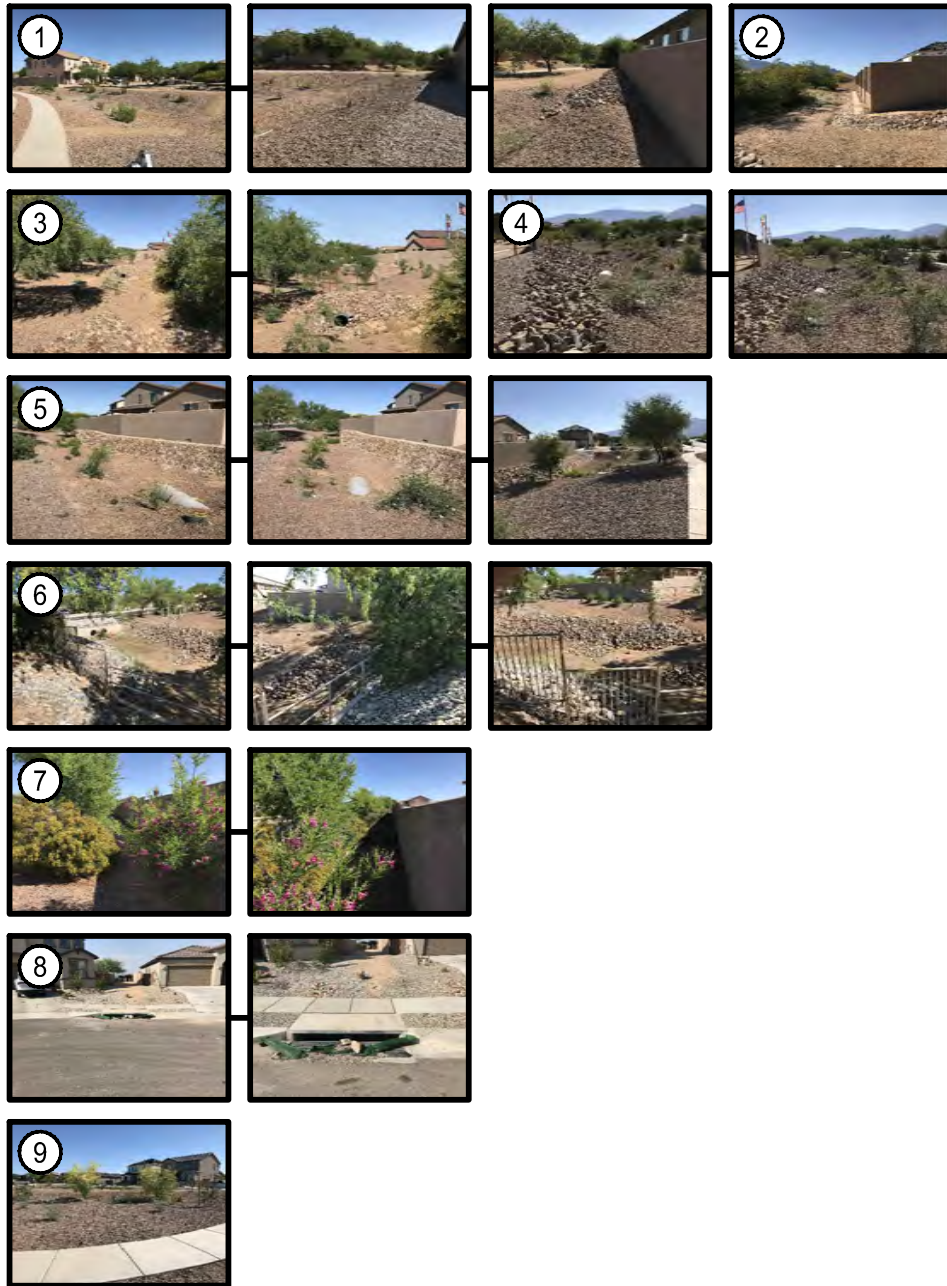
RANCHO VISTOSO MASTER ASSOCIATION				
Subdivision/Facility ID	Date/Description	Field Observations	Priority	Recommendations
Site 24	Culvert Outlet	Minor sedimentation and debris build up at outlet
